STATE OF NEW HAMPSHIRE
DEPARTMENT OF TRANSPORTATION

IN-DEPTH INSPECTION AND CONDITION REPORT

GENERAL SULLIVAN BRIDGE - DOVER 200/023
OVER THE LITTLE BAY

May 2014 Inspection
and
June 2016 Inspection

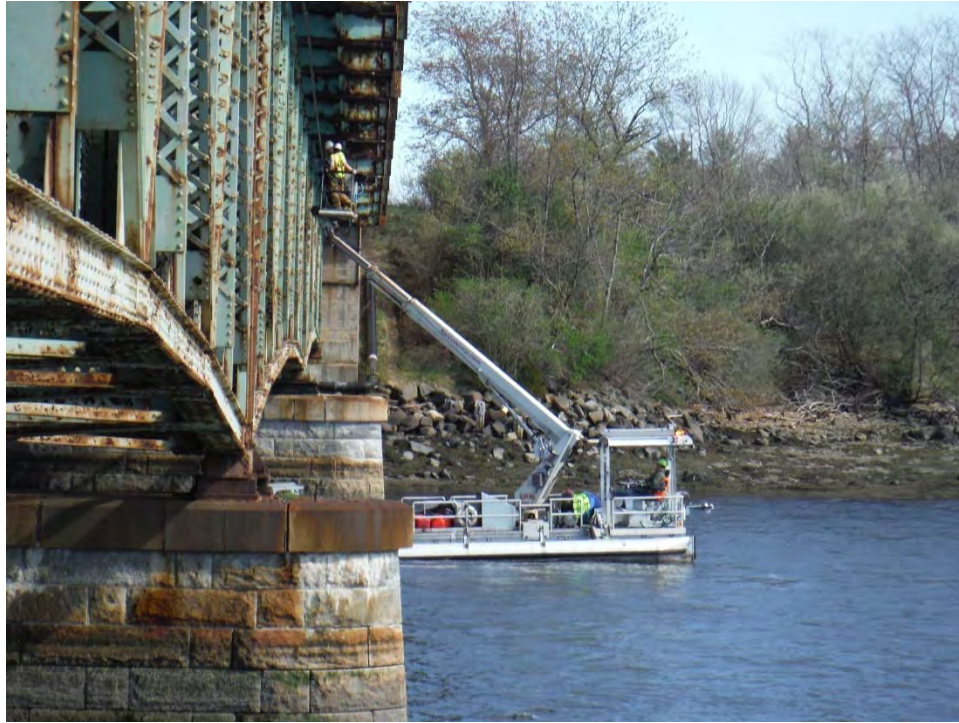
Photo M.1: Proprietary inspection equipment, including the Bucket Boat (shown), and the Tracker (an all-terrain treaded vehicle) were used to inspect Floor systems of Spans 1-2 and 8-9, as well as Trusses of Spans 1-3 and 7-9.

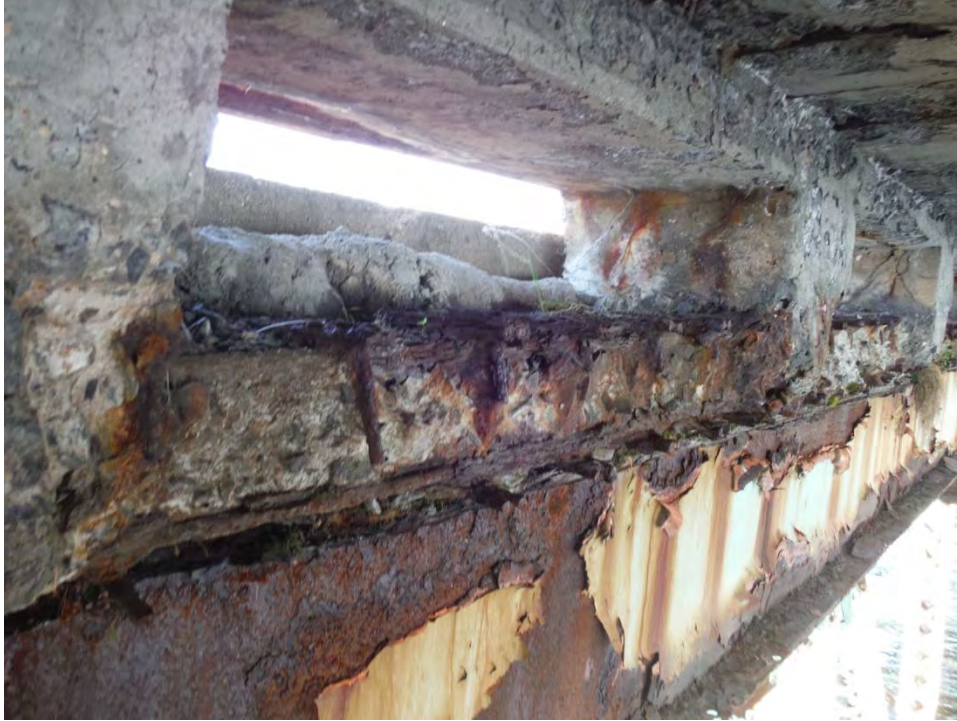
Photo D.1: Span 7, East end of deck at deck drains. Severe spalling and up to 100% section loss in rebar at ends typical.

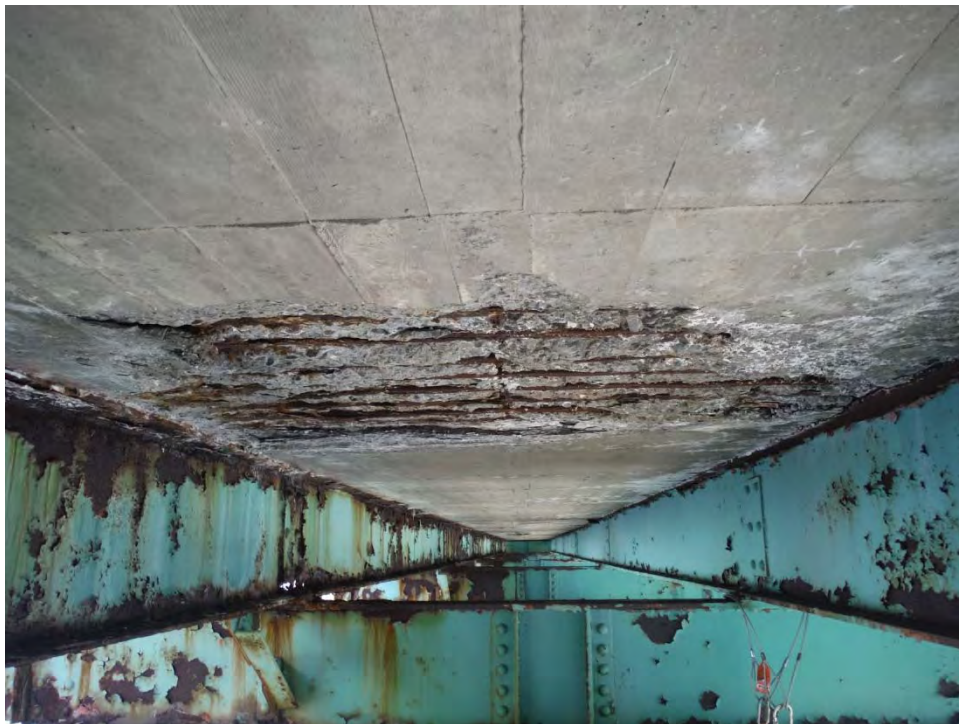
Photo D.2: Span 3, deck at mid-panel between Floorbeams 8 and 9, also between Stringers 4 and 5. Typical spalling in deck, exposed rebar with section loss.

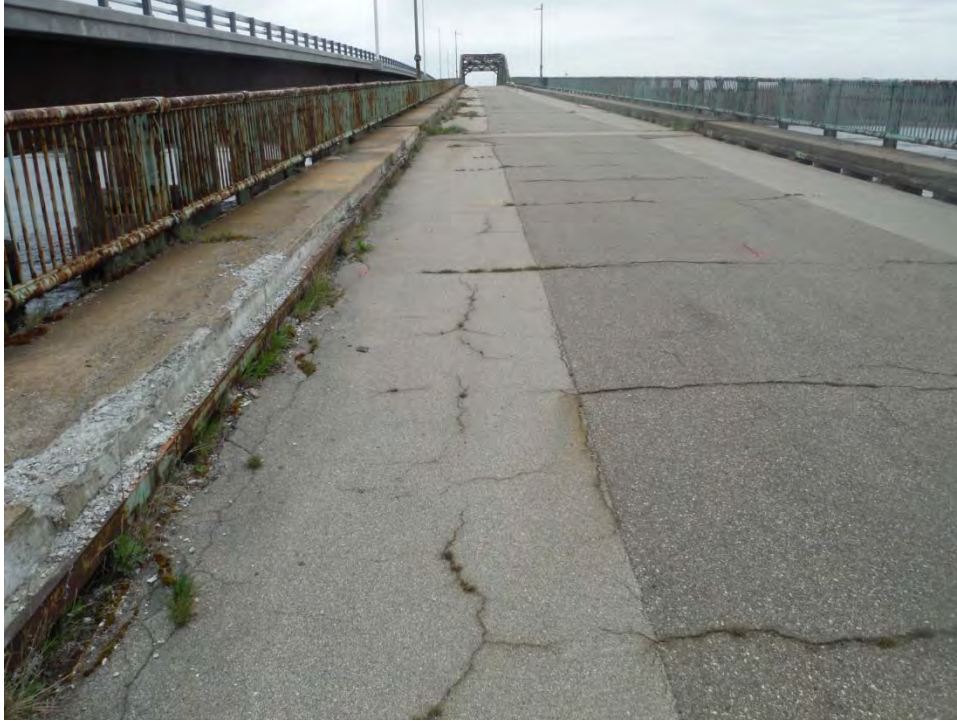
The bituminous wearing surface of the bridge deck has been patched and repaired numerous times. The wearing surface ranges in thickness from 2 1/2" to 5 1/2". There is cracking of the wearing surface throughout the bridge with vegetation growth adjacent to the gutter line. See Photo D.3 and D.4.

Photo D.3: Bridge looking south from north approach. Cracking in deck wearing surface with vegetation typical throughout bridge.

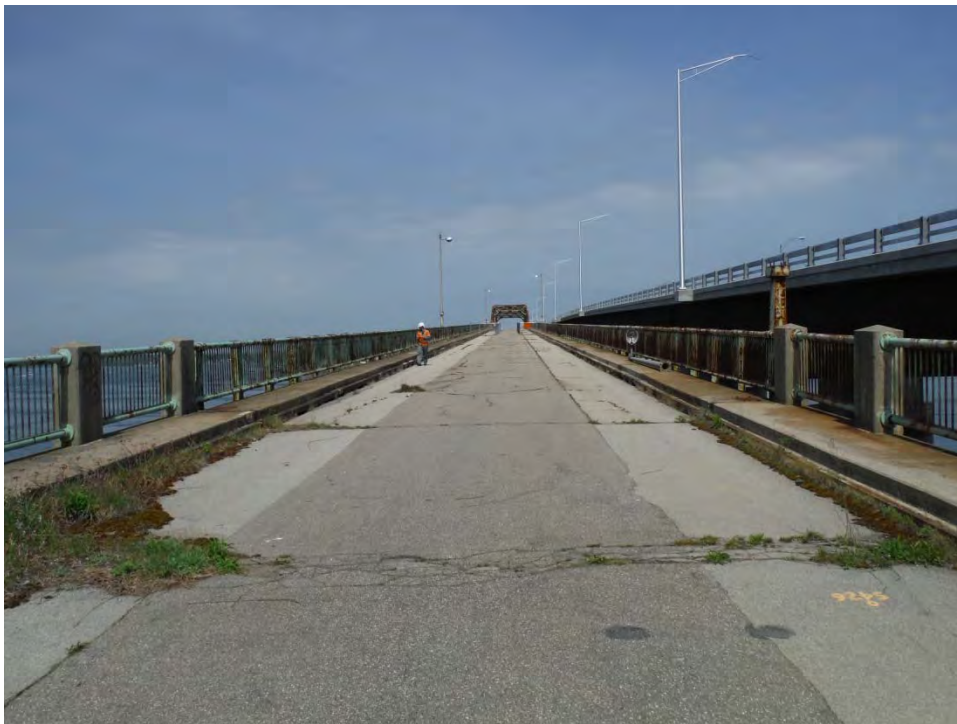
Photo D.4: Bridge looking north from south approach.

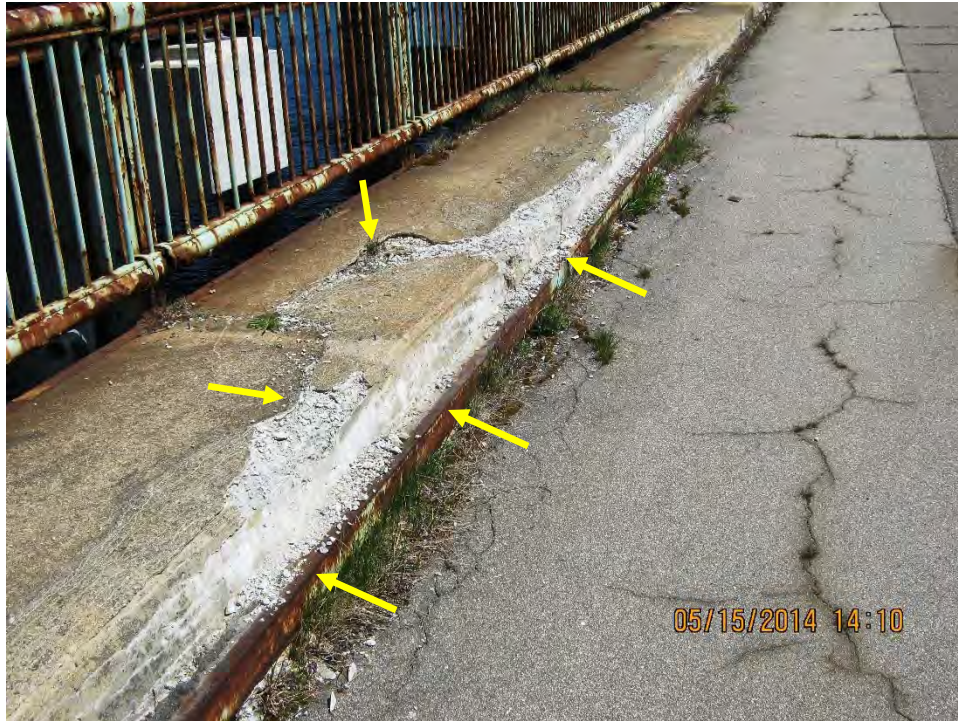
Shallow spalls to 1" were found on the sidewalk surface throughout the bridge. Spalls and cracking were also found at the curb randomly throughout the bridge. The east curb in Span 1 has a large area of spalling where the channel member has separated from the curb and large cracks have formed. See Photo D.5. The west curb in Span 6, near mid-span, exhibits spalling and sagging, with spalls in the concrete pedestals supporting the sidewalk (between deck drains). See Photo D.6.

Photo D.5: Span 1, curb over east fascia. Large area of curb spall where channel has separated from curb and large cracks have formed. Similar condition exists on several locations throughout the deck.

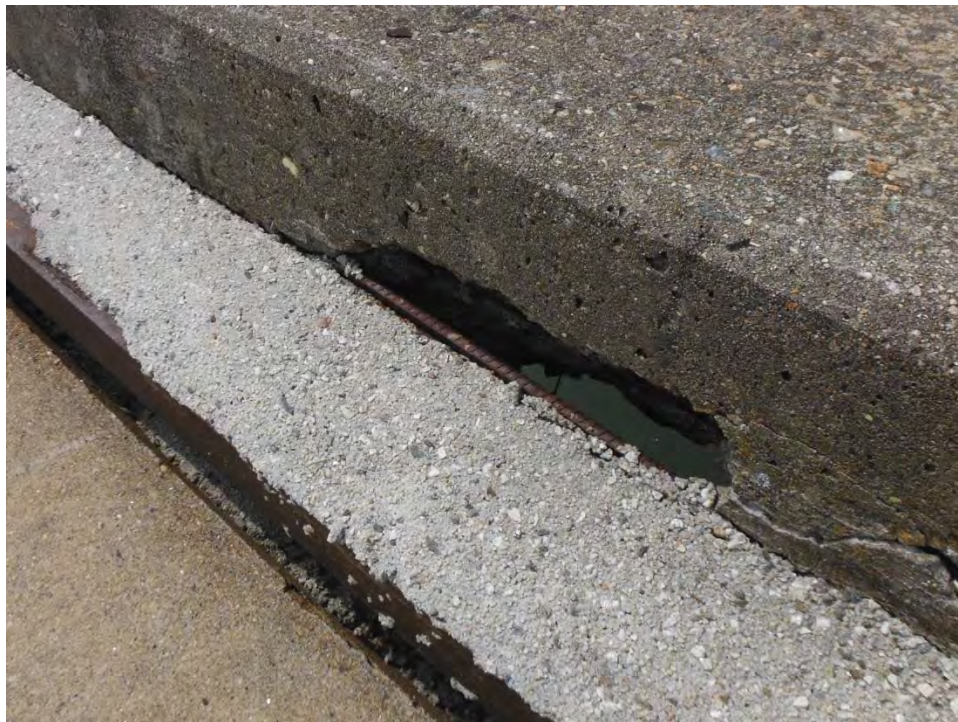
Photo D.6: Span 6, west curb at mid-span. Spalling and cracking in curb at mid-span. Stringer at this location exhibits signs of overstress

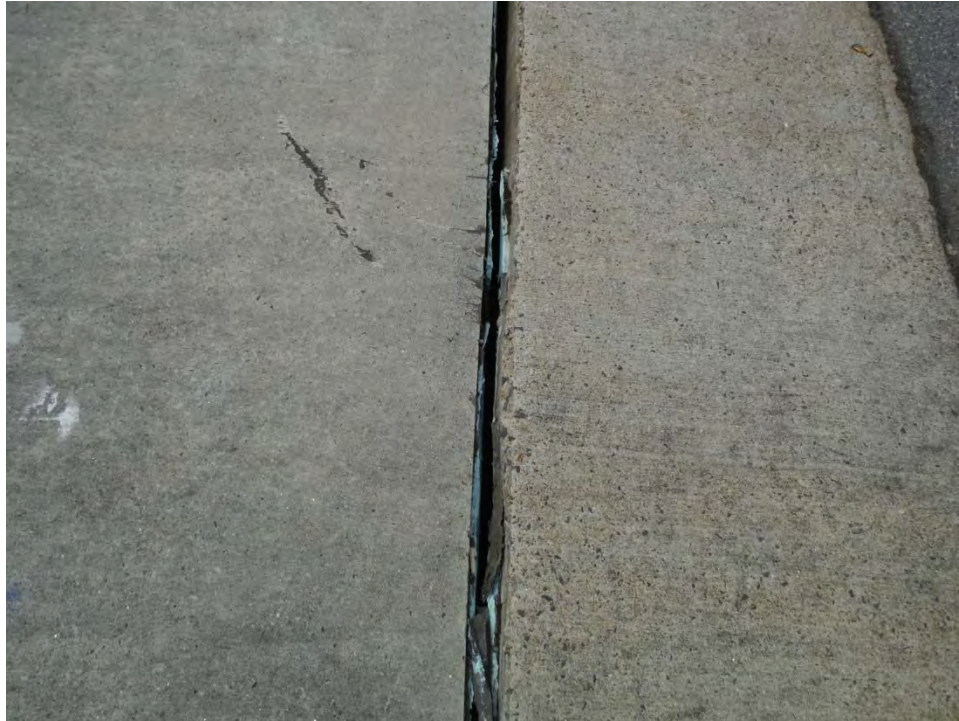
The deck joint seals are typically failed, with the exception for the joint at Pier 7. See Photo D.7. The armored joints at sidewalks exhibit rusting throughout, and prying to 3/4" at the east sidewalk at the Pier 3 and Pier 6 joints and the west sidewalk at the Pier 3 joint.

Photo D.7: Deck joint at Pier 6. Joint seal failed full width.

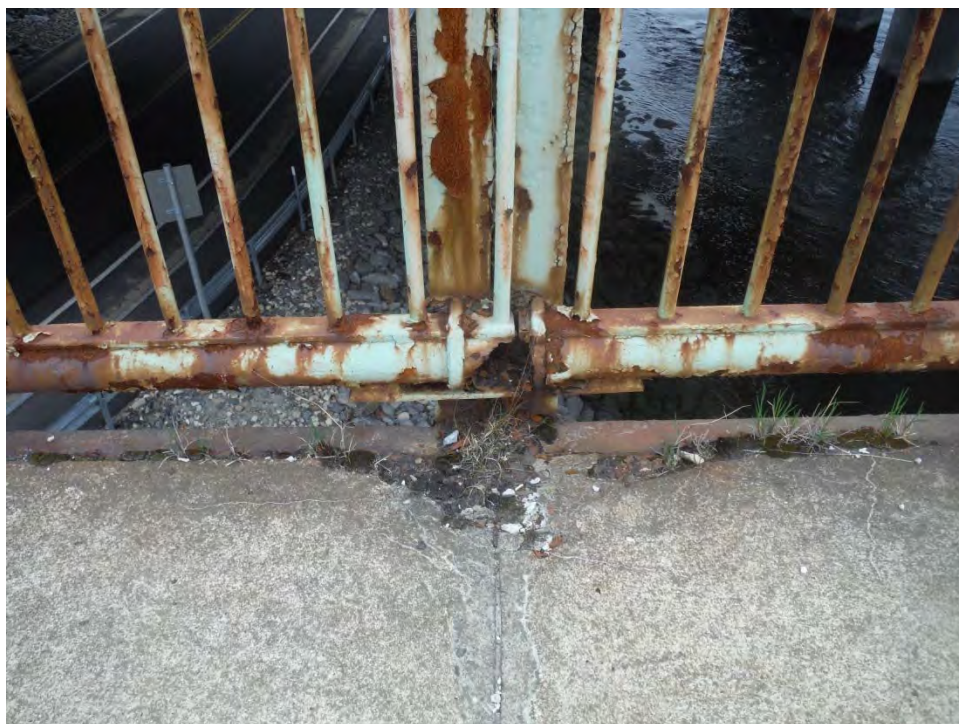
The lower bridge railing has perforations due to corrosion, especially where it connects to posts. Support posts for the railing have section loss along the interface with the deck, and along the interface at the floorbeams. See Photo D.8 and D.9.

Photo D.8: Span 1, bridge railing and post. Up to 100% section loss in lower rail, and over 50% section loss in post flanges typical throughout bridge.

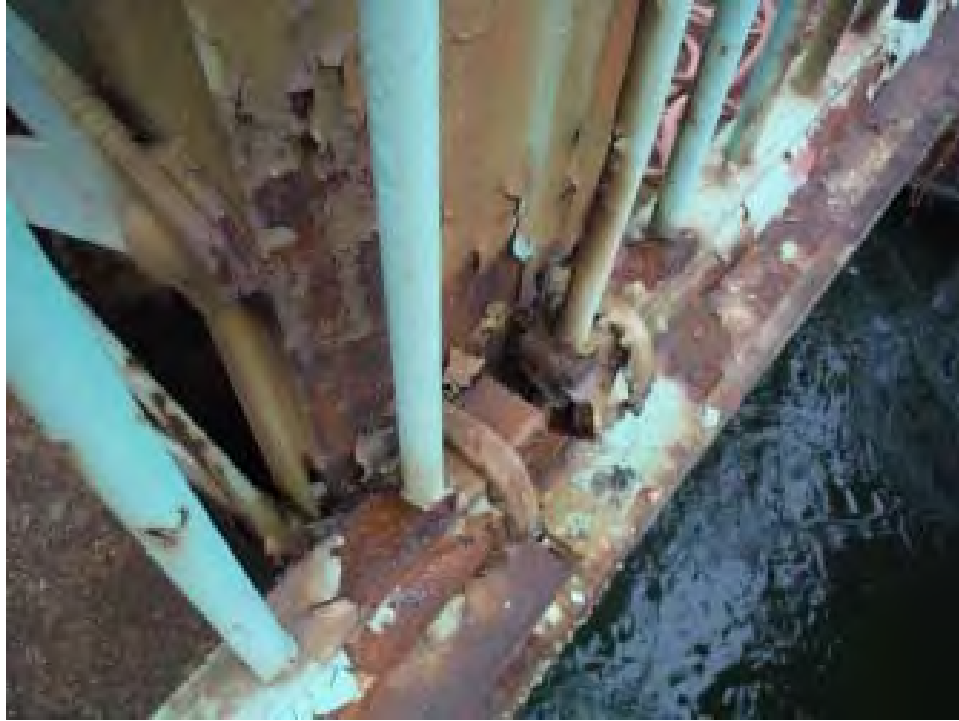
Spans 4 through 6 truss members located below the bridge deck and railing range from poor to fair condition. Truss members above the bridge railing were generally in satisfactory condition. Truss members located above the deck, in Span 5, typically exhibit paint failure and surface corrosion. There are some isolated areas with up to 1/16" section loss. Span 5 truss verticals and diagonals exhibit section losses along their connection to the bridge railing, with section losses up to 3/16". See Photo D.9.

Photo D.9: Span 5, railing at top of east vertical member L11'-U11'. Section loss to exterior web of vertical channel. Similar condition throughout Span 5

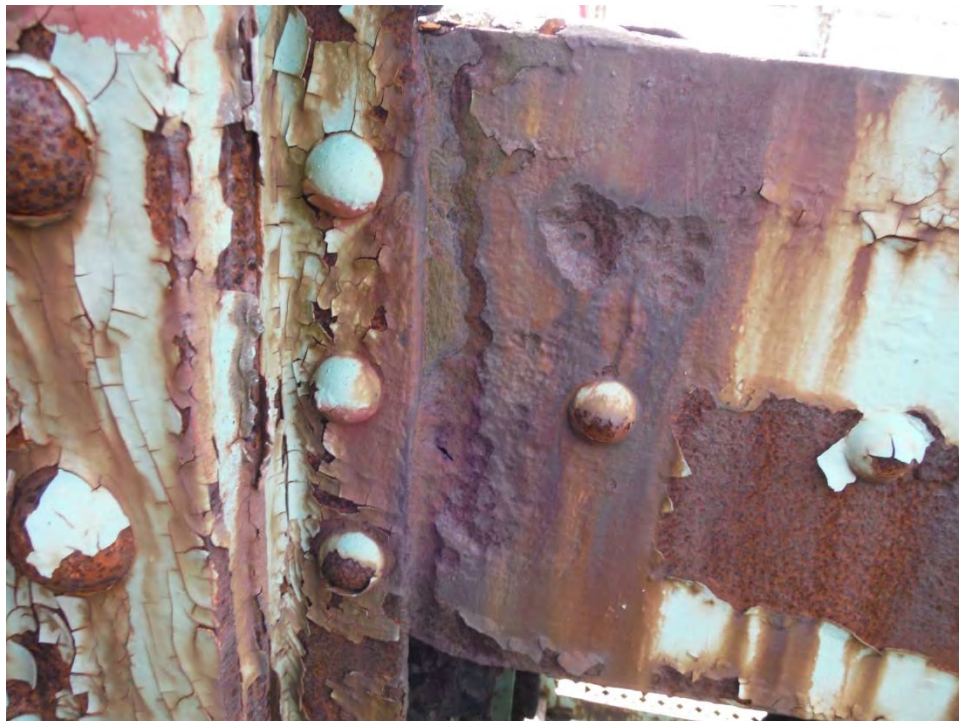
Photo D.10: Span 4, fascia channel at east end of sidewalk deck, located at Floorbeam U1. ¼" pitting full height, along the connection to the bridge railing support. Section loss on fascia channels at railing supports is typical throughout the bridge.

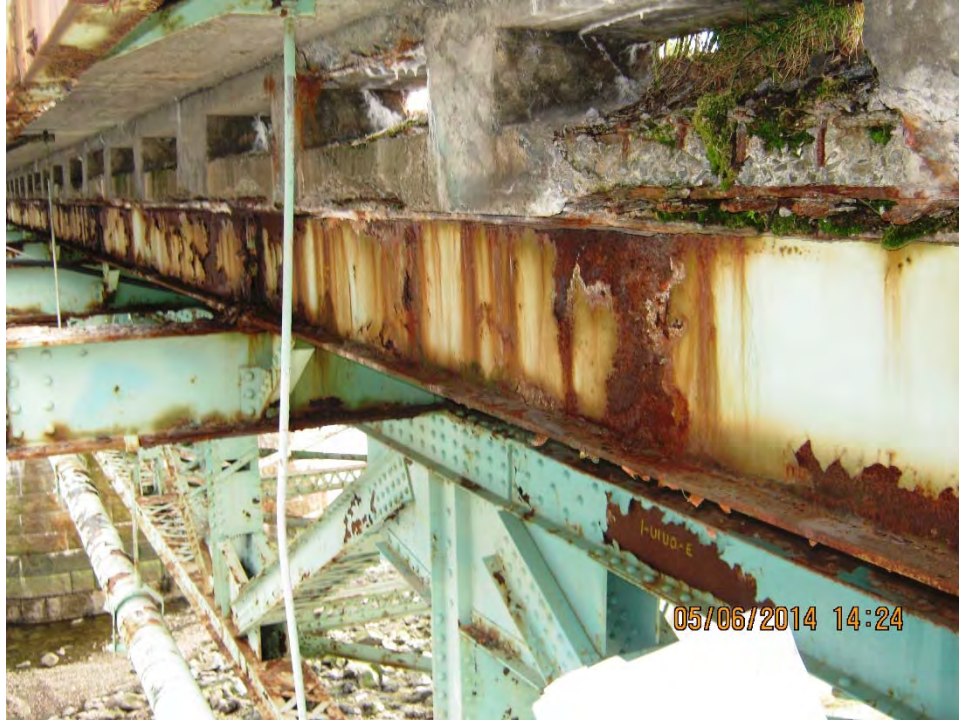
Each section of deck system consists of five rolled W-beam stringers spanning between two floorbeams. Stringer sizes range from W18x47 and W20x60 in Span 1, W21x55 and W21x67 in Spans 2,3, and 7 through 9, W21x62 and W24x74 in Spans 4 and 6, and W21x73 and W24x84 in Span 5. Generally, the exterior stringers are in far worse condition than the interior stringers due to the open deck drain detail directly above. Typically, exterior stringers have experienced heavy corrosion and perforations around the connection plates and along the top and bottom of the web. There are also heavy delaminations along the bottom flanges and moderate delaminations along the top flanges of exterior stringers. Photo F.1 (Appendix B) shows the typical exterior stringer condition.

Photo F.1: Span 1, exterior stringers on east fascia directly under deck drains. Typical in poor to serious condition.

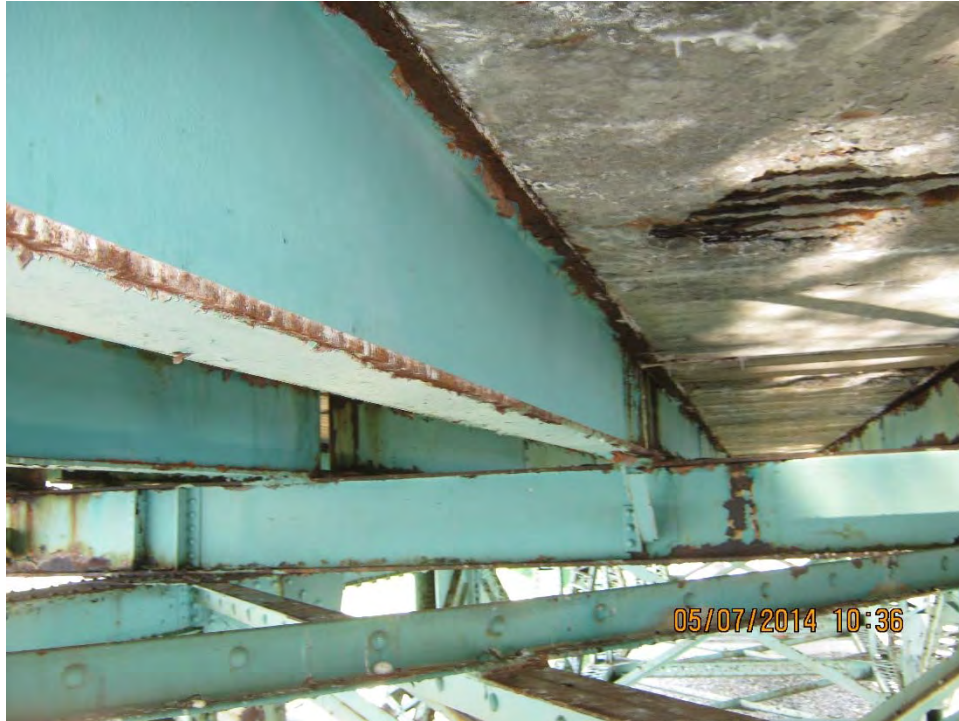
Typically, the interior stringers only exhibit minor losses with sporadic areas of rust and paint failures throughout. This condition is amplified for interior stringers located directly below deck joints. Photo F.2 shows the typical interior stringer condition. For specific losses and defects see the Stringer Condition tables in Appendix C.

In the approach spans, the portion of floorbeam between the two trusses is generally in fair condition and the cantilevered end portions are generally in poor to serious condition. Cantilevered ends of the floorbeams are experiencing heavy rust, section loss, and some perforations along the bottom of the web. Heavy delamination and section loss in the top and bottom flanges of cantilevered portions is also common. Photo F.7 (Appendix B) shows the typical losses for the exterior section of floorbeams. For specific losses and defects see the Floorbeam Condition tables in Appendix C. Losses noted on cantilevered ends of floorbeams are only reported from truss bearing to the exterior stringer. The section of floorbeam from exterior stringer to end of floorbeam experiences little stress and is considered “non-critical”. (See sketch in Floorbeam Condition tables.) The interior portions of the approach span floorbeams were generally in fair condition with some minor losses, rust, and paint failure throughout each portion. Photo F.2 shows the typical condition for the interior portion of the floorbeams.

Photo F.2: Span 2, interior stringers and interior of floor beams typically in fair condition.

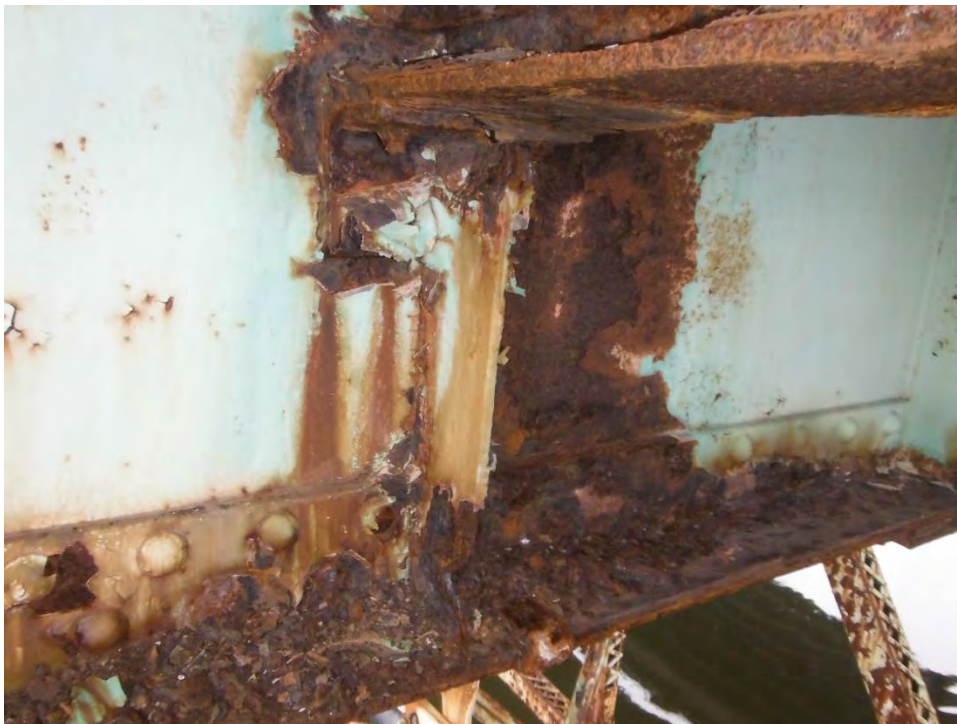
Photo F.10: Span 6, Floorbeam 8 at west stringer. Section loss in floorbeam at ends with holes in stiffeners typical.

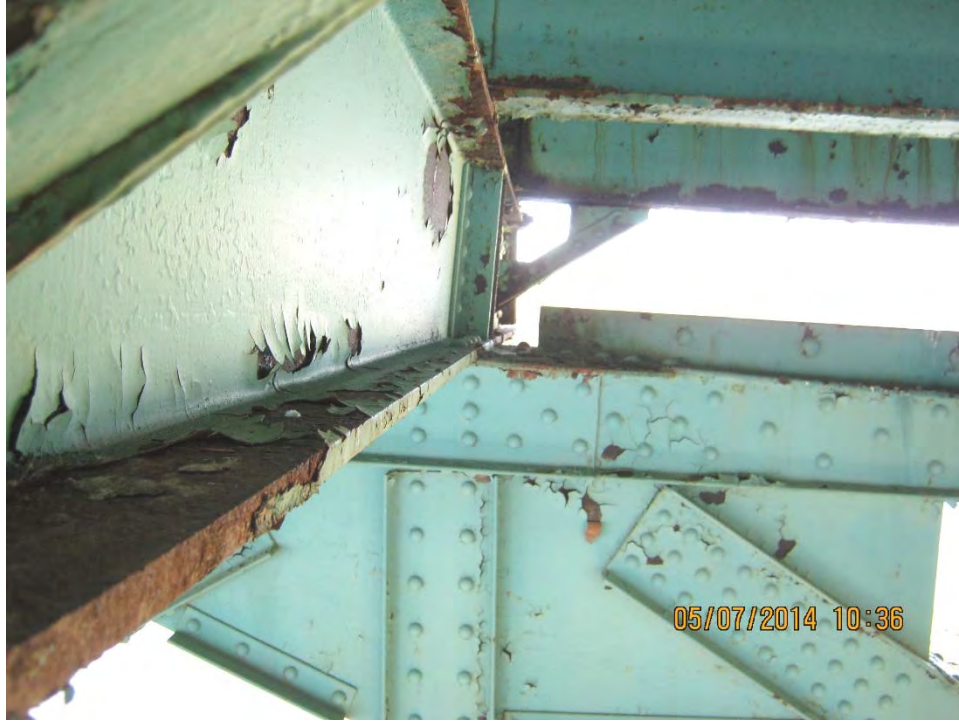
Critical floorbeams have been denoted with a "†" symbol on the Floorbeam Condition tables in Appendix C. Floorbeams marked as critical have experienced large areas of perforation in the web coupled with heavy flange loss in critical locations. Photo F.8 shows a floorbeam in critical condition. Although not a critical defect, it is noted that the floorbeams in Span 2 all appear racked five to ten degrees to the north. Span 9 exhibits a similar condition but in the southerly direction. Photo F.11 displays the racked floorbeams in Span 2.

Photo F.11: Span 2, floorbeam F1. All floorbeams in Span 2 are racked 5°- 10° to the north. Similar conditions exist on Span 9 floorbeams.

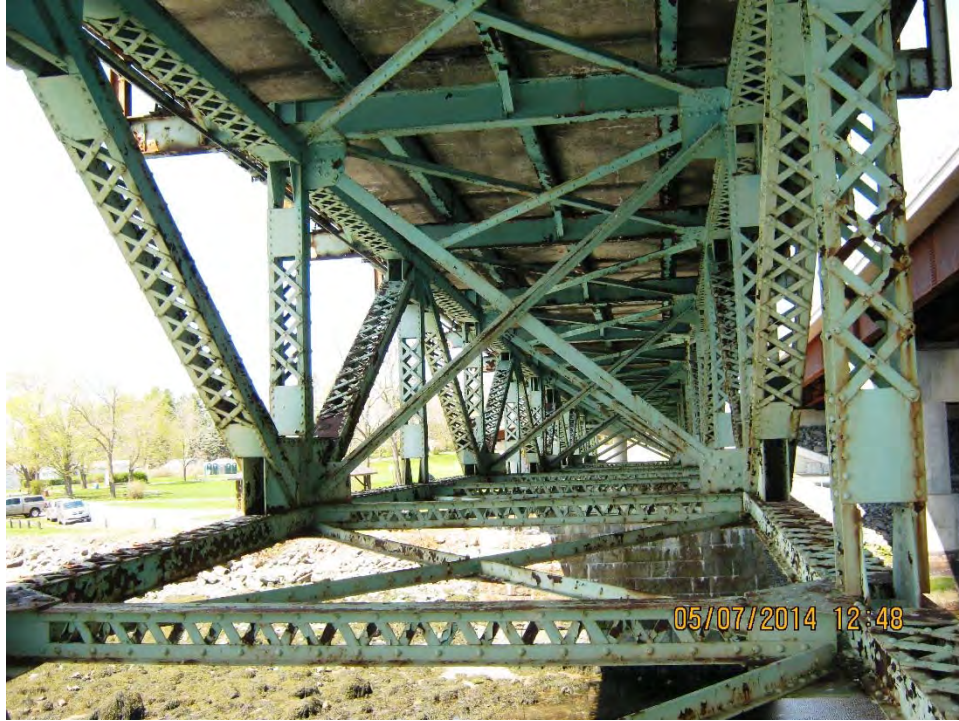
Photo: T.3: Span 2, built-up channel members throughout the truss generally in fair to poor condition.

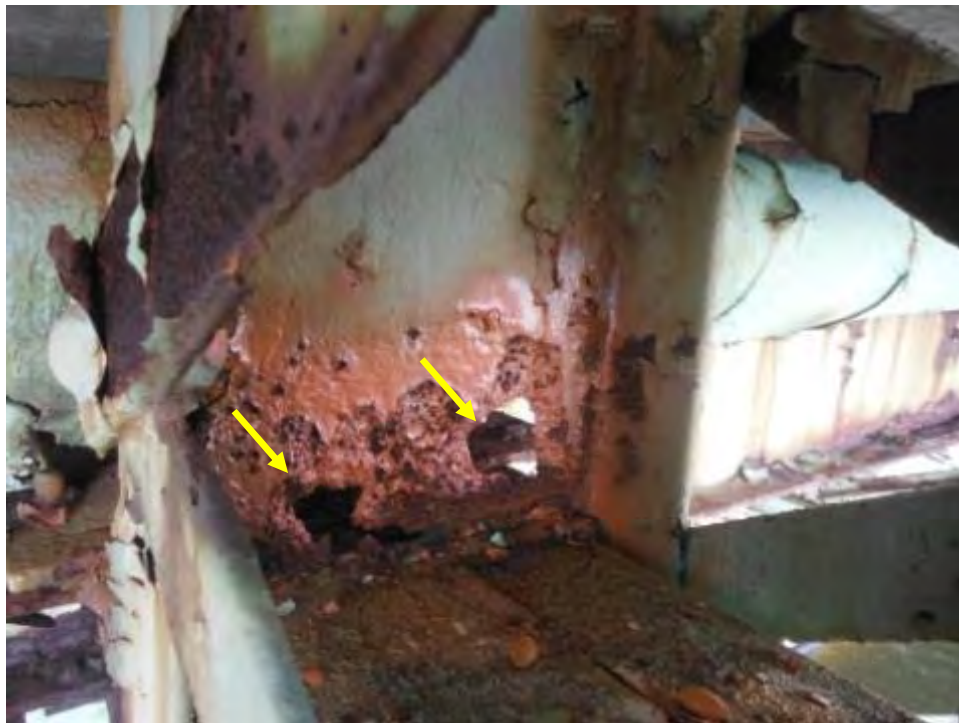
Photo T.4: Span 5, east vertical member U9L9 inner channel web above FB9. Heavy corrosion holes at bottom of hanger. Photo taken of the inside face of U9L9.

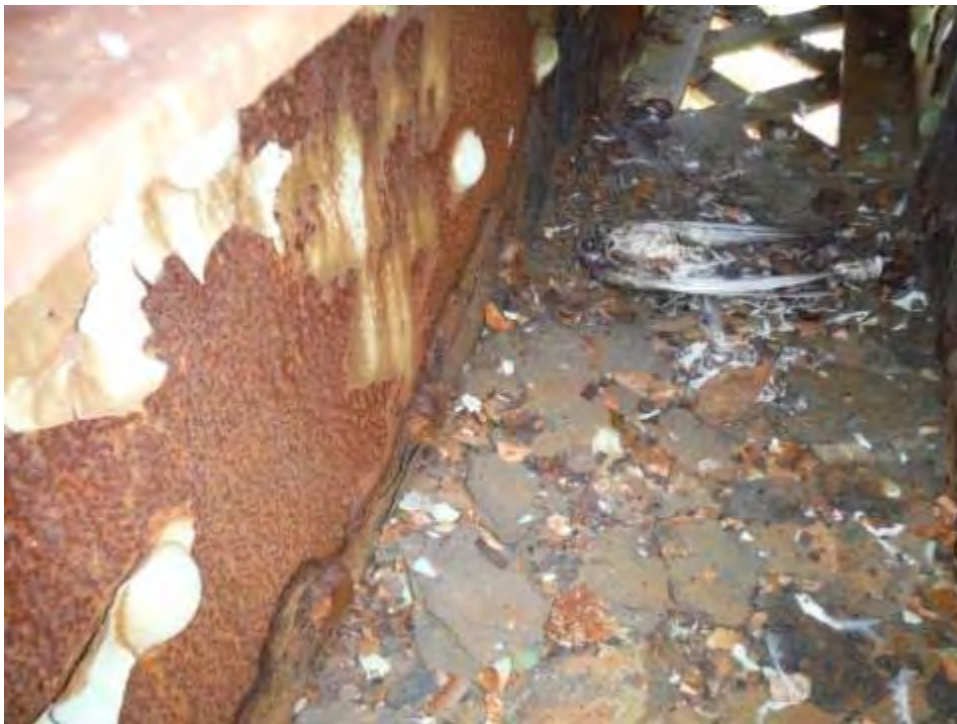
Photo T.8: Span 4, east bottom chord inside L7. Section loss due to laminar corrosion under bottom plate and inside gusset plate connection. Typical condition of bottom chords at gusset plate connections throughout bridge.

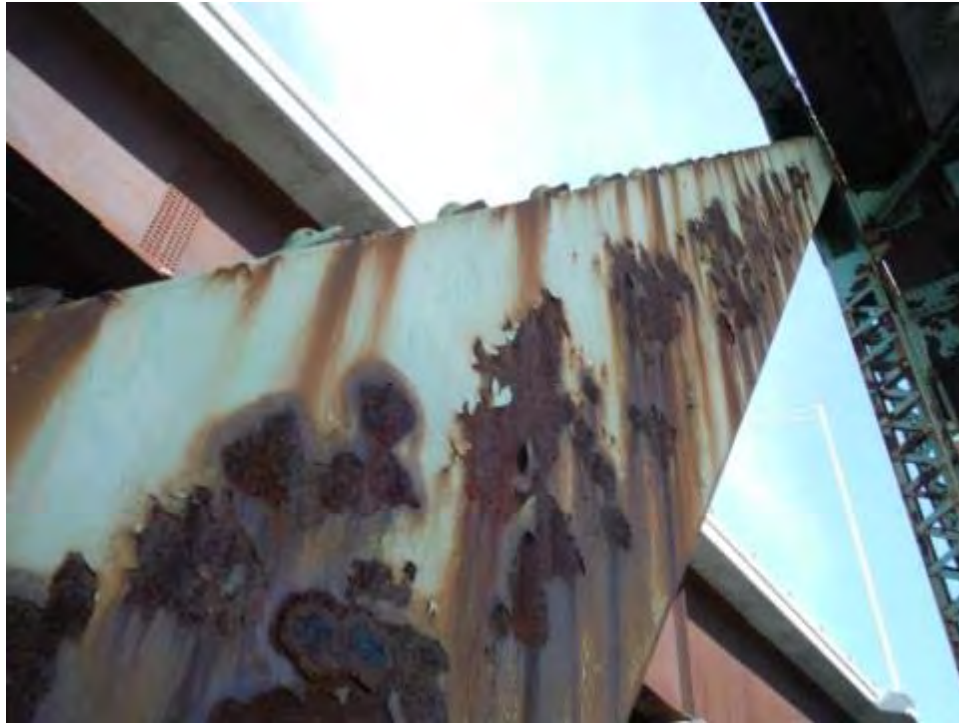
Photo T.9: Span 4, east diagonal L6U7. Random pitting on truss web exterior. Common condition on interior channels throughout the Spans 4, 5 and 6.

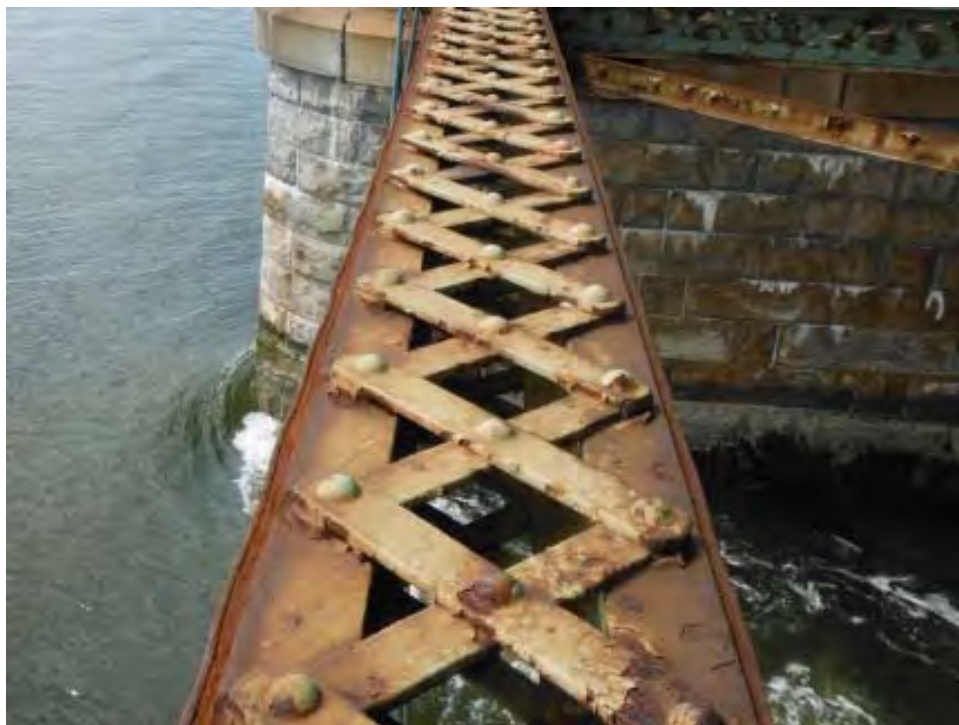
Bottom chords of Spans 4 and 6 have up to 1/4" pack rust between truss bottom chords and gusset plates at many locations. See Photo T.6. Bottom chords from Node L6 to L10 (and L10' to L6') have cover plates on the webs that typically have up to 1/2" pack rust between the channel and the cover plate. See Photo T.10.

Photo T.10: Span 6, west bottom chord L6'L7'. Scalloping and pack rust between outer plate and webs of both channels. Typical condition throughout Spans 4, 5 and 6.

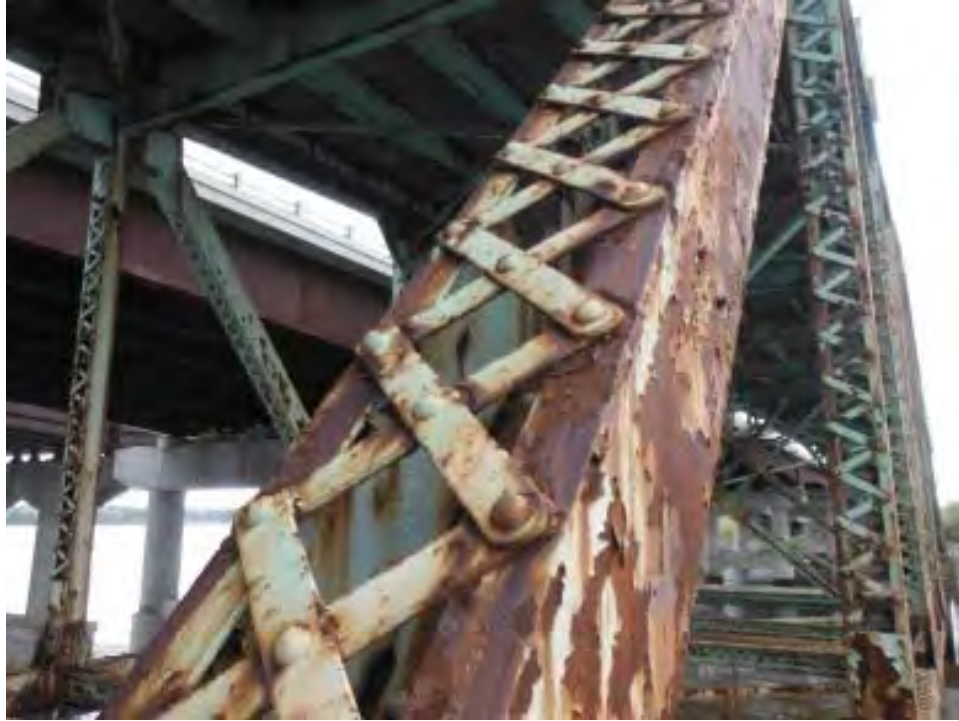
Lacing bars and batten plates on chords and diagonals have section loss throughout, and pack rust between the bars and the truss member flanges in many locations. See photo T.11 and T.12. There are isolated locations where lacing bars and batten plates have corrosion holes. With the exception of Span 5 West Truss L9U9, the maximum perforation diameter is 4 1/2". See Photo T.13. Span 5 West L9U9 was found to have two holes in the interior web with a total width of 7" at the web's interface with the floorbeam top flange.

Photo T.11: Span 4, west diagonal truss member U5L4. Section loss on flange at lacing bars. Section loss at interface with lacing bars typical for most channel flanges on top and bottom throughout the bridge.

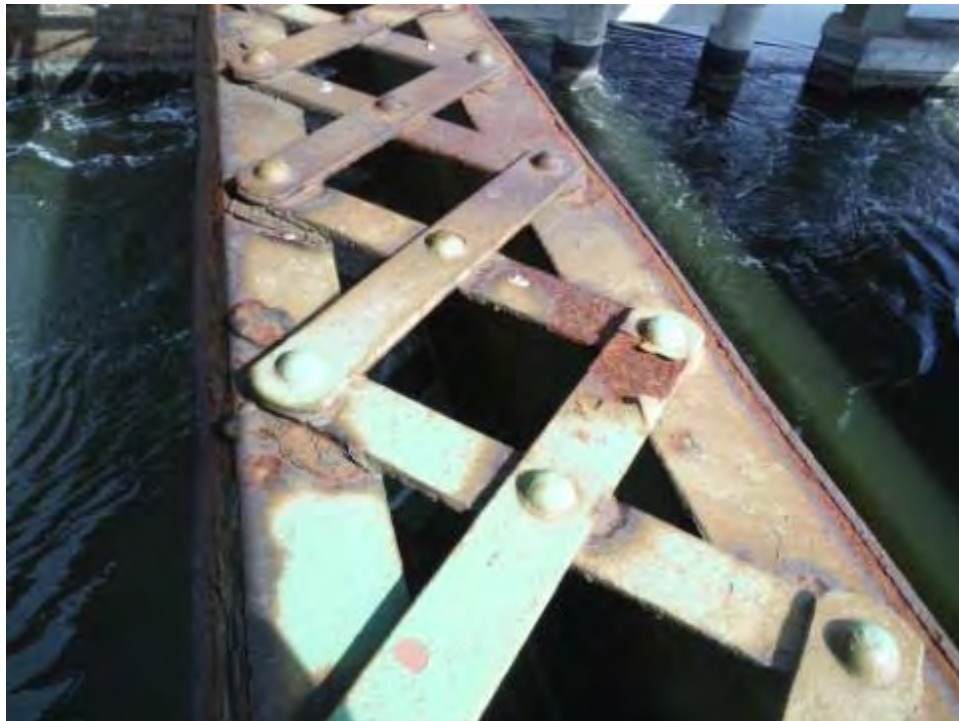
Photo T.12: Span 5, east bottom chord L12L13. Pack rust and section loss to lacing bars. Typical throughout the bridge.

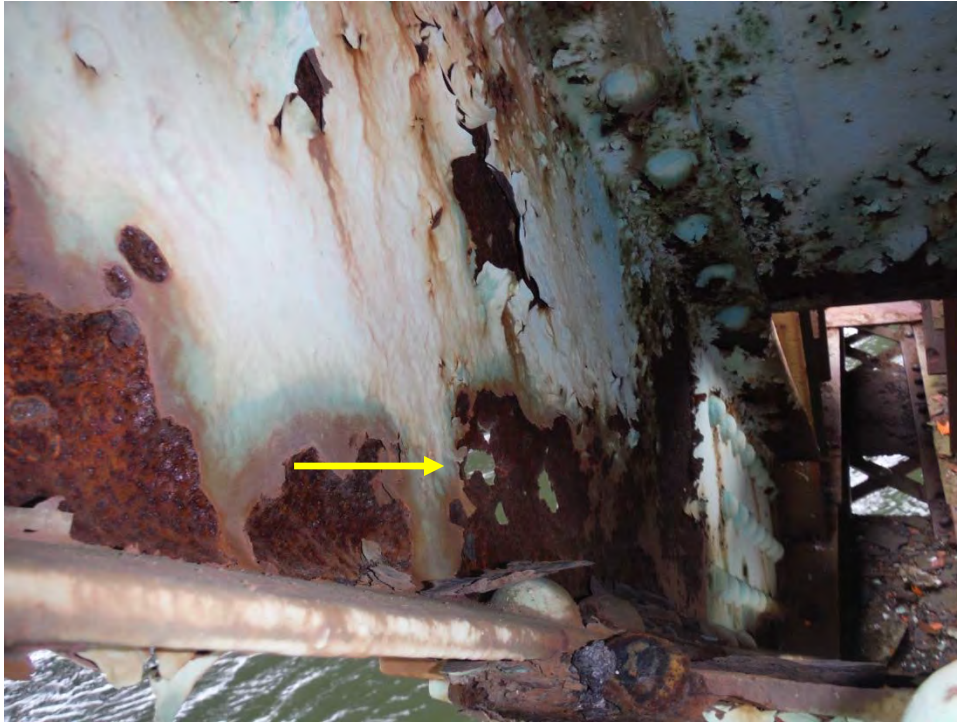
Photo T.13: Span 4, Diagonal L2U1 of the east truss – corrosion holes up to 4½” in diameter on diagonal webs at lower end of chord, adjacent to U1.

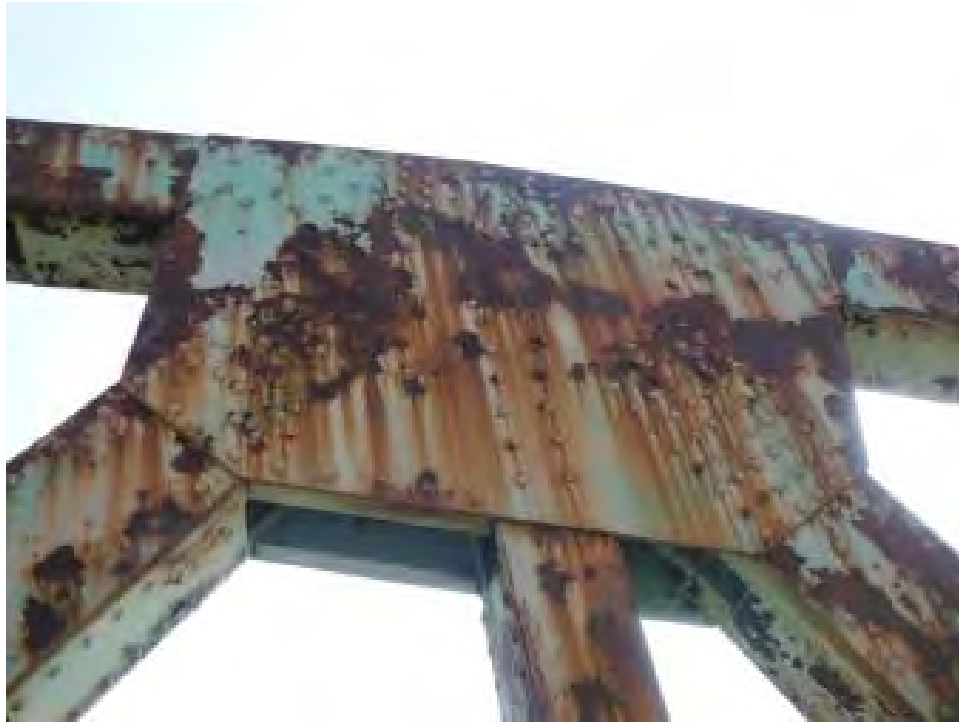
Photo T.21: Span 5, inner west gusset plate at U9. Surface corrosion only. Typical at top chord member gusset plates throughout Span 5.

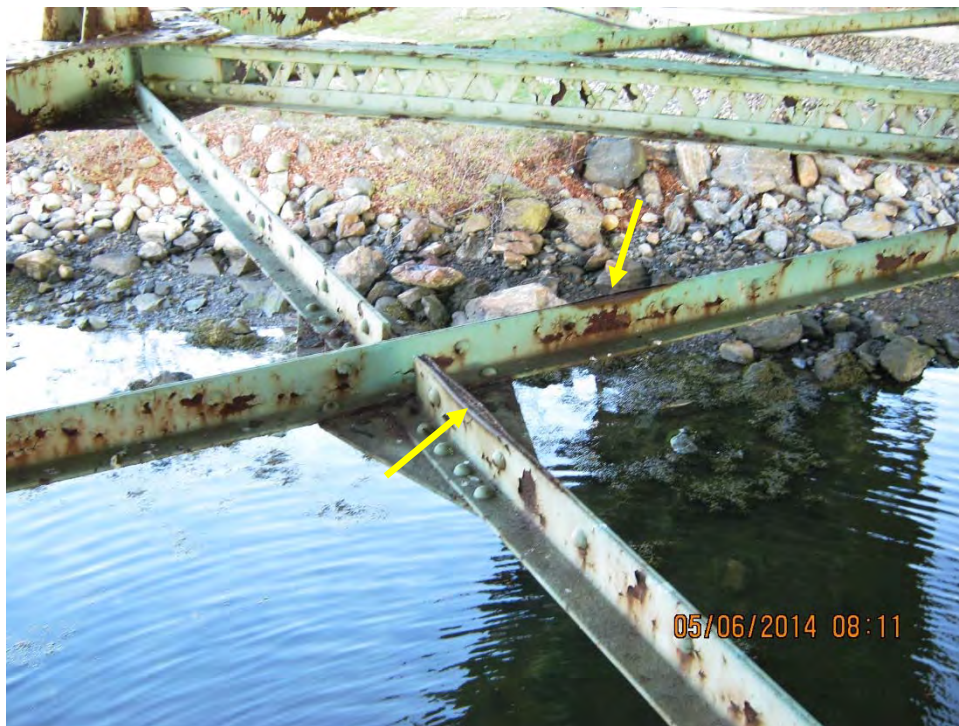
Photo B.1: Span 1, typical bottom lateral bracing condition with pack rust between angles.

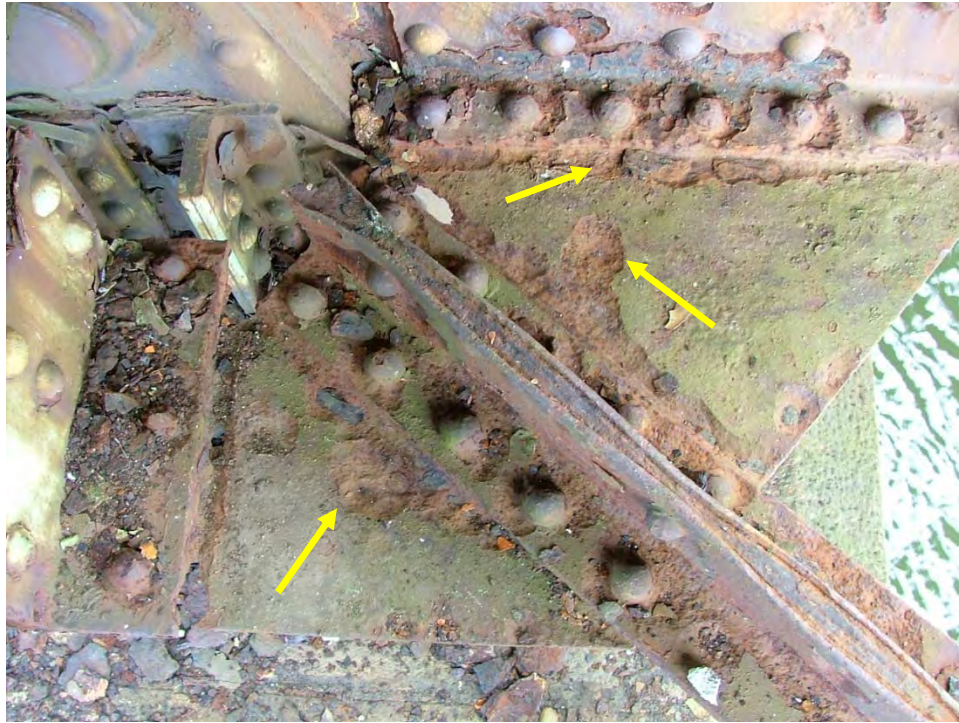
Photo B.2: Span 1, typical bottom lateral bracing gusset plate condition with moderate pitting and corrosion.

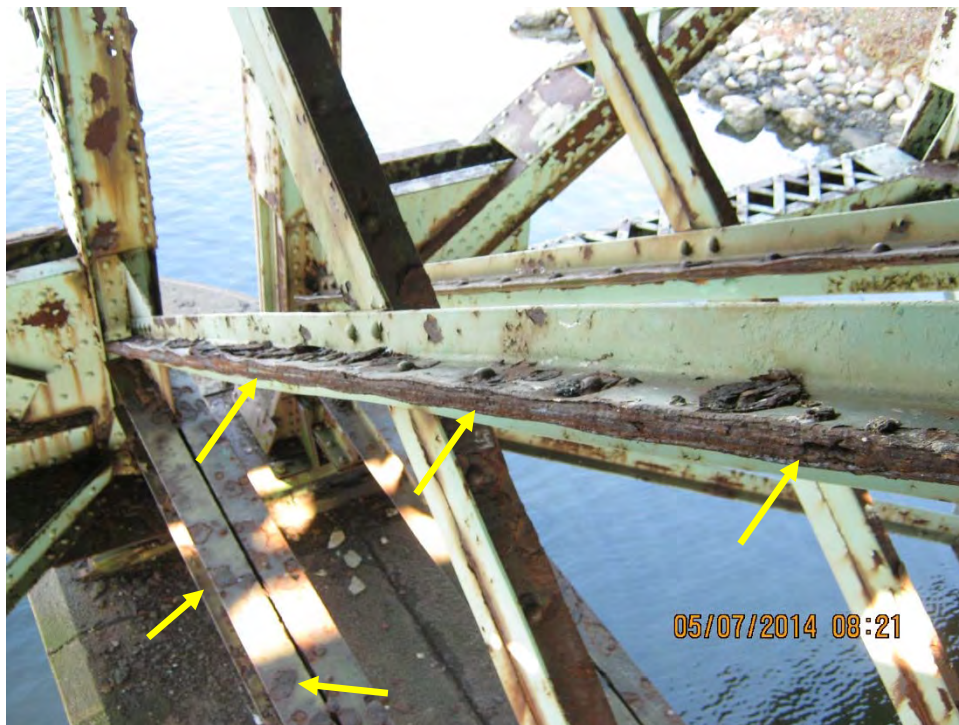
Photo B.3: Pier 1, Span 2, sway bracing below deck joint with heavy pack rust between angles. Pitting on top flanges of lateral strut below.

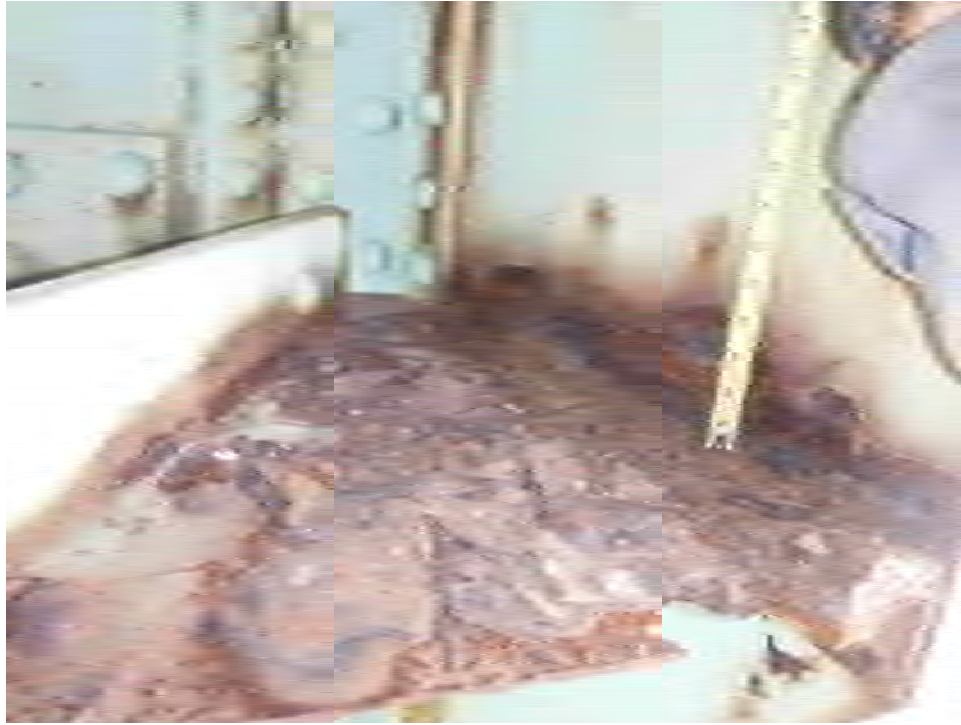
Photo B.4: Span 4, bottom lateral bracing gusset plate at U2 on the west truss, pitting to 1/8" along lateral gusset plate. Several top lateral bracing gusset plates similar.

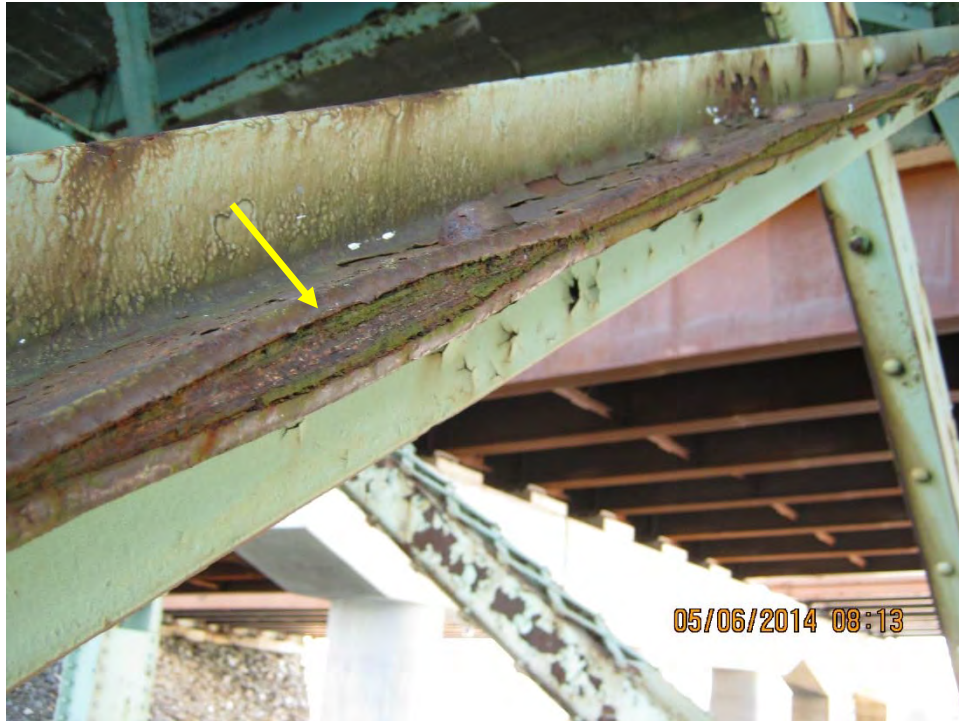
Photo B.6: Pier 1, Span 2, close up view of pack rust between angles, typical on sway and lateral bracing.
