STATE OF NEW HAMPSHIRE
DEPARTMENT OF TRANSPORTATION

IN-DEPTH INSPECTION AND CONDITION REPORT

GENERAL SULLIVAN BRIDGE - DOVER 200/023
OVER THE LITTLE BAY

May 2014 Inspection
and
June 2016 Inspection

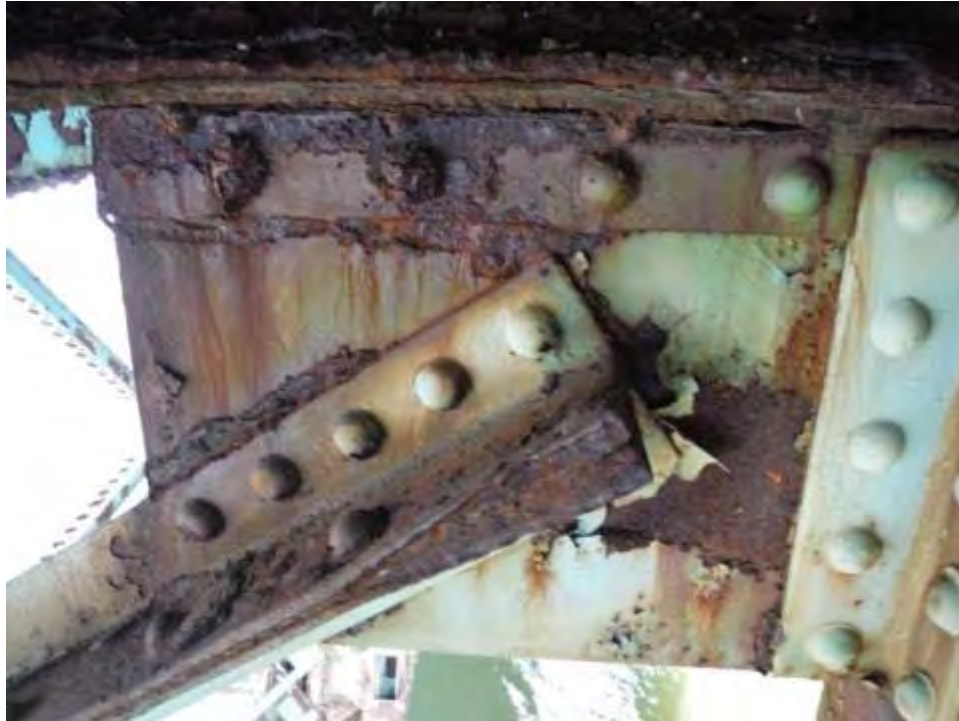
Photo B.7: Span 4, east sway frame gusset plate at U0. Section loss along connection angles to floorbeam bottom flange and truss connections. Typical in many locations throughout the bridge.

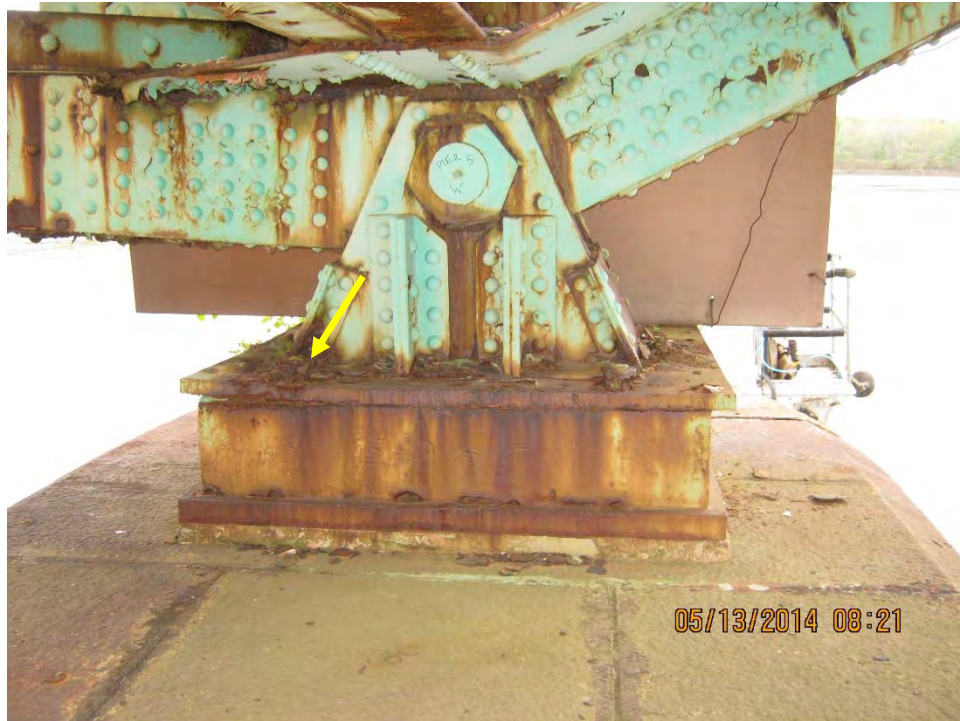
Photo BR.1: Pier 5, fixed bearing under west truss. Typical condition with minor loss in top cover plate and around bearing stiffeners.

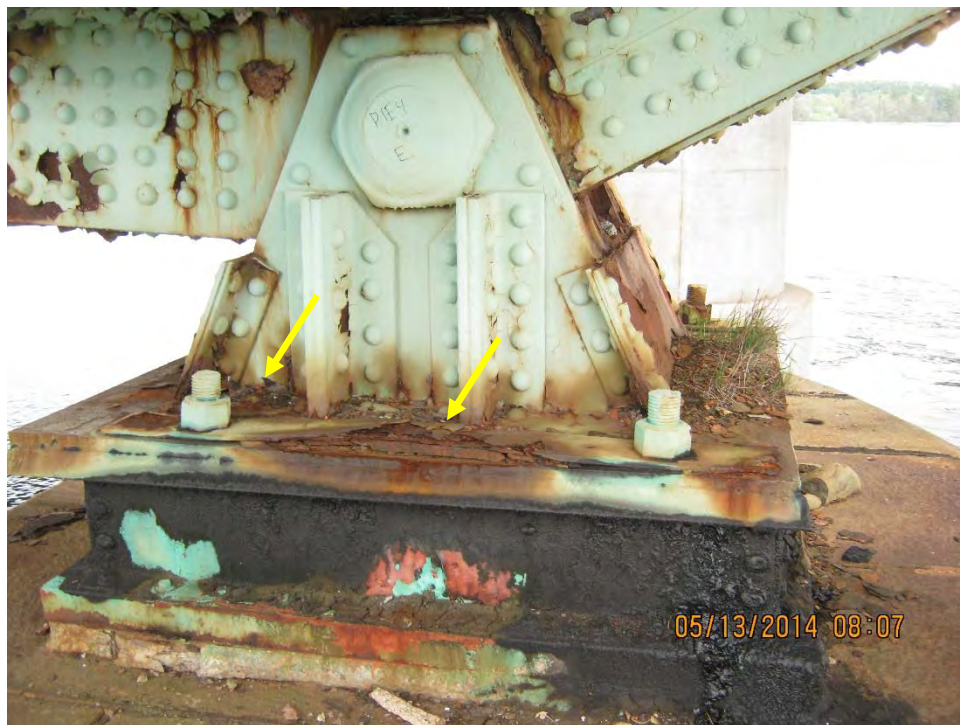
Photo BR.2: Pier 4, expansion bearing under west truss. Typical condition with minor loss in top cover plate and around bearing stiffeners.

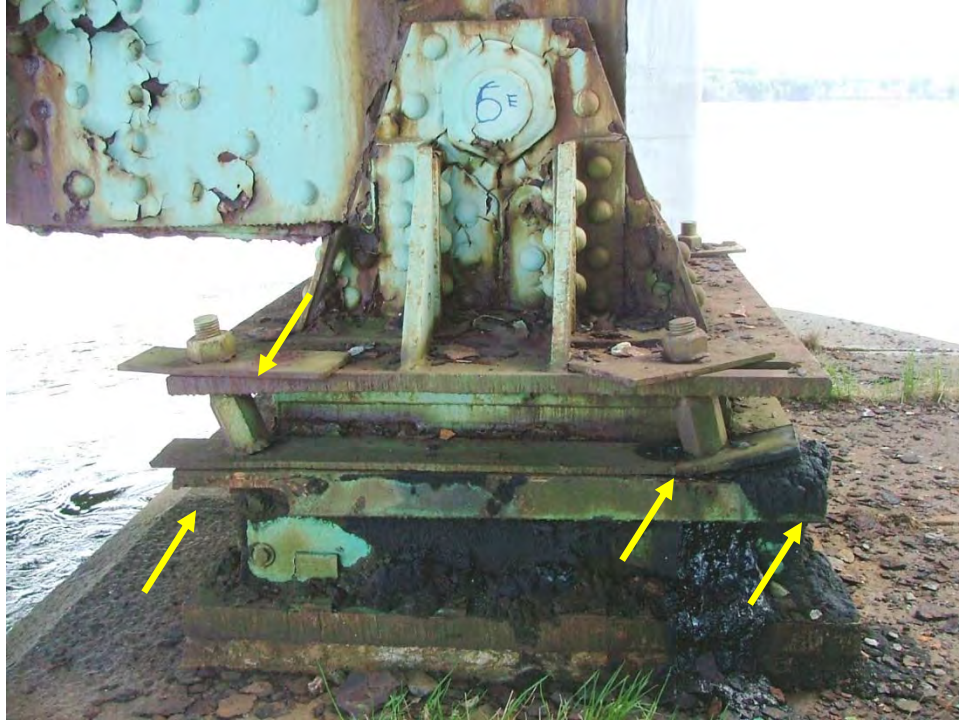
Photo BR.3: Pier 6, east expansion bearing adjacent to Span 6. Bearings are overextended resulting in anchor bolt failure and damaged bearing shroud. Similar conditions exist at Pier 3.

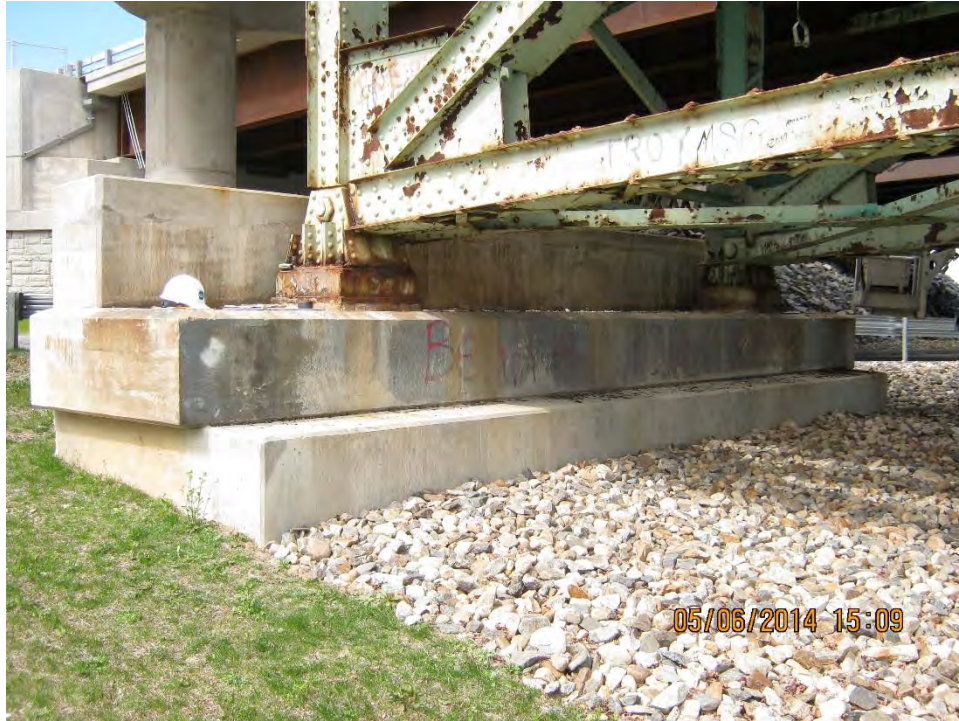
Photo S.1: Dover abutment in overall good condition.

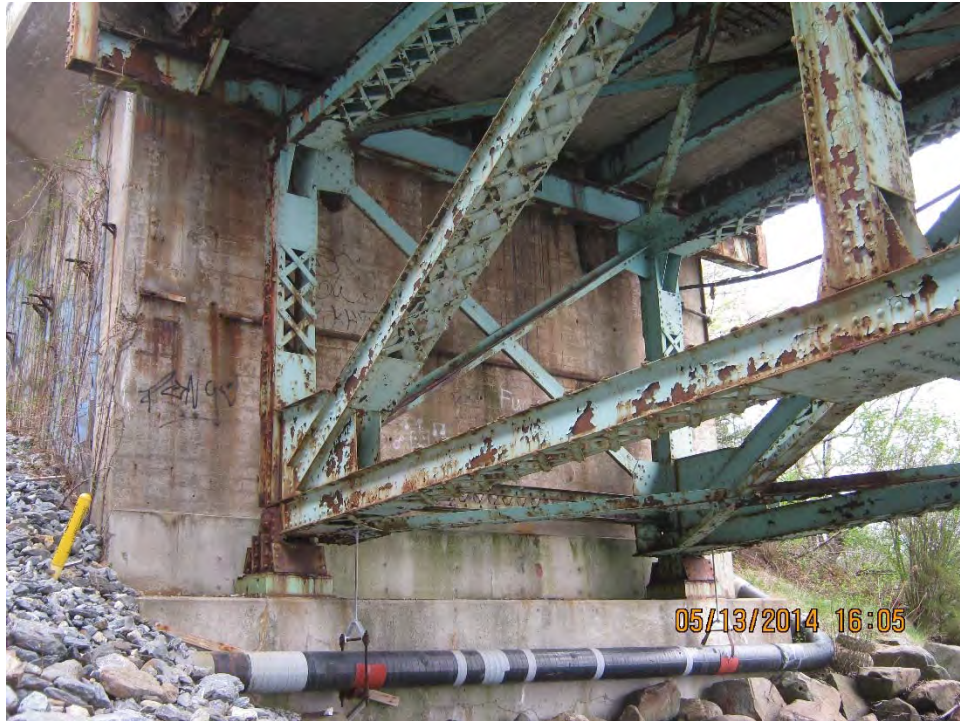
Photo S.2: Newington abutment and wingwalls in overall good condition.

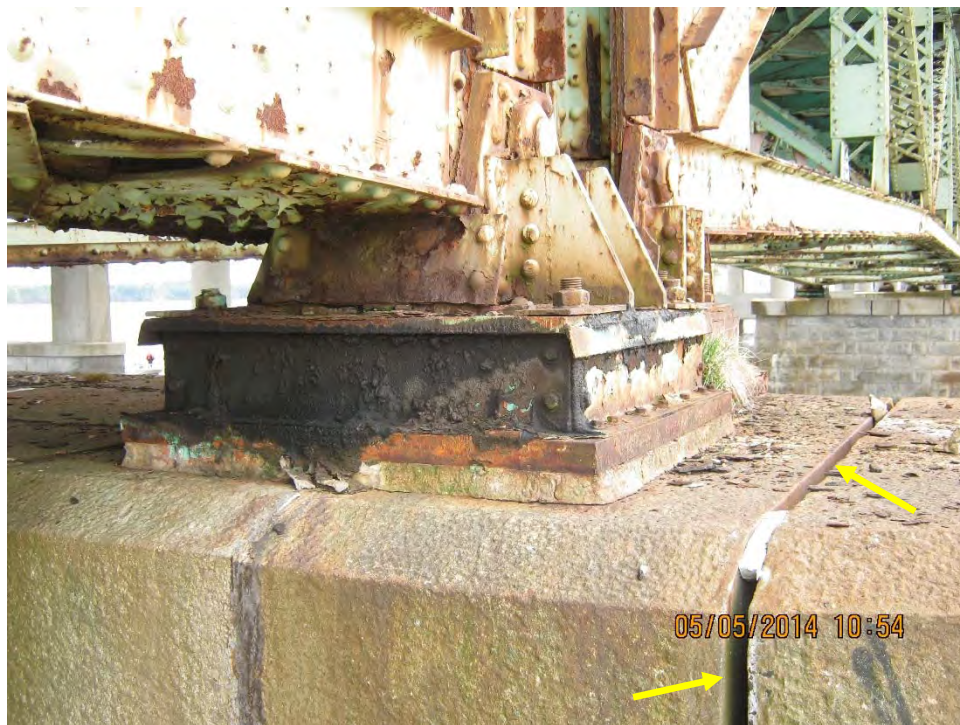
Photo S.3: Pier 1, mortar loss between granite blocks in pier cap. Typical at most piers.

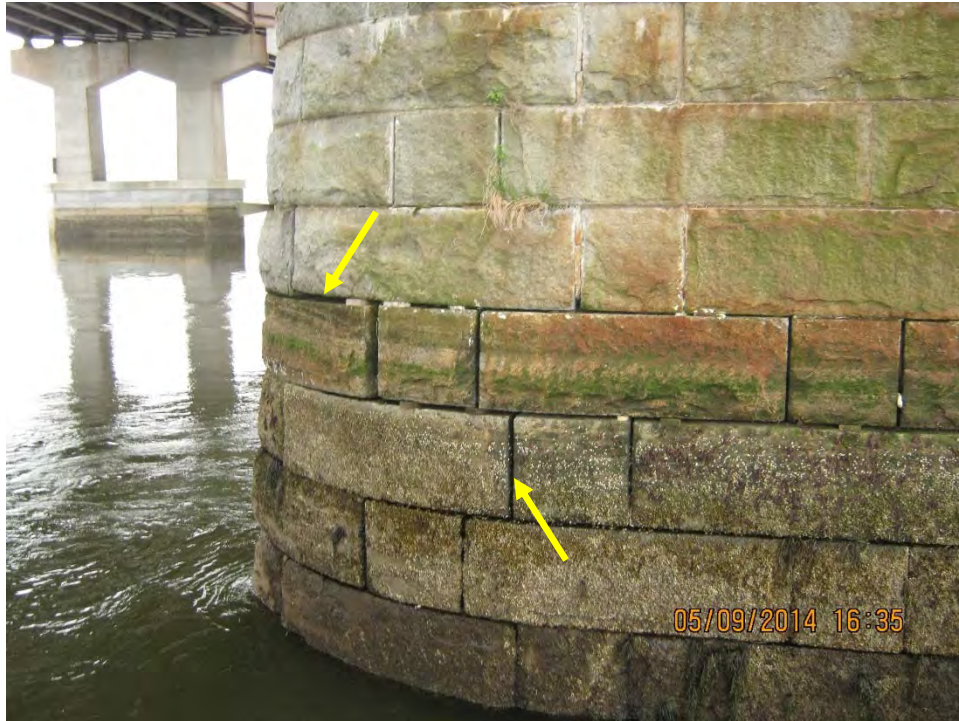
Photo S.4: Pier 3, heavy mortar loss between granite blocks below water level. Typical condition for most piers.

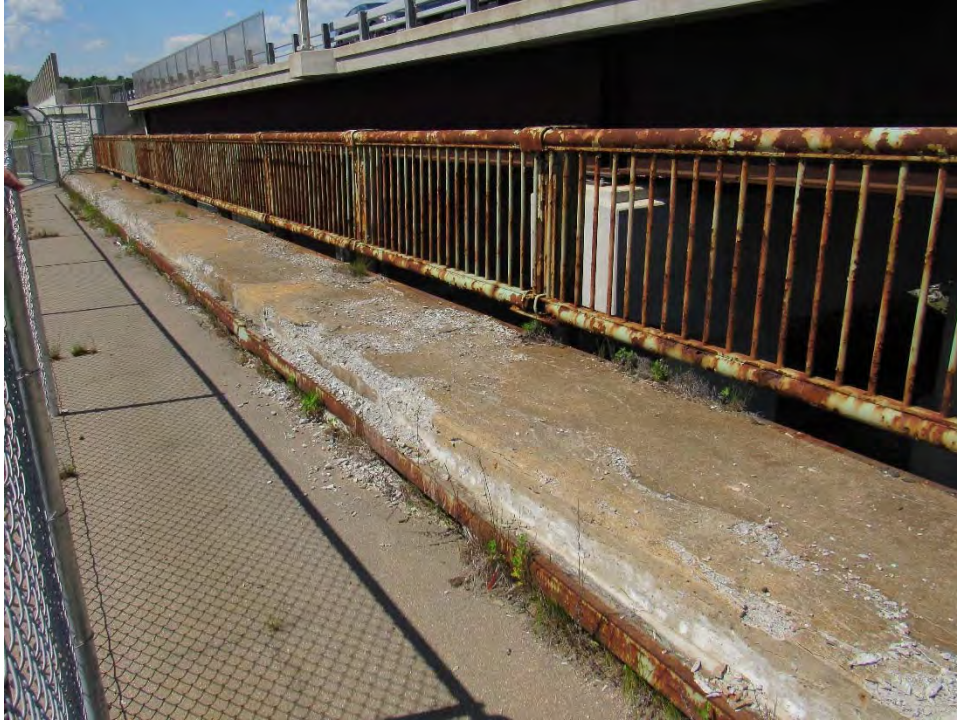
Photo D1: Span 1 and 2 East Sidewalk – Concrete and Railing Deterioration

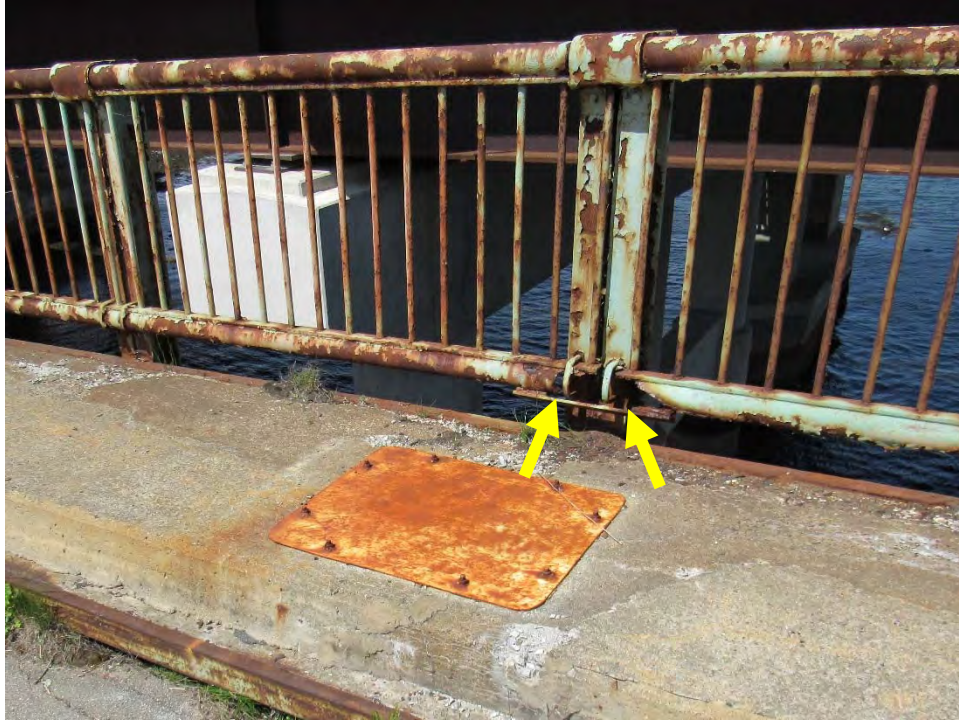
Photo D3: Span 3 East Bridge Railing – Lower Rail Section Loss

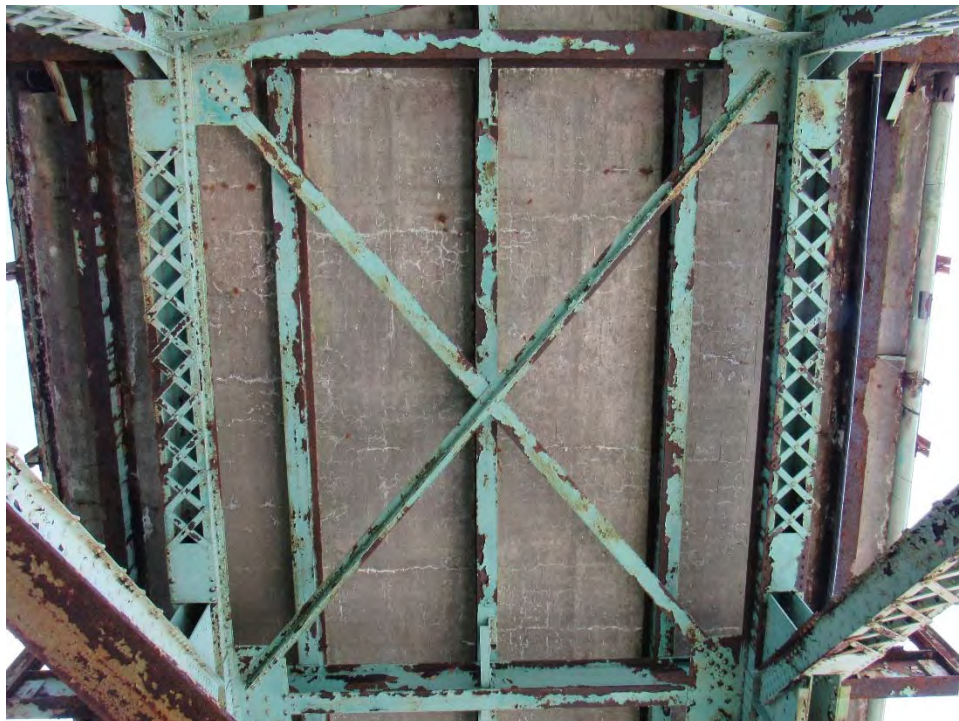
Photo D4: Span 8 – Typical Deck Cracking and Efflorescence

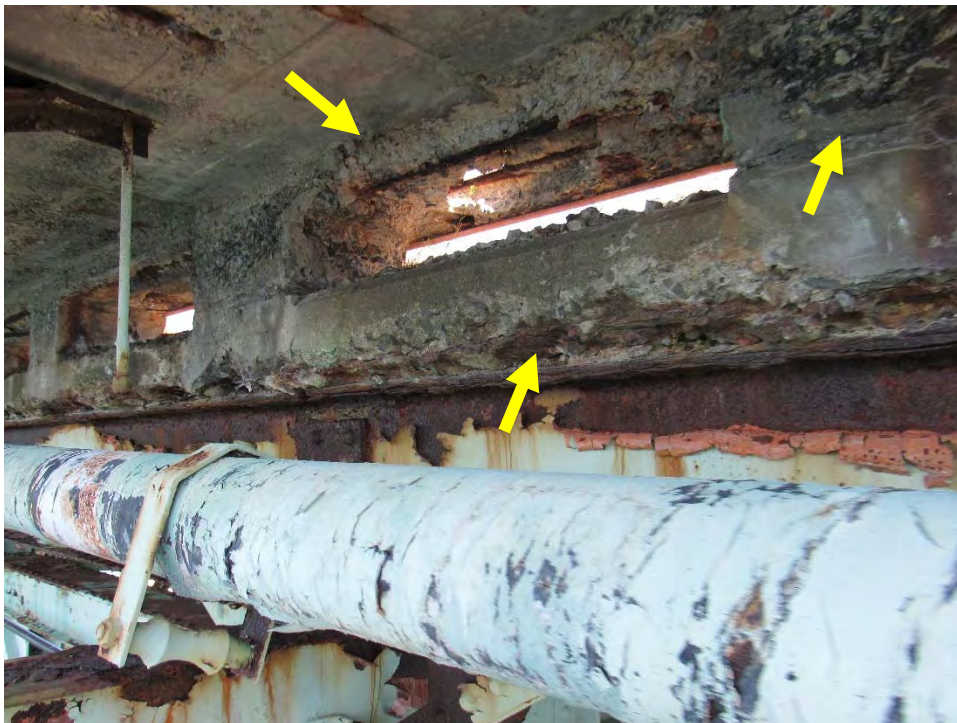
Photo D6: Span 6 – Spalls and Exposed Rebar at Curb Openings

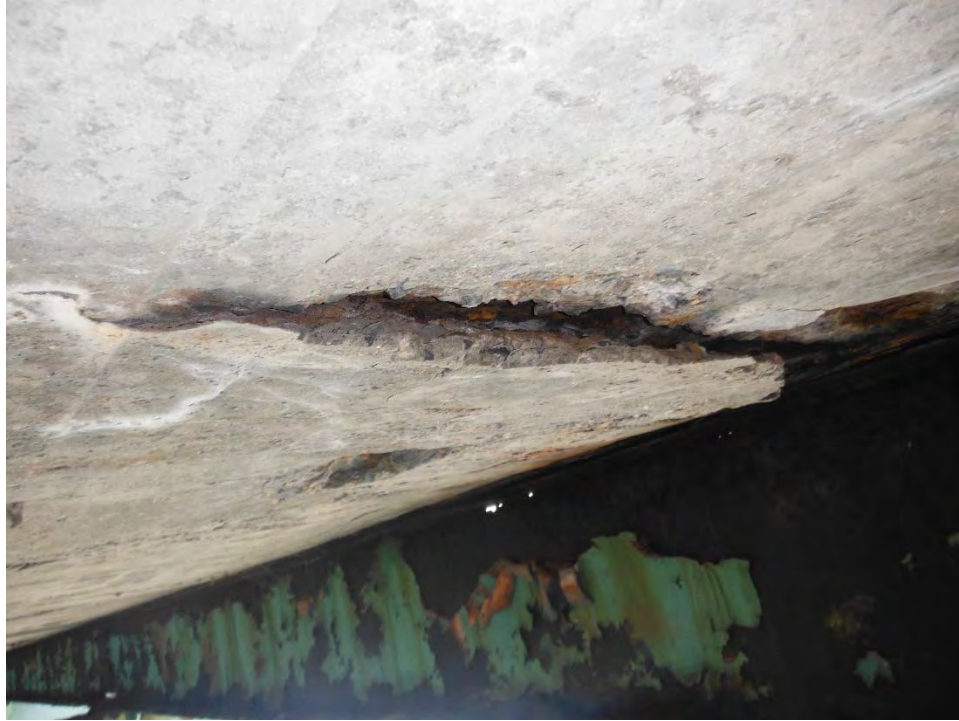
Photo D7: Span 3 – Imminent Deck Spall

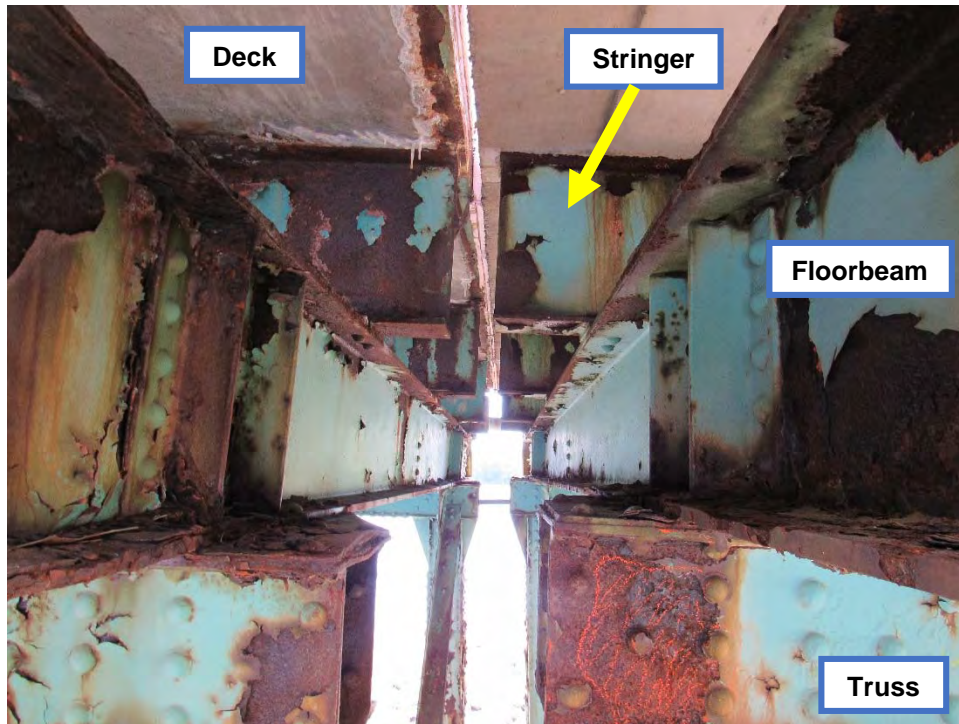
Photo D8: Span 1 and 2 Floor System - Typical Condition at Joint Locations

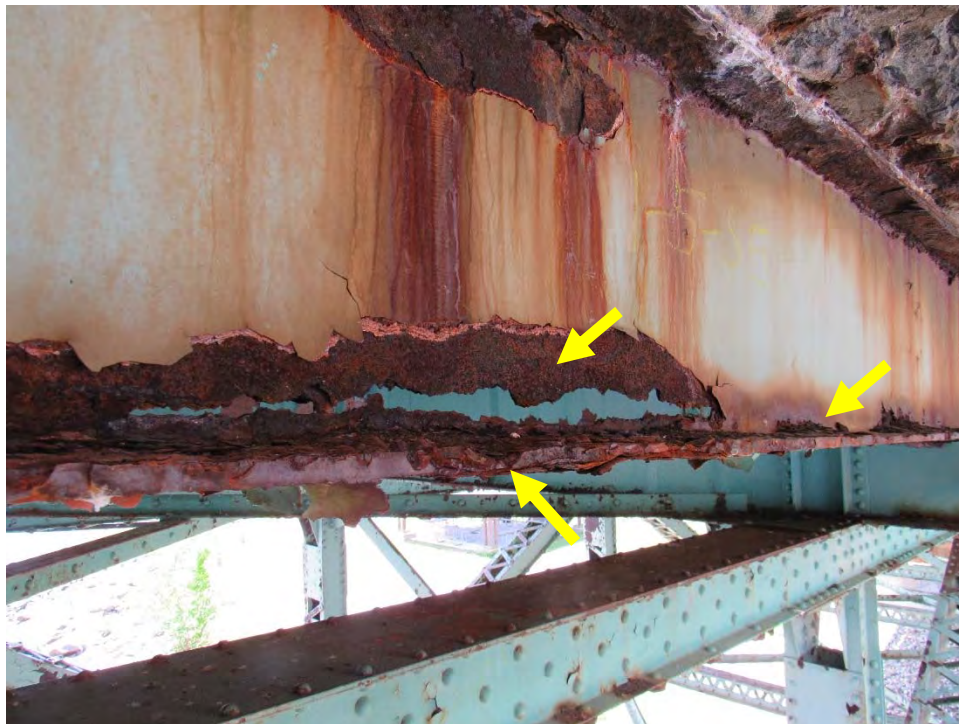
Photo D15: Span 1 Exterior Stringer – Bottom Flange and Web Section Loss

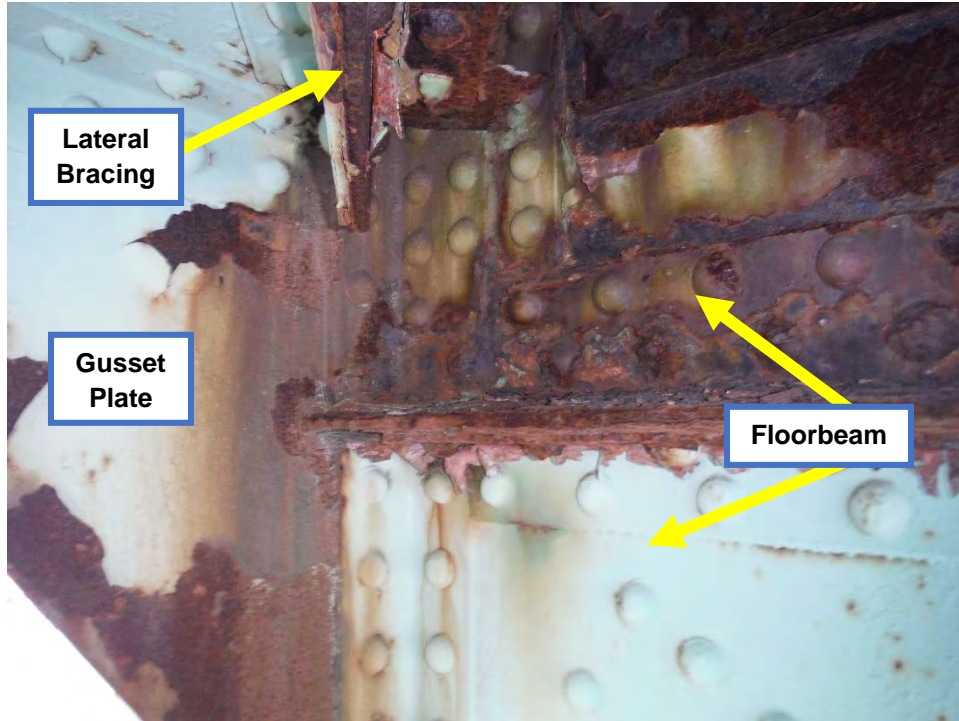
Photo D20: Span 6 Floorbeam (Panel 0') – Section Loss at Truss Connection

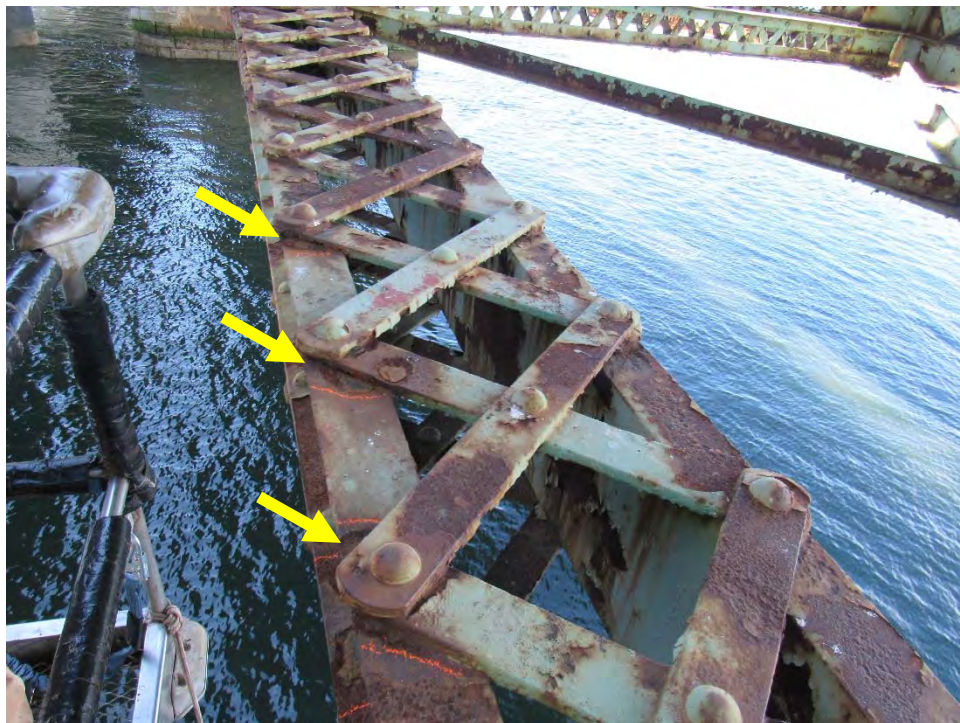
Photo D21: Span 3 Bottom Chord – Section Losses at Lace Bars

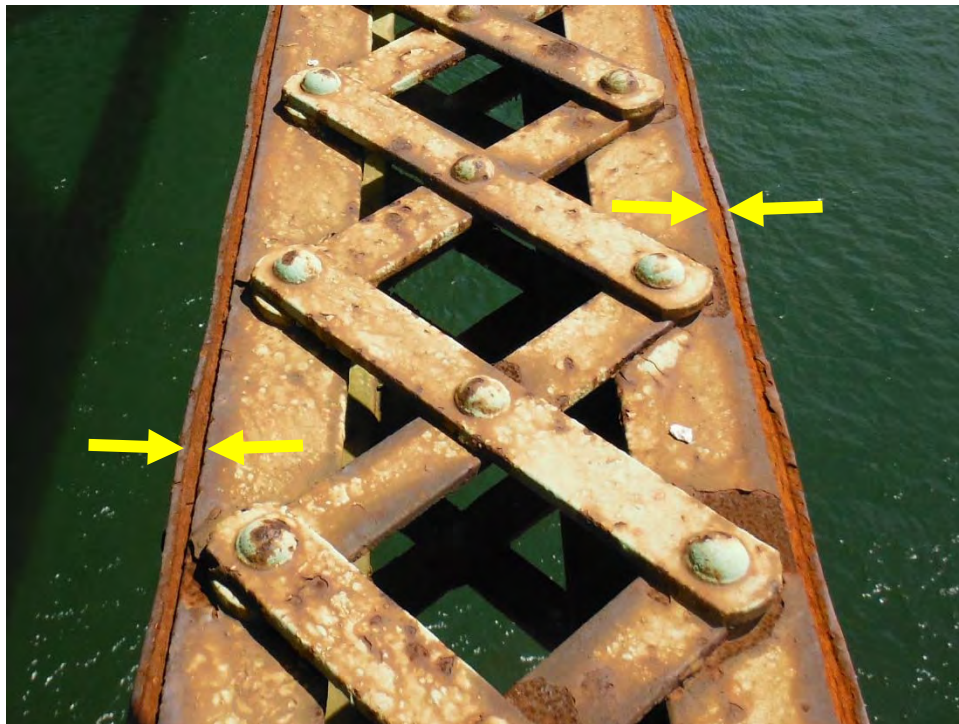
Photo D25: Span 6 – Pack Rust Between Channel and Web Plate

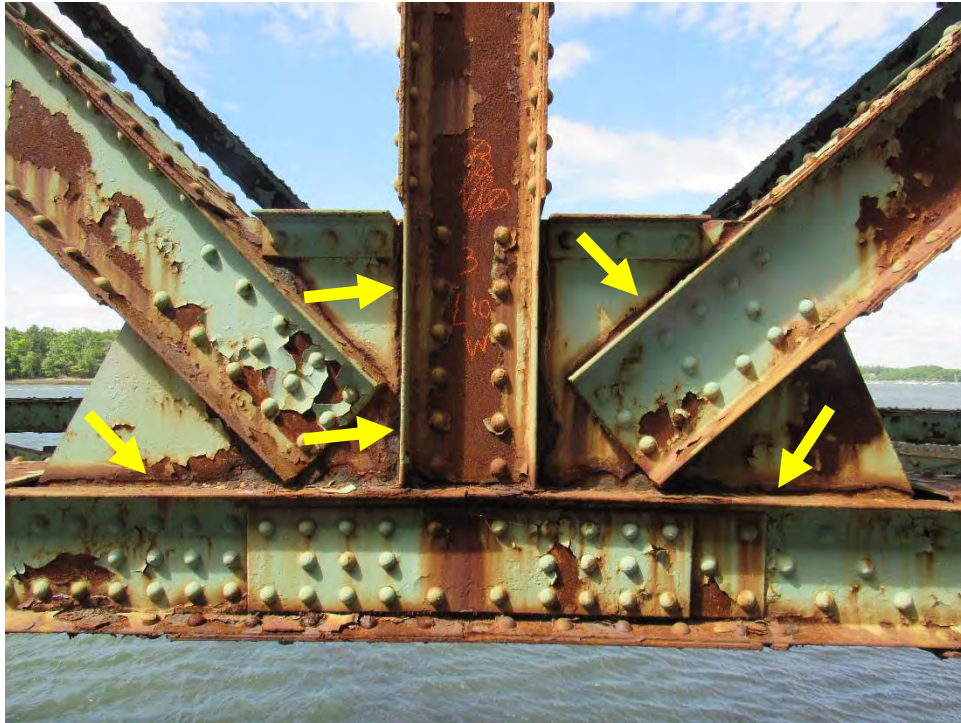
Photo D26: Span 3 Gusset Plate – Section Losses Along Member Connections

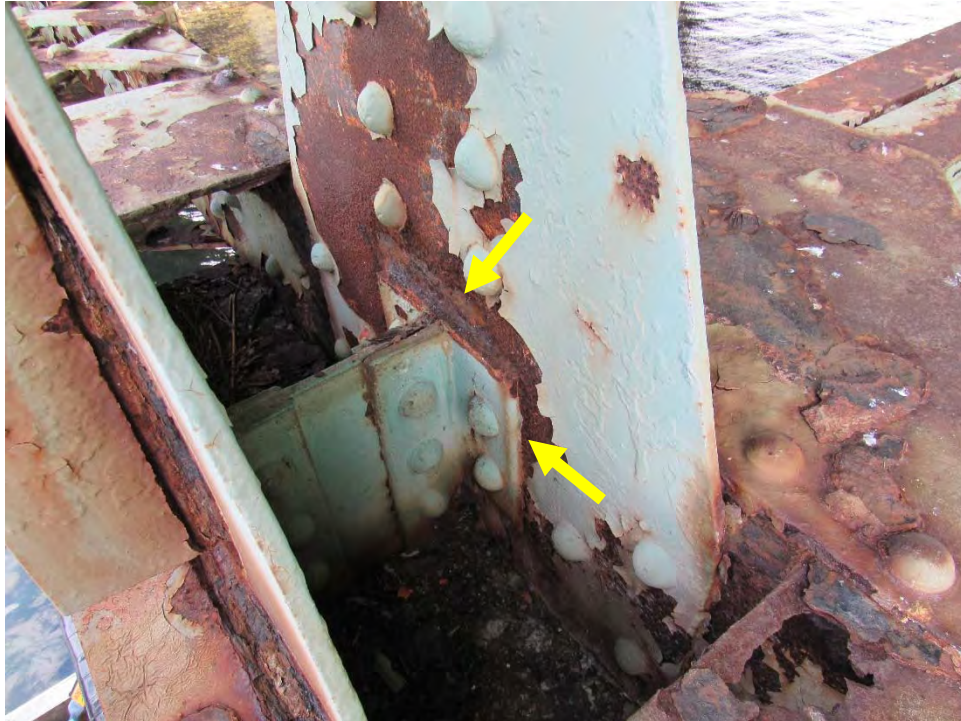
Photo D27: Span 2 Gusset Plate – Section Losses at Interior Stiffener/Diaphragms

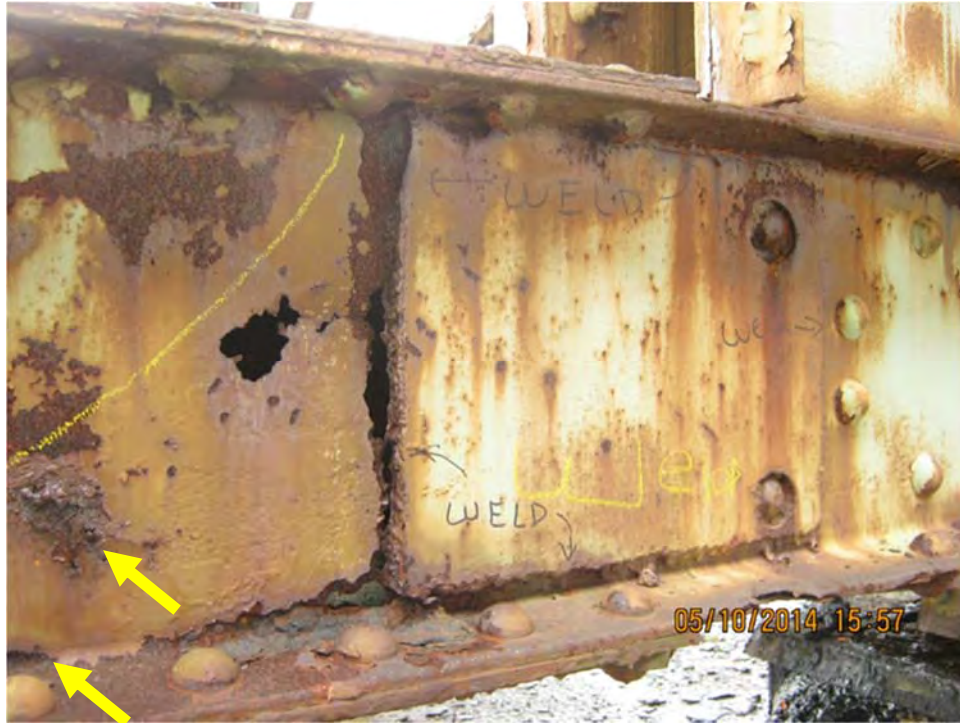
Photo D28: 2014 Inspection – Span 7 East Member L0L1

Visible and measurable increases in section loss since 2014 of truss members and gusset plates are generally limited to locations near bridge deck joints (Photos D28 thru Photo D33). Some of the gusset plates along the bottom chords exhibit minor increases in section loss. A new corrosion hole was also discovered in the web of Span 4 vertical member L3-U3 (Photo D34).

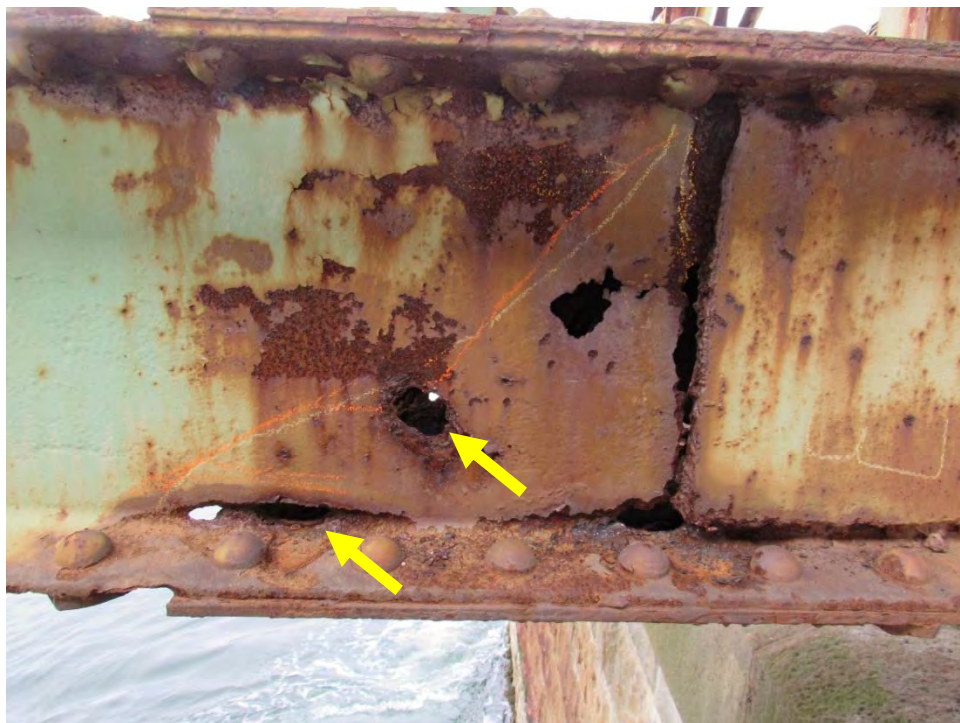
Photo D29: 2016 Inspection – Span 7 East Member L0L1 (New Holes and Section Loss)

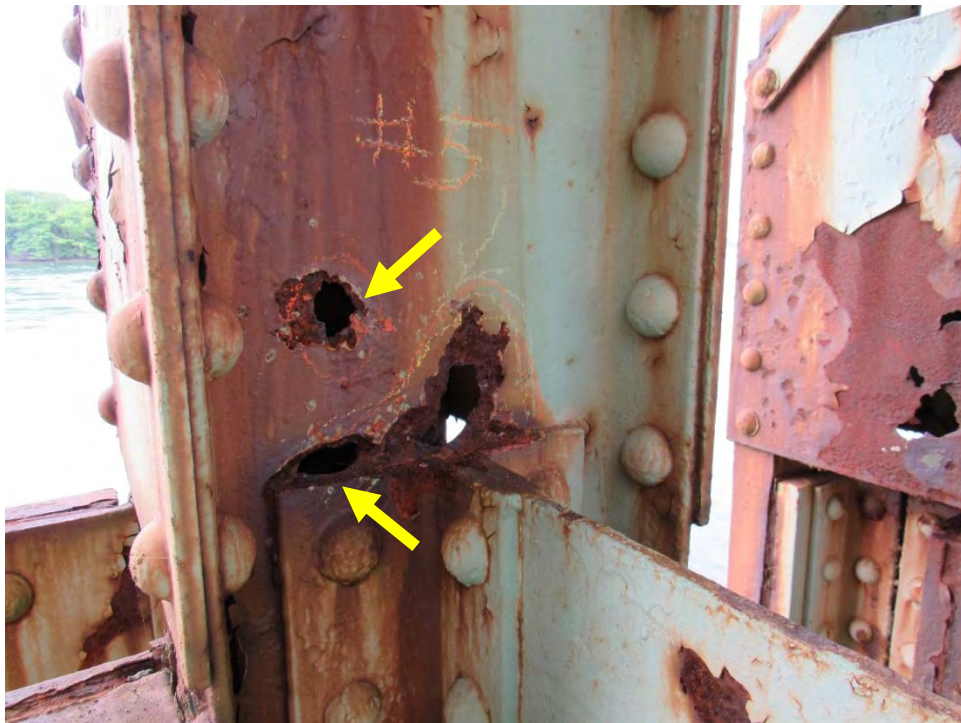
Photo D31: 2016 Inspection – Span 8 West Member L14U14 (New Holes and Section Loss)

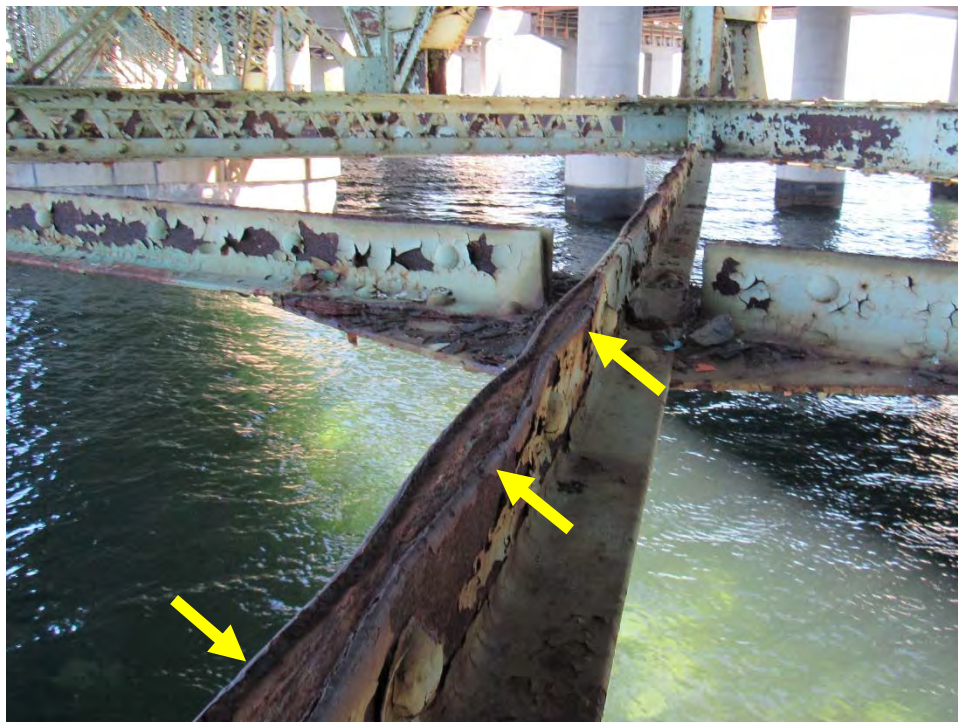
Photo D35: Span 9 Lower Lateral Bracing – Pack Rust Between Double Angles

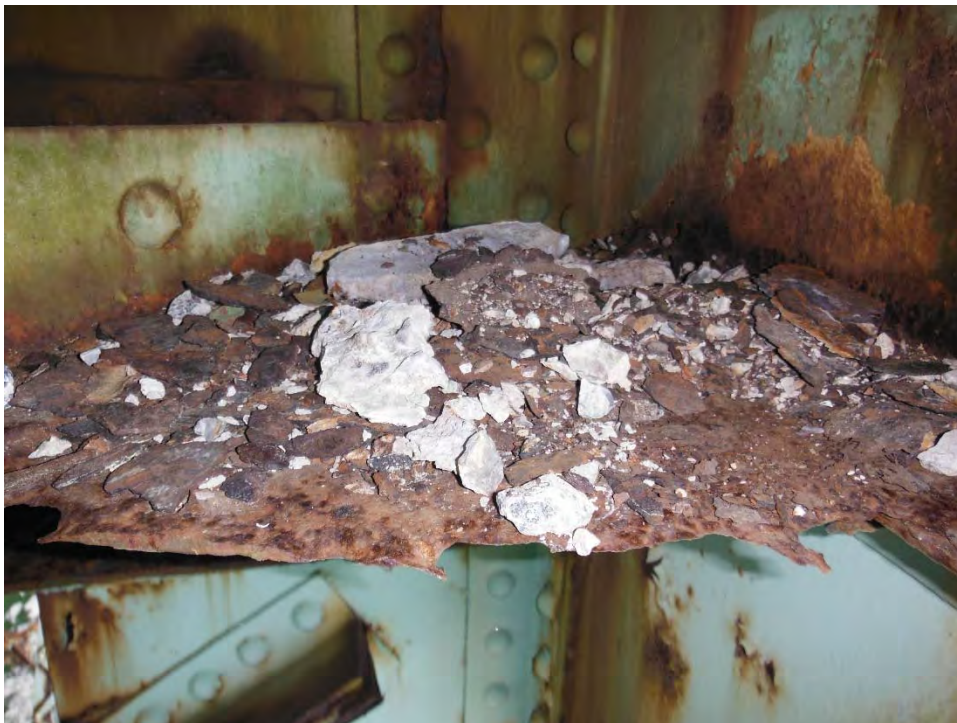
In 2014, numerous upper lateral bracing connection plates were either deformed or exhibited 100% section loss. A list of these locations is provided in the 2014 inspection report. In 2016, there are five more connection plates in Span 4 and six more connection plates in Span 6 that fell into this category. Of the 28 upper lateral bracing connection plates per span, fifteen in Span 4 and twelve in Span 6 are now in this category.

Photo D37: Span 6 – Severe Section Loss in Upper Lateral Bracing Connection Plate

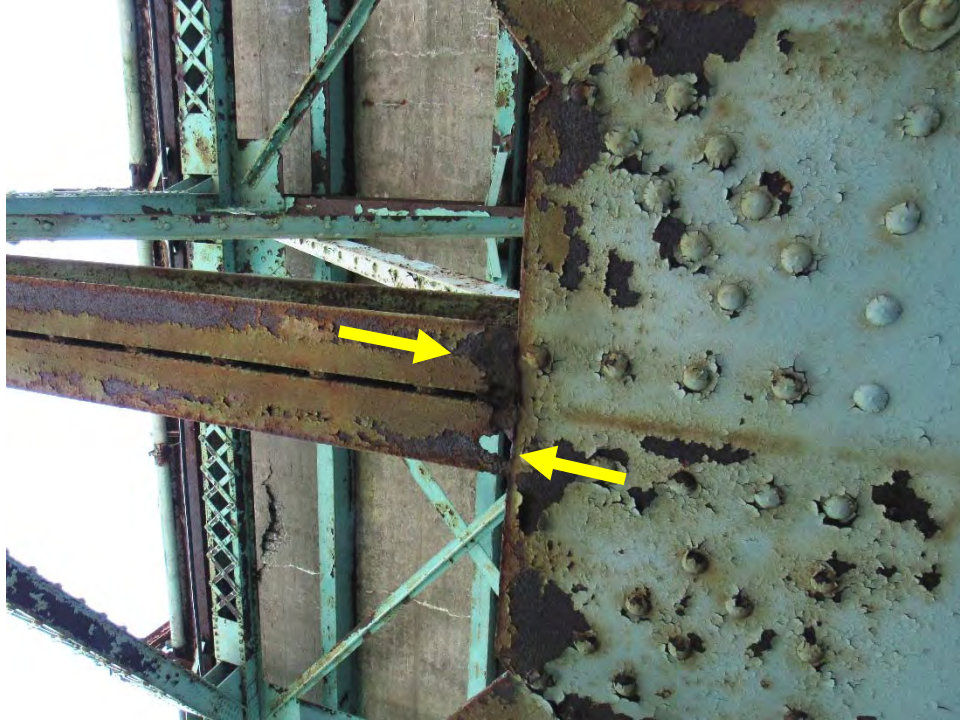
Photo D38: Span 8 Lower Strut of Sway Brace – Section Loss at Connection Plate

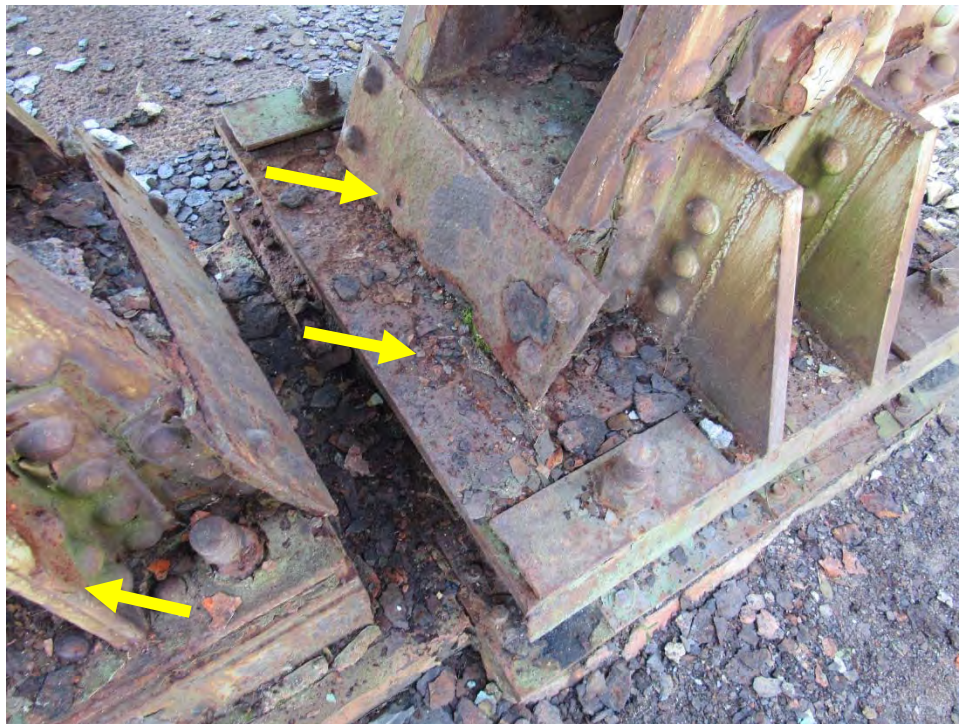
- Deep pitting, deterioration and section loss on the top plate, the upper stay plates and stiffener angles (Photo D39 and Photo D40)
- Bent, loose, “necked-down” and/or heavily deteriorated anchor bolts, nuts, and anchor bolt plate washers (Photo D40 and D41)
- Over-extension of expansion bearings (Photo D41)

Photo D39: Pier 1 Bearings – Top Plate and Stay Plate Deterioration

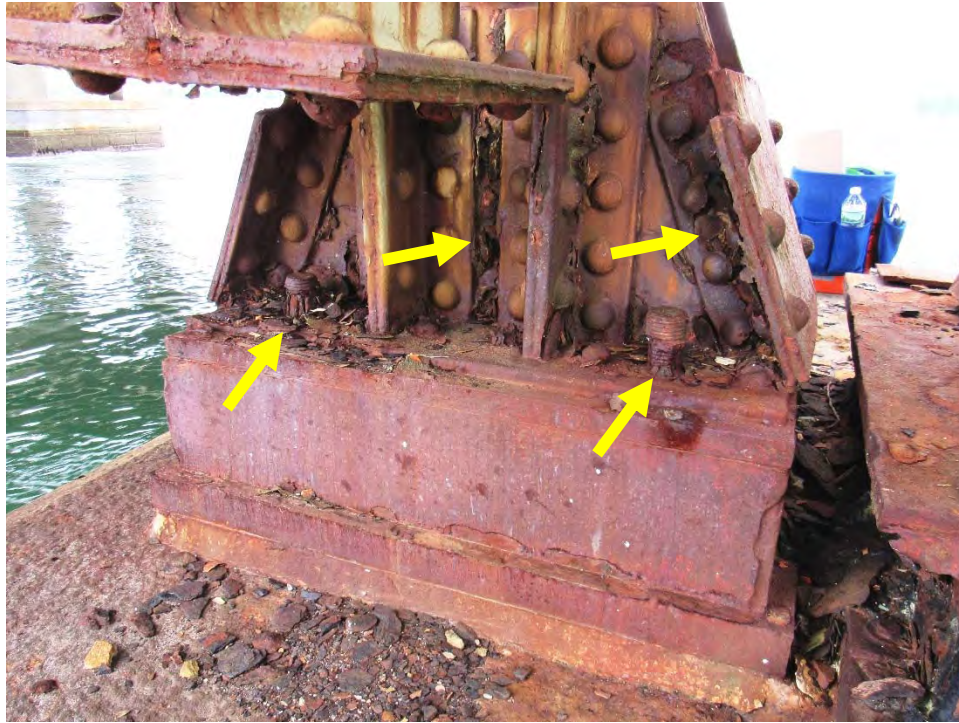
Photo D40: Pier 7 Fixed Bearing – Anchor Bolt and Stiffener Deterioration

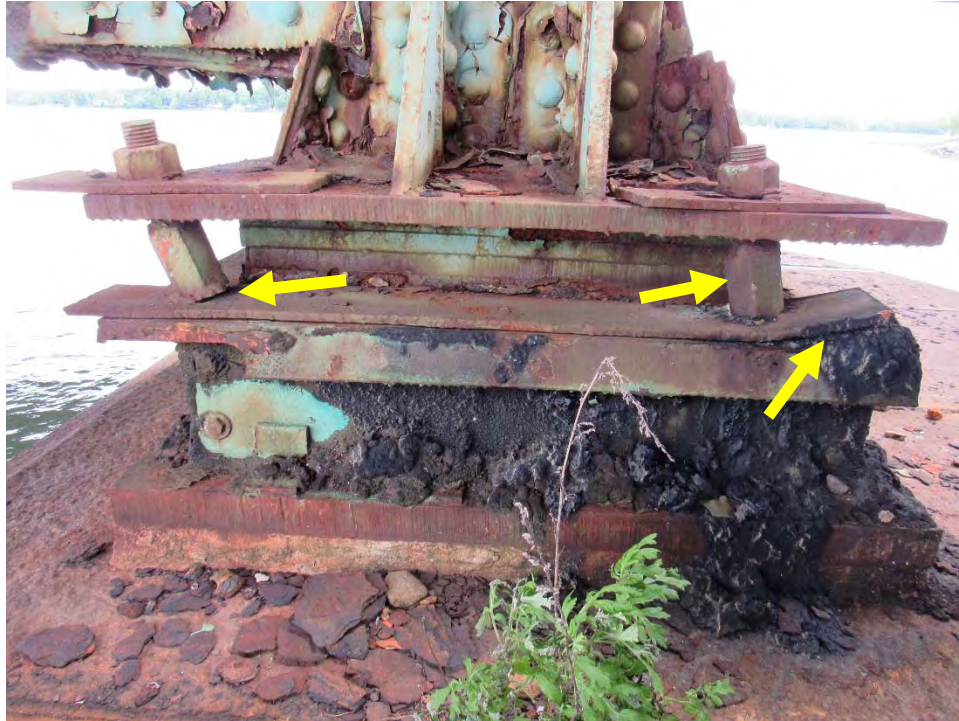
Photo D41: Pier 7 Expansion Bearing – Over-extended With Bent Anchor Bolts

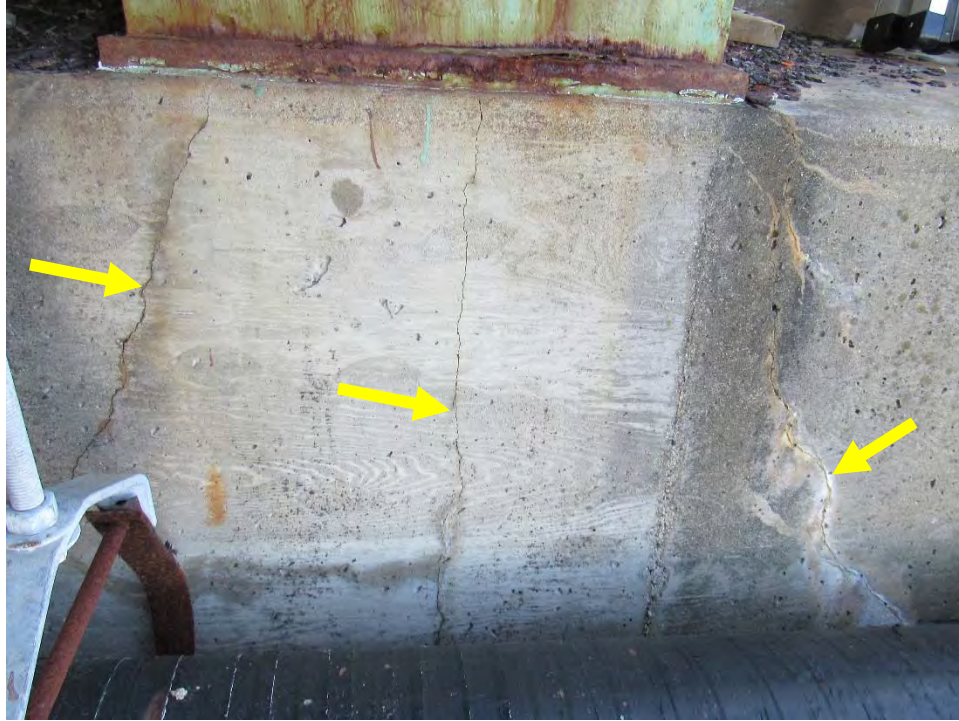
Photo D43: Newington Abutment - Stress Cracks Under West Bearing

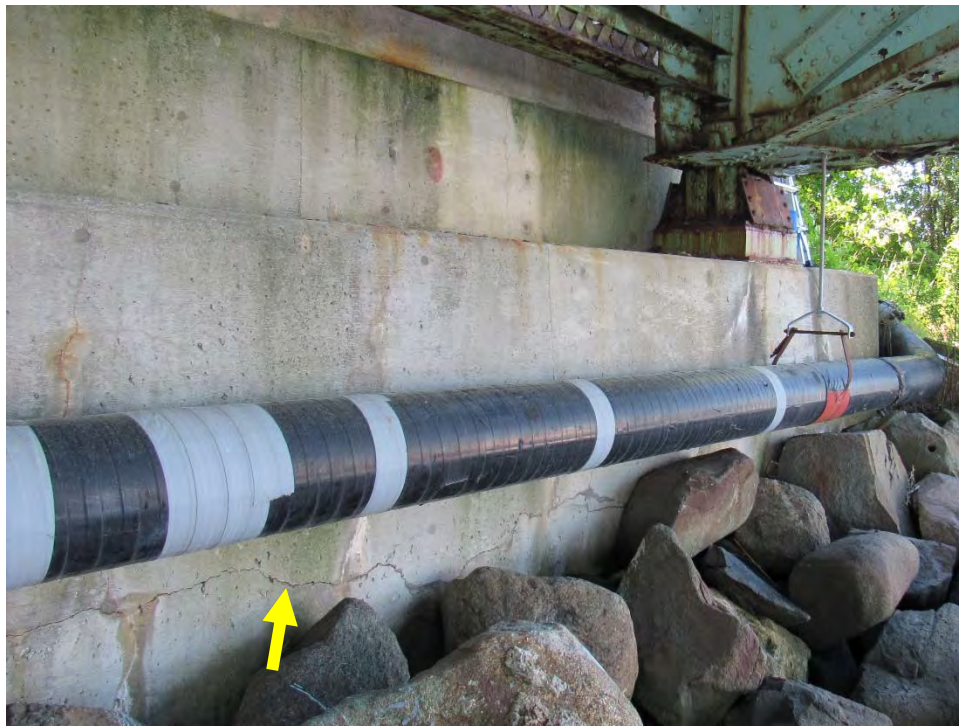
Photo D44: Newington Abutment – Horizontal Crack in Breastwall
