STATE OF NEW HAMPSHIRE
DEPARTMENT OF TRANSPORTATION

IN-DEPTH INSPECTION AND CONDITION REPORT

GENERAL SULLIVAN BRIDGE - DOVER 200/023
OVER THE LITTLE BAY

May 2014 Inspection
and
June 2016 Inspection

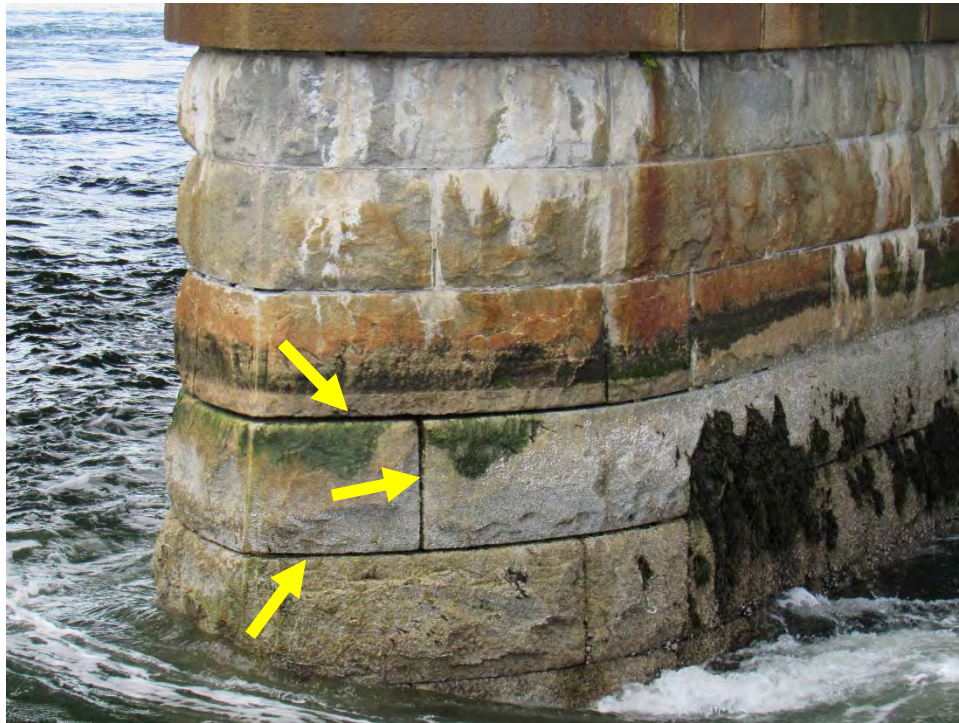
- Pointing/mortar loss between the granite fascia blocks. The majority of the pointing at or below mean sea level has been lost. Pointing above mean sea level is missing sporadically throughout. (Photo D45)
- Sporadic pointing/mortar loss and vegetation growth between the granite blocks that form the pier cap. (Photo D46)

Photo D45: Pier 7 – Missing pointing mortar

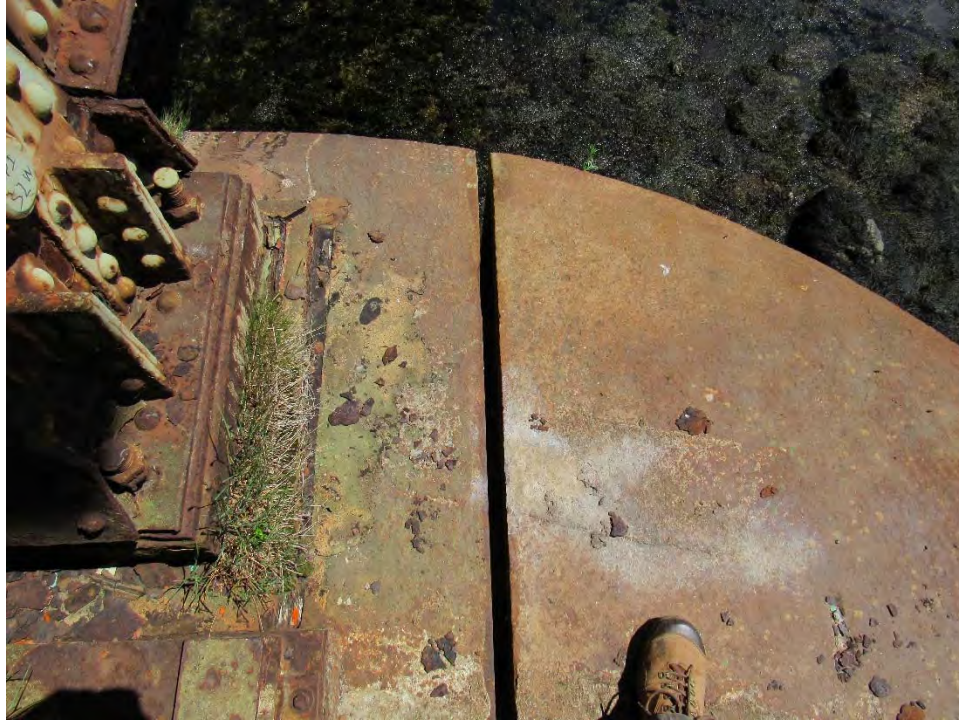
Photo D46: Pier 1 – Missing pointing mortar in cap
