STATE OF NEW HAMPSHIRE
DEPARTMENT OF TRANSPORTATION

IN-DEPTH INSPECTION AND CONDITION REPORT

GENERAL SULLIVAN BRIDGE - DOVER 200/023
OVER THE LITTLE BAY

May 2014 Inspection
and
June 2016 Inspection

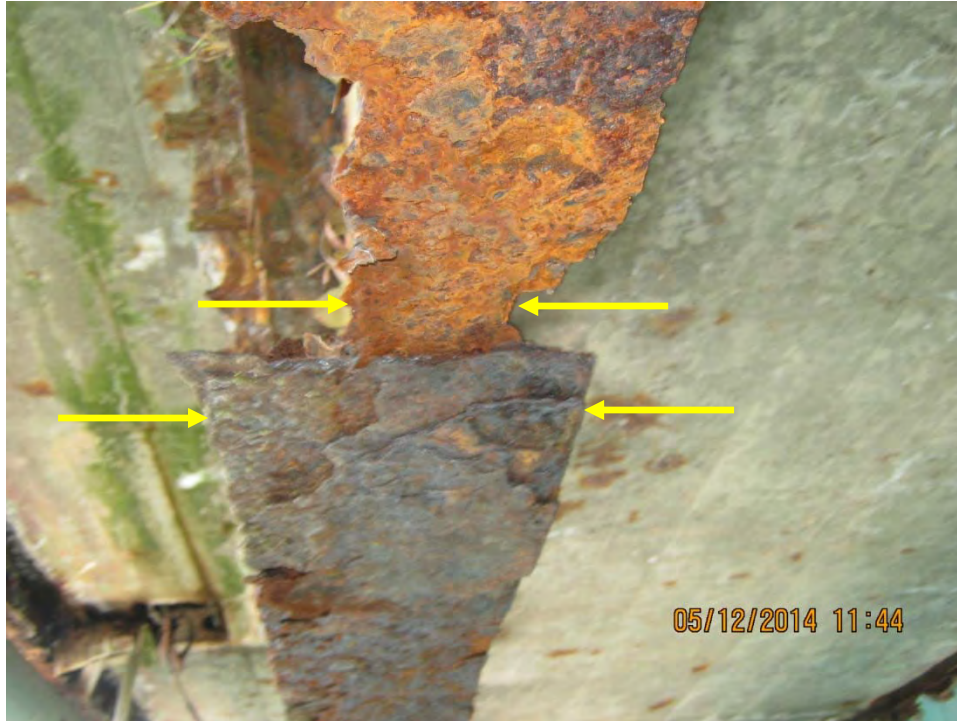
Photo F.3: Span 8, west exterior stringer between F8 and F7. 80% section loss in bottom flange at mid-span.

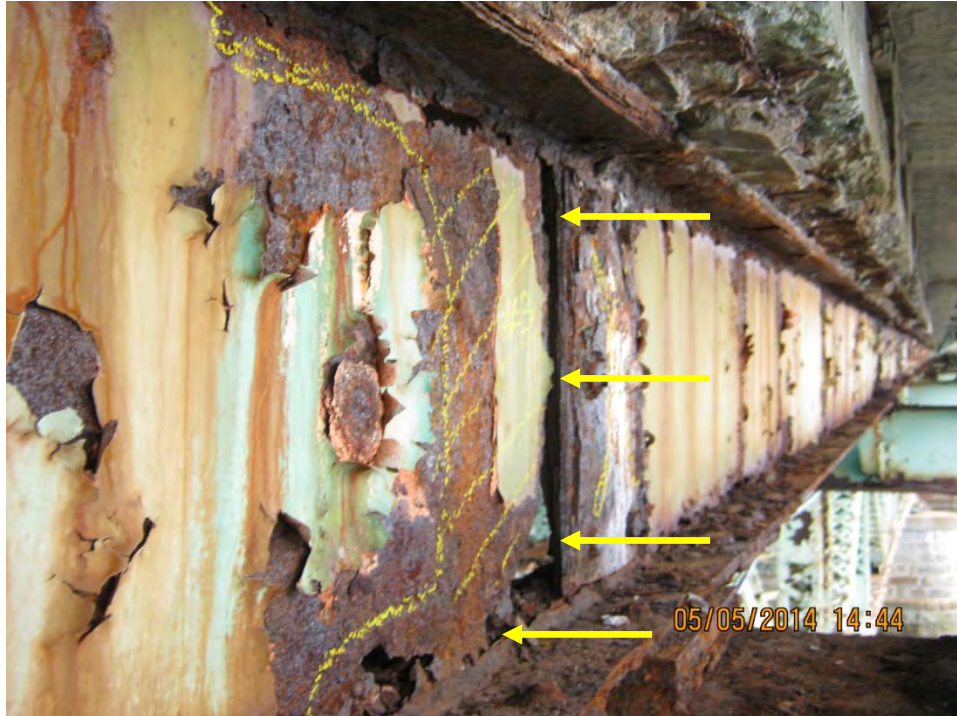
Photo F.4: Span 1, west exterior stringer above F4. Full section loss in the top and bottom of the web and along the connection plate.

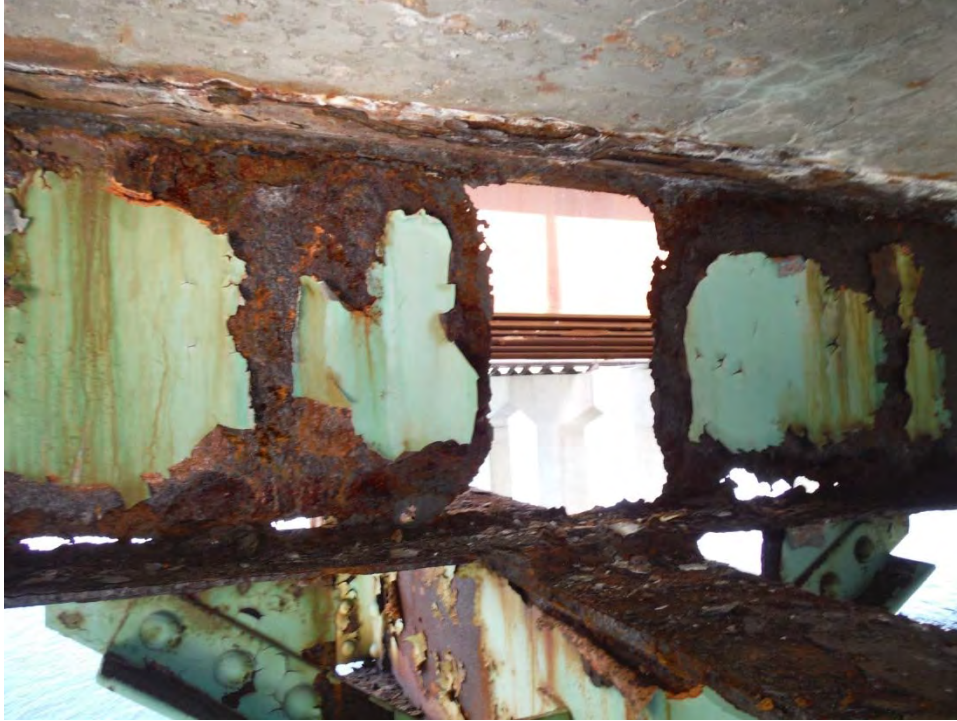
Photo F.5: Span 4, east stringer at FB5. 100% section loss in web at the connection of the two stringers. Connection plate was removed by hand during inspection.

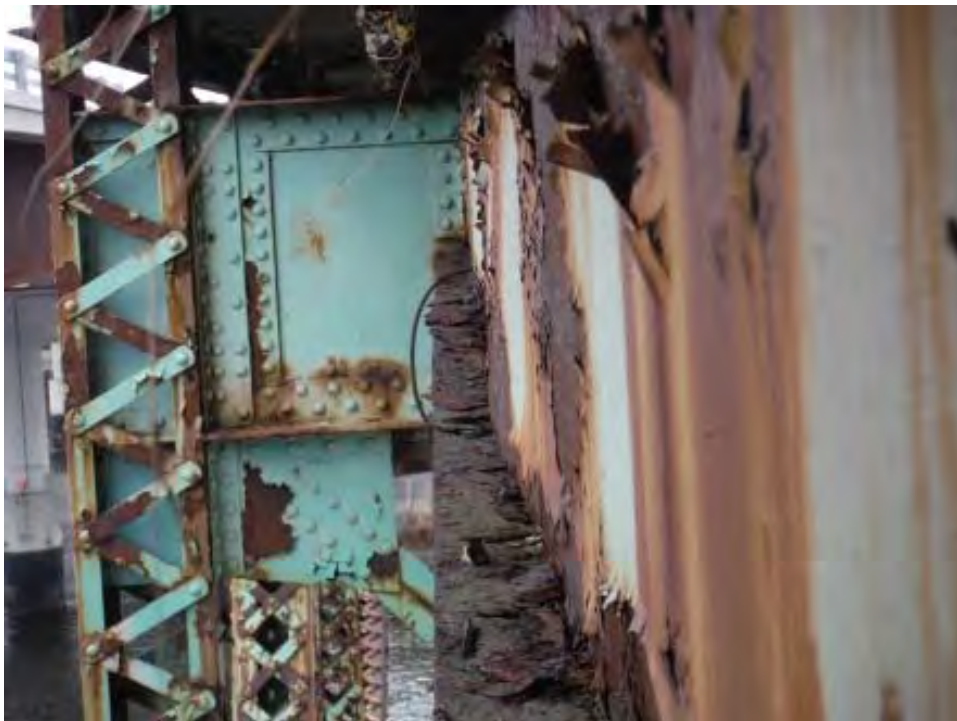
Critical stringers have been denoted with a “†” symbol on the Stringer Condition tables in Appendix C. Stringers marked as critical have either experienced heavy loss in the top or bottom flange at mid-span (>40%) or have large areas of perforation and loss in the web around the floorbeam connections. See Photos F.3, F.4, and F.5. A total of thirteen exterior stringers have experienced web buckling as a result of heavy web losses. These stringers are found in Spans 4 through 8. Photo F.6 shows a stringer with a buckled web.

Photo F.6: Span 4, east stringer U7U8. Mid-span buckle on lower web at flange. Due to nearly full-length perforations. Note that a rigging cable had previously been rigged through the hole in the web.

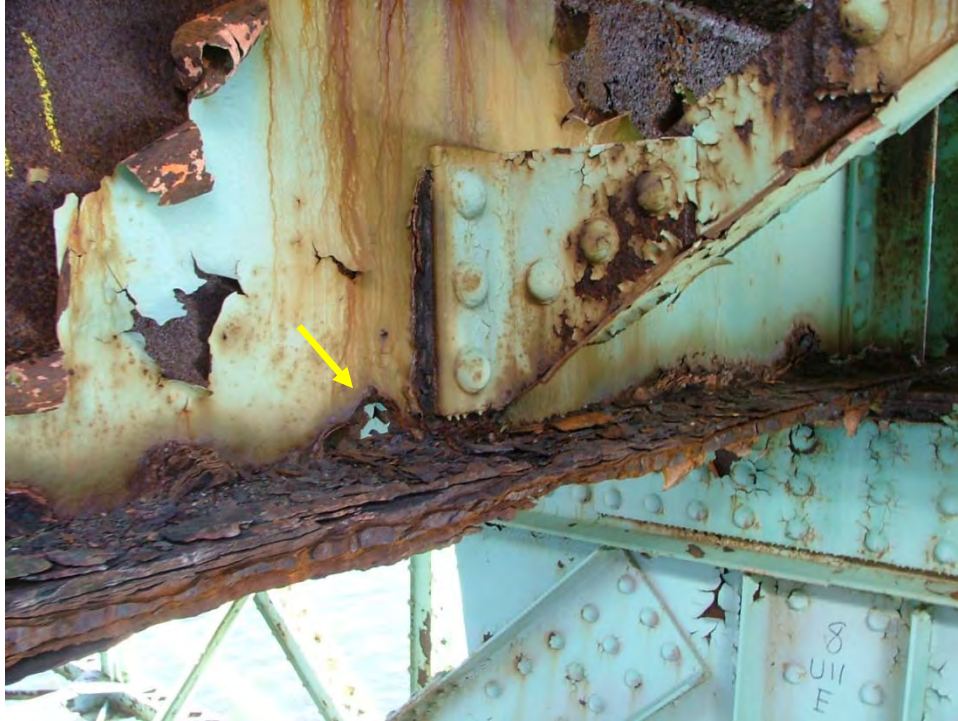
Photo F.7: Span 8, east cantilevered end of floor beam F9. Net thickness of 0.6" in the top and bottom flange with a 2" hole in the web at the exterior stringer knee brace.

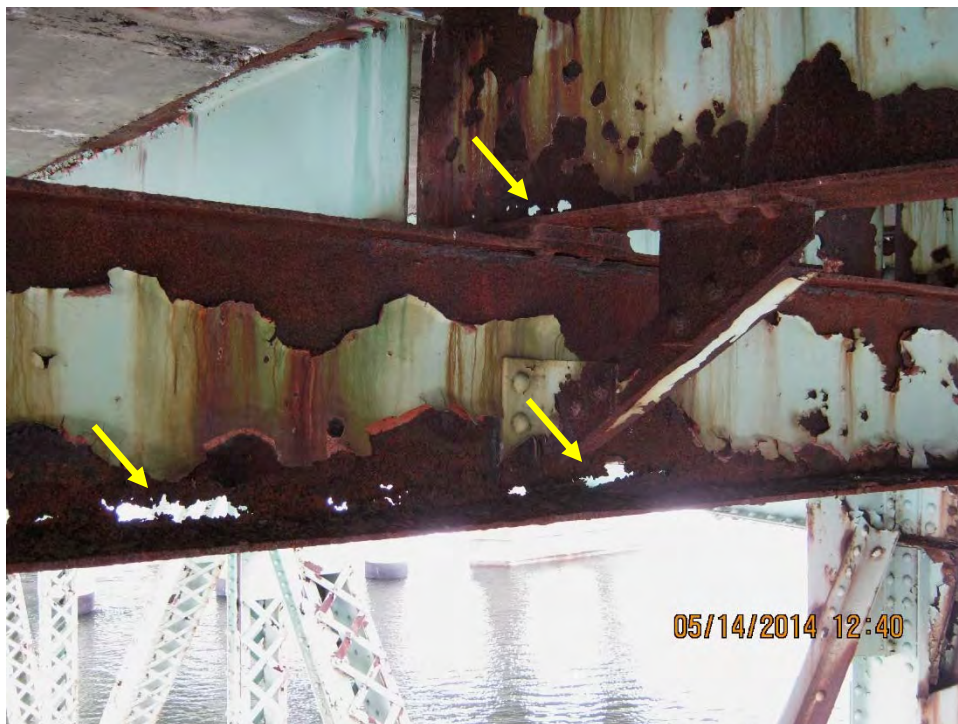
Photo F.8: Span 8, floor beam F14 and interior stringer directly under deck joint. Large areas of full perforation along the bottom of web in floor beam and stringer coupled with flange loss.

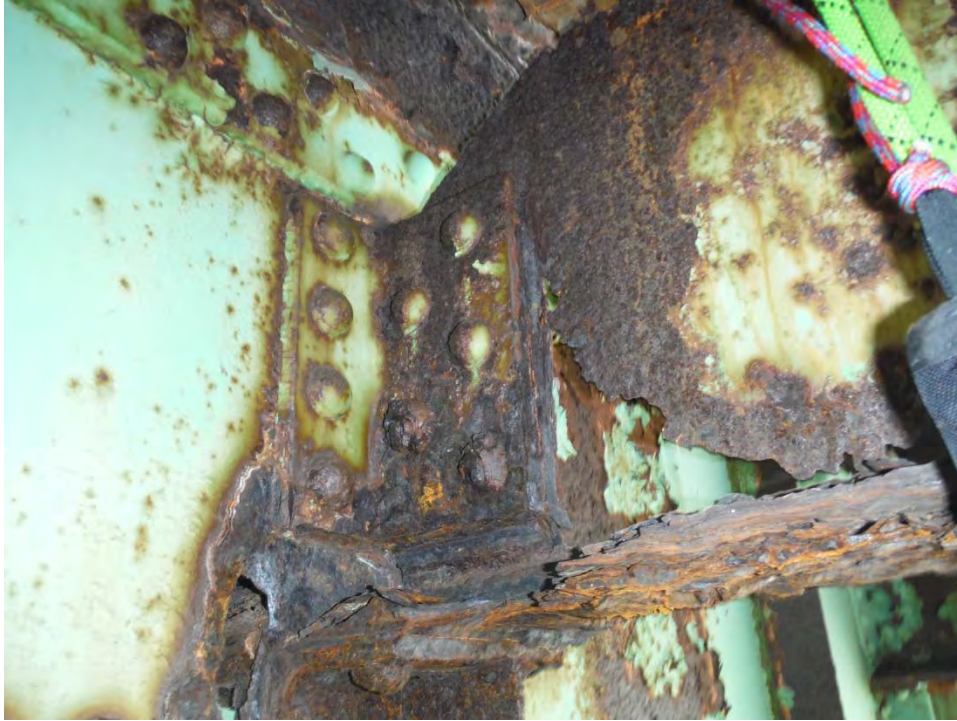
Photo F.9: Span 6, east stringer connection at Floorbeam 7'. Corrosion holes and section loss in web of stringer and in floorbeam.

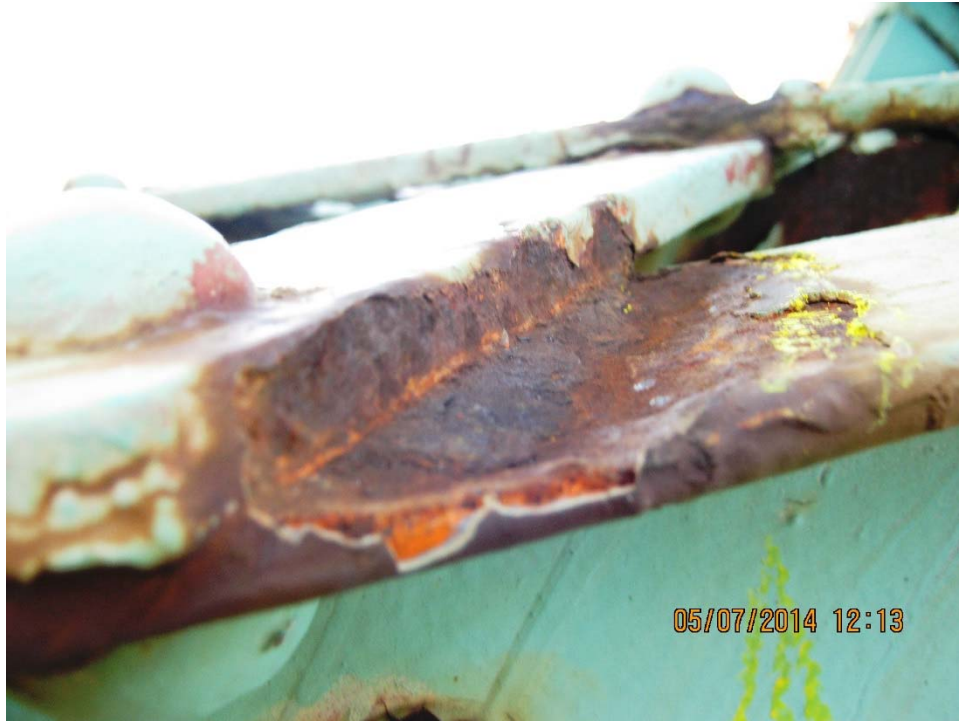
Photo T.1: Span 2, diagonal member between L6 and U5 on east truss. Typical loss on top flange of channel member at lacing bar.

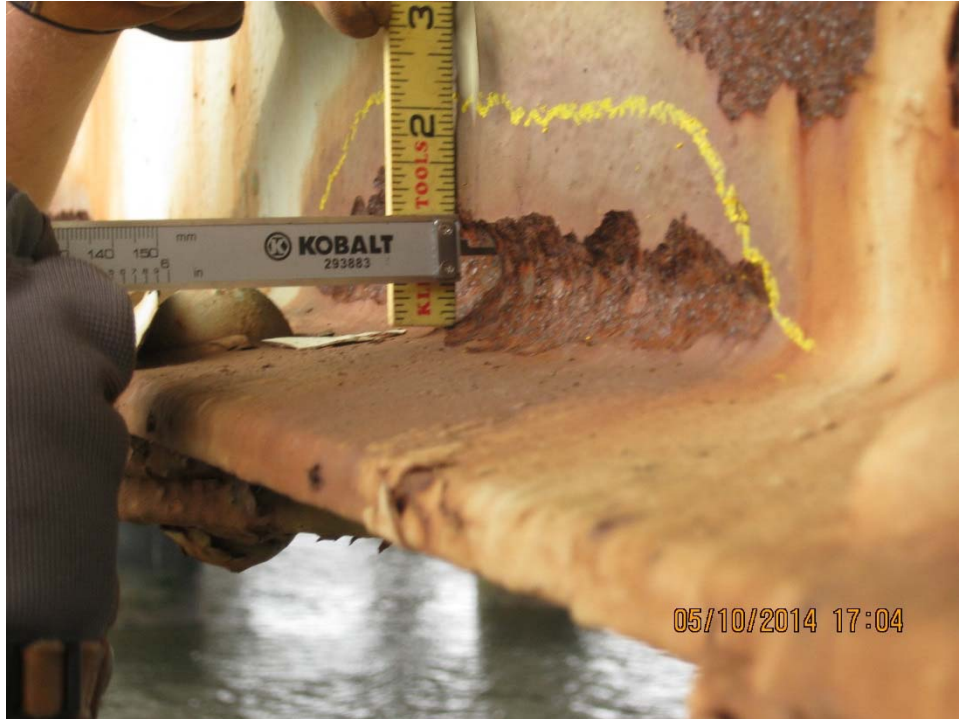
Photo T.2: Span 7, bottom chord member between L7 and L8 on east truss. Typical loss at the bottom of web on channel members.

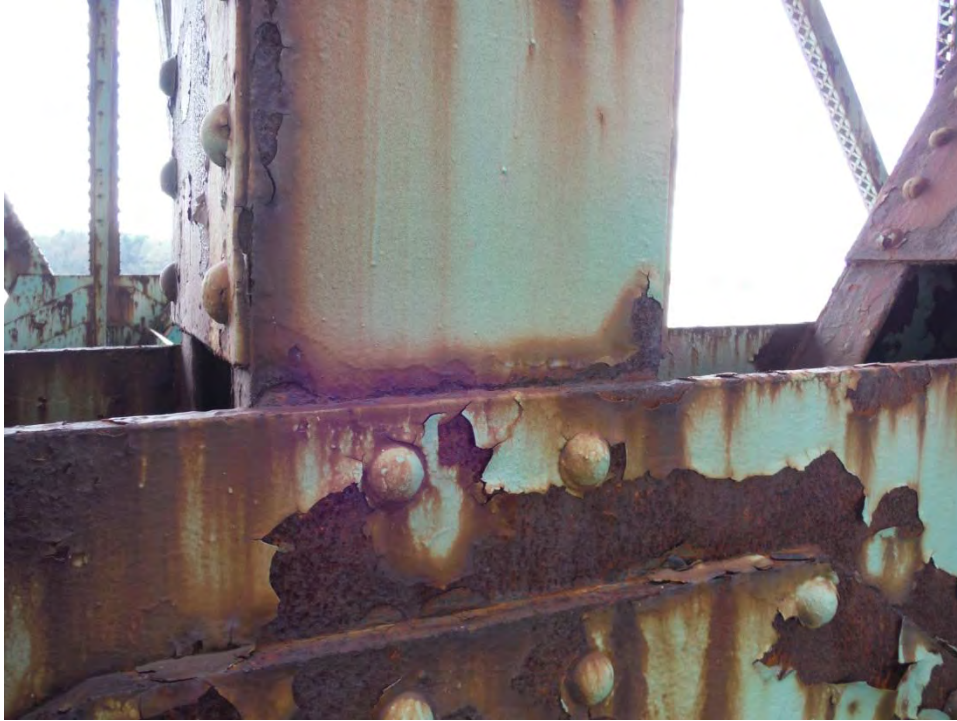
Photo T.5: Span 4, gusset plate at L8 on the east truss. Section loss on vertical L8U8 channel web along gusset plate interface. Typical condition for most lower locations.

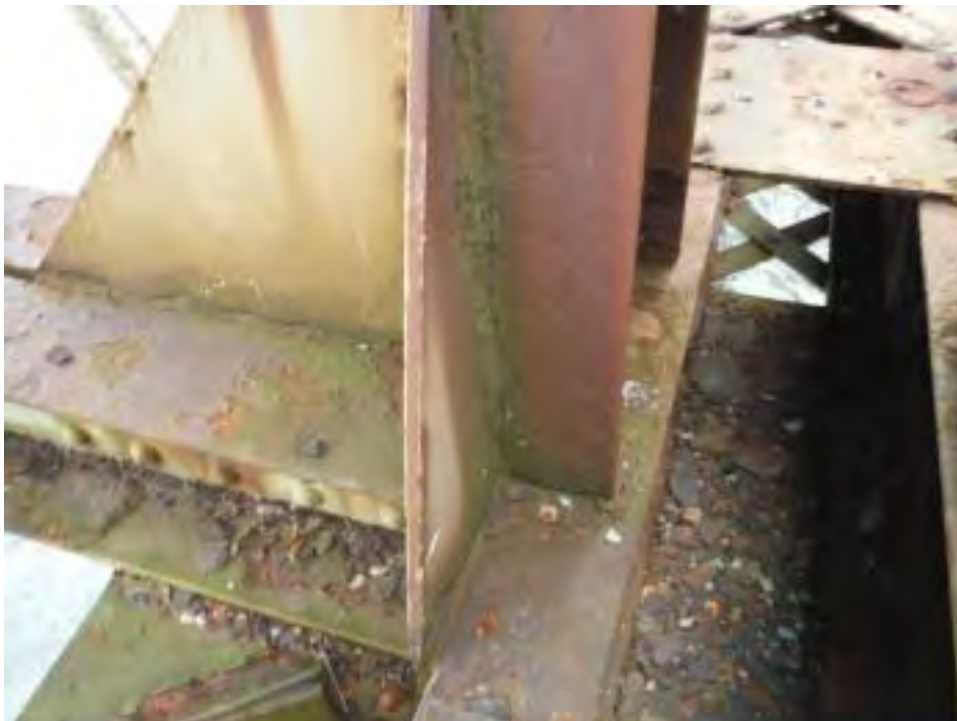
Bottom chords of Spans 4 and 6 have up to 1/4" pack rust between truss bottom chords and gusset plates at many locations. See Photo T.6. Bottom chords from Node L6 to L10 (and L10' to L6') have cover plates on the webs that typically have up to 1/2" pack rust between the channel and the cover plate. See Photo T.10.

Photo T.6: Span 4, east gusset plate at L3. Section loss and pack rust on gusset plate along interface with bottom chord. Typical condition of diagonal and bottom chord interfaces throughout Spans 4, 5 and 6.

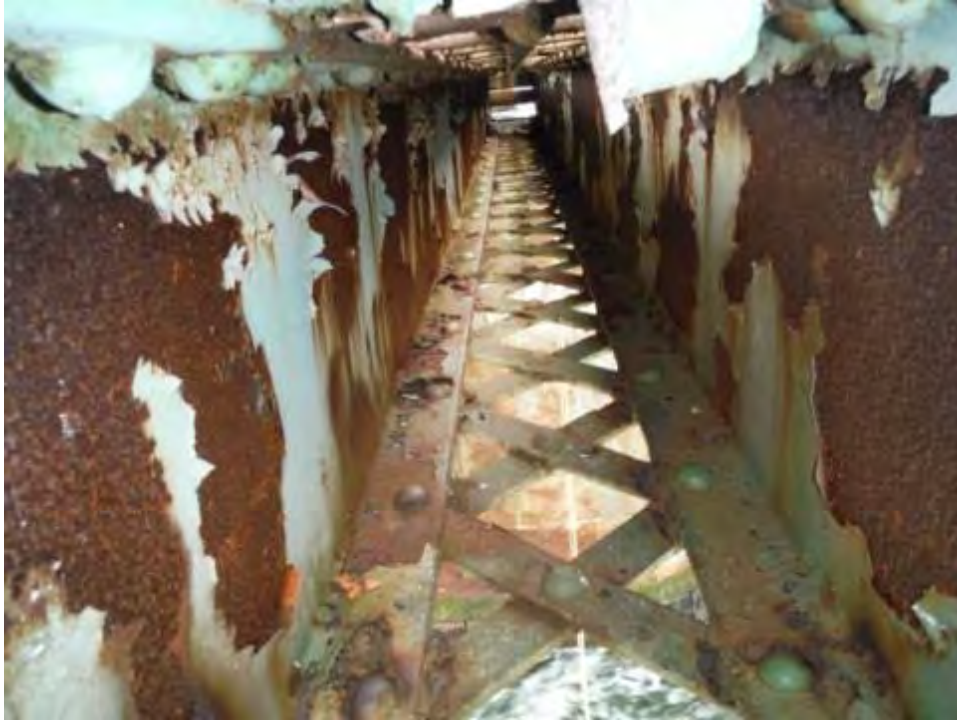
Photo T.7: Span 4, bottom chord L0L1. Surface corrosion and bottom flange section loss inside of chord. Typical throughout all truss members.

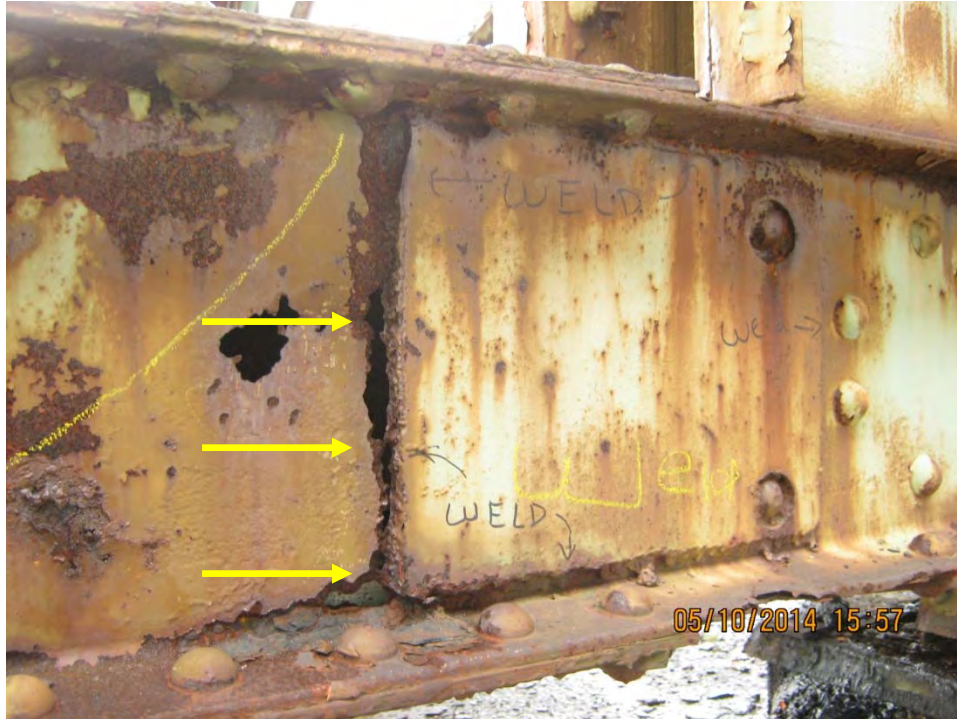
Span 7 is in the worst condition of all truss spans. Between both the east and west trusses, five members have between 15% and 30% total loss and seven members have over 30% total loss. The bottom chords of both trusses adjacent to Pier 6 (L0L1) are in serious condition. At this location on the west truss both channels have approximately 50% section loss due to several large web holes coupled with heavy losses in the top and bottom flange. At this location on the east truss, there is a retrofit plate poorly welded to the web of the outer channel. Around this plate are several large holes and heavy losses in the bottom flange resulting in over 65% total section loss. Photo T.14 and photo T.15 illustrate the losses to both trusses at L0L1.

Photo T.14: Span 7, bottom chord member L0L1 of east truss. Full perforation and heavy loss in web along welded retrofit plate in outside channel.

- Span 7 bottom chord inspections: The Span 7 Truss Bottom Chord L0L1 (east and west trusses) should be inspected at 6-month intervals. The east truss member has severe deterioration and has previous welded repairs that have also sustained advanced deterioration. The west truss member has advancing deterioration and should also be inspected at 6-month intervals.

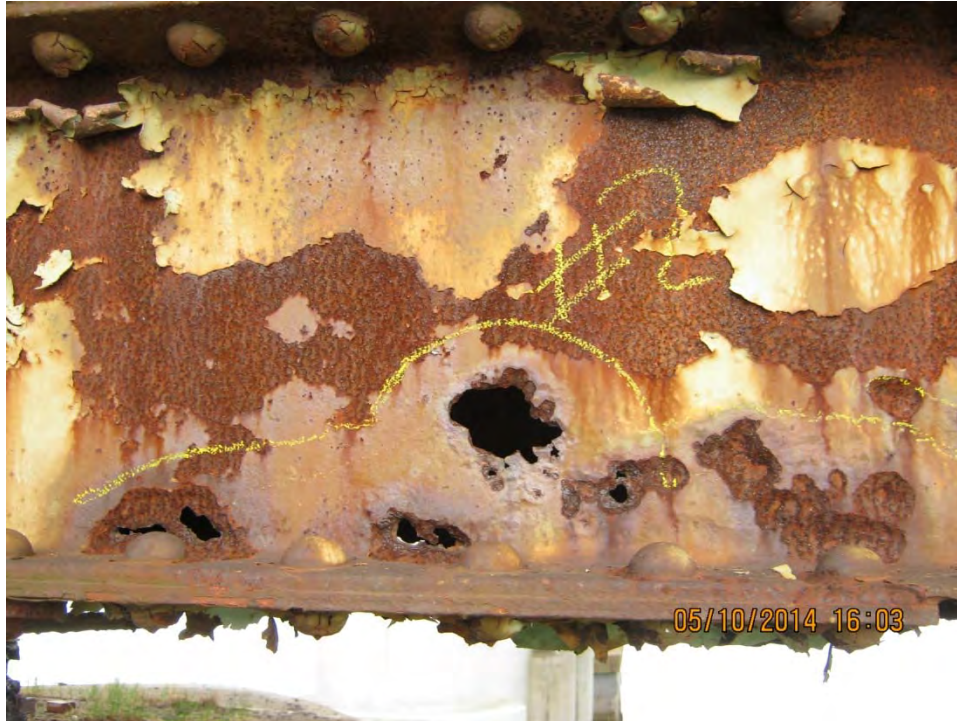
Photo T.15: Span 7, bottom chord member L0L1 of east truss. Several holes surrounded by 50% loss throughout the full height of web in the inner channel.

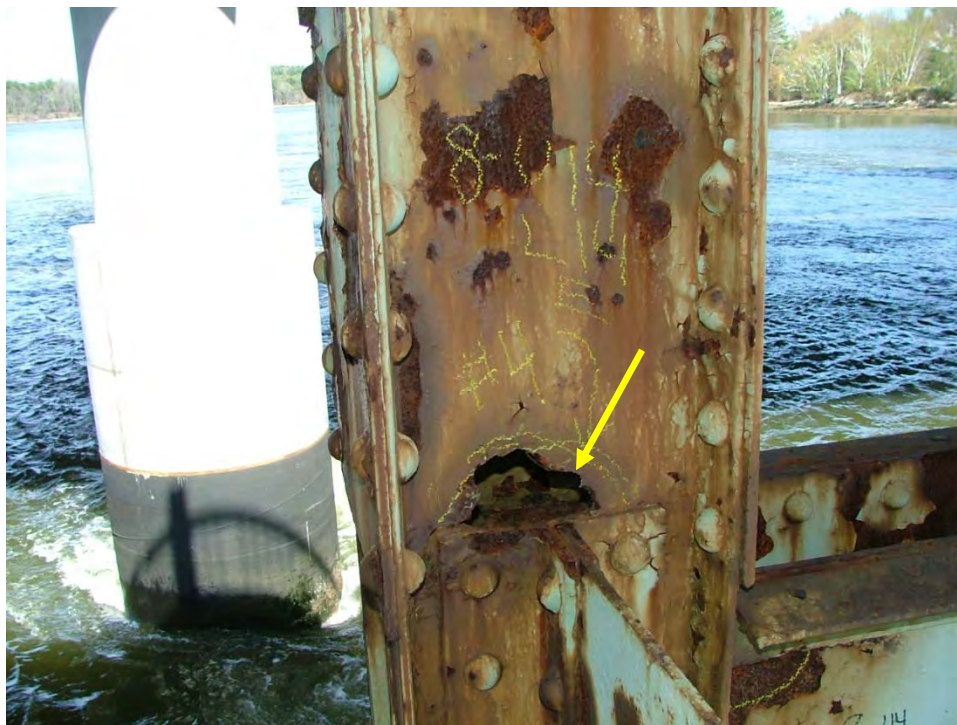
Photo T.16: Span 8, vertical member in east truss at Pier 7. 5" wide hole in web surrounded by 50% loss in full width of web.

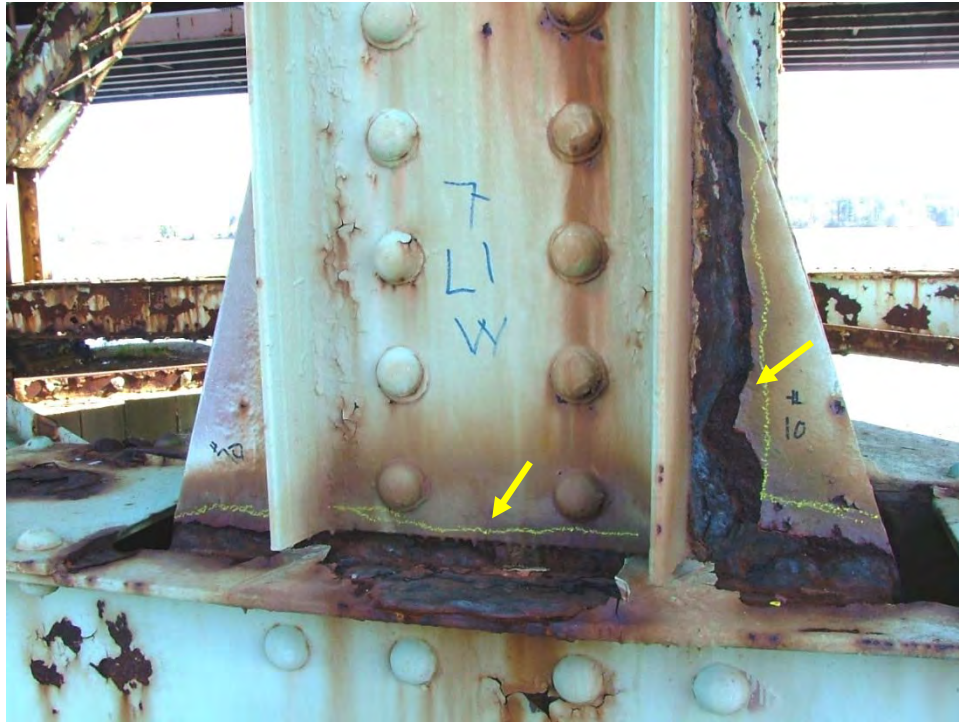
Photo T.17: Span 7, lower gusset plate at L1 on west truss. Heavy loss along the top of the bottom chord adjacent to vertical member.

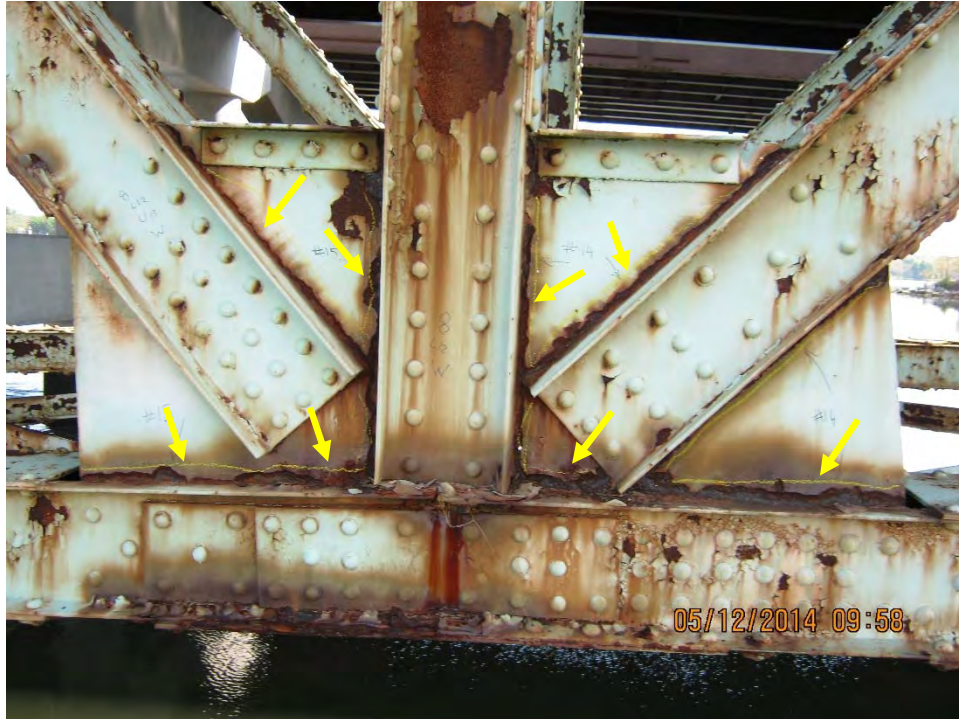
Photo T.18: Span 8, lower gusset plate at L12 on west truss. Typical losses along the bottom chord, diagonal, and vertical members.

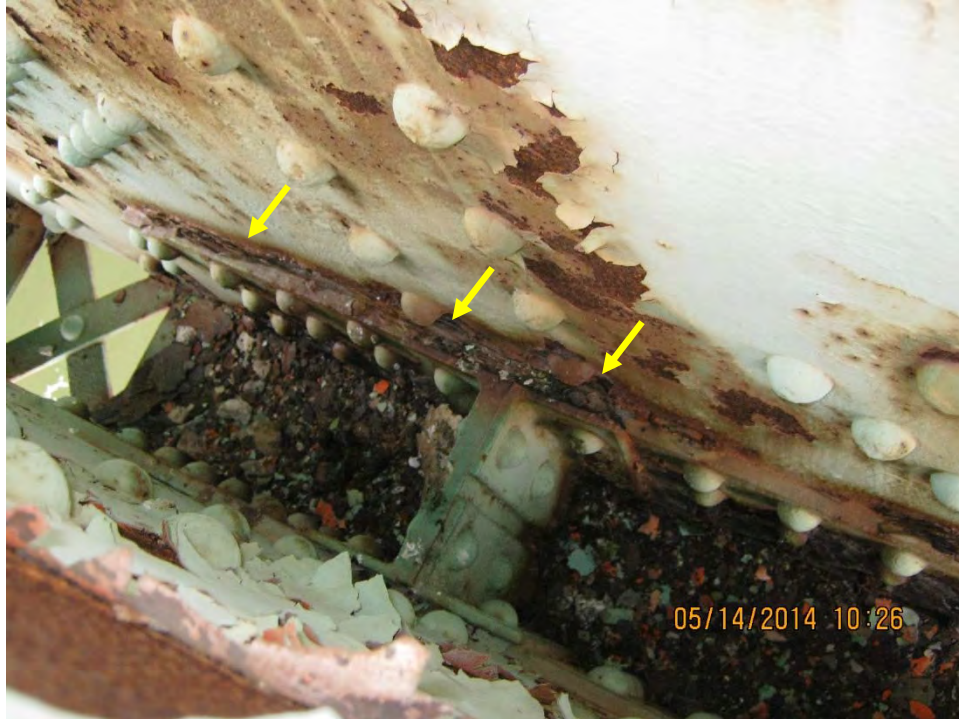
Photo T.19: Span 8, inside of lower gusset plate at L12. Typical loss along the top of diaphragm on the inside of the interior gusset plate.

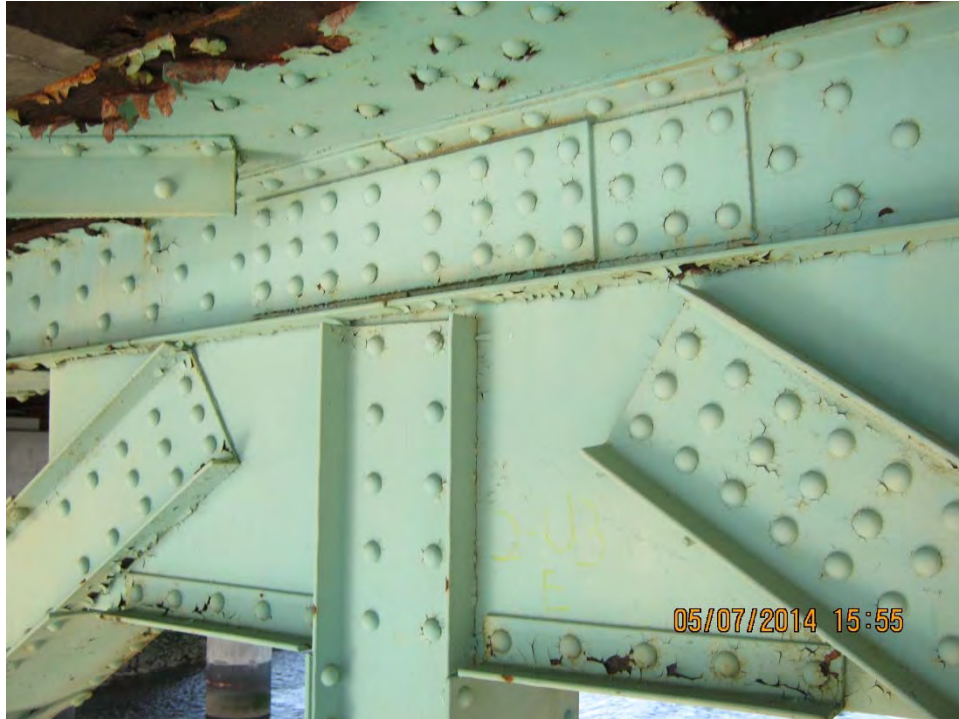
Photo T.20: Span 2, upper gusset plate at U3 on east truss. Upper gusset plates typically in good condition.

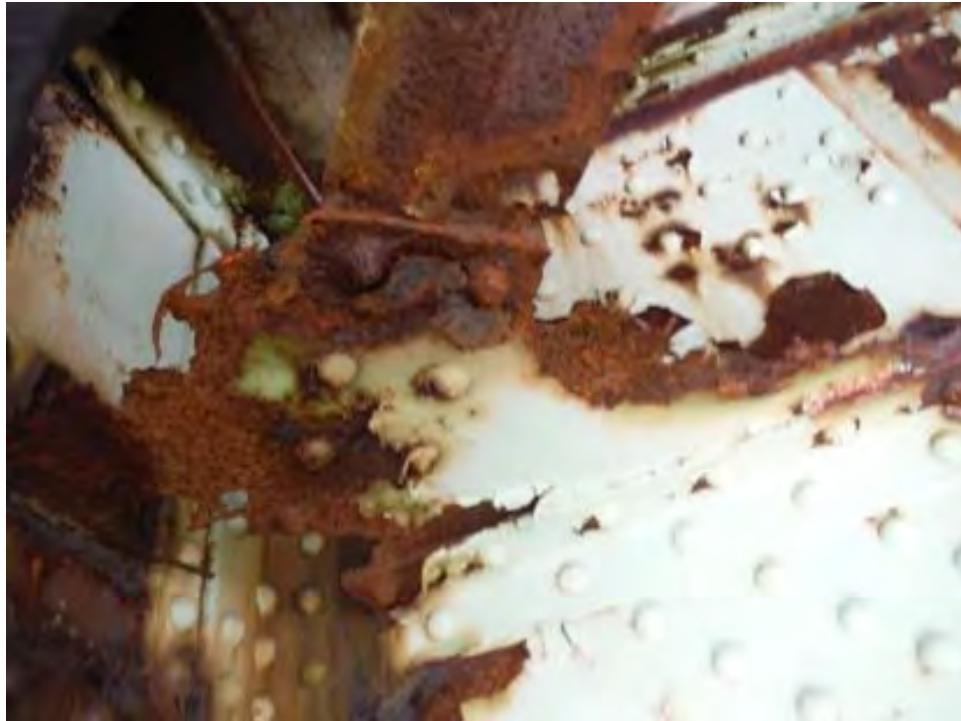
Photo B.5: Span 4, lateral gusset plate U1. Severe section loss in lateral gusset plate, with 100% section loss in connection to floorbeam. Many severe cases exist throughout Spans 4, 5 and 6.

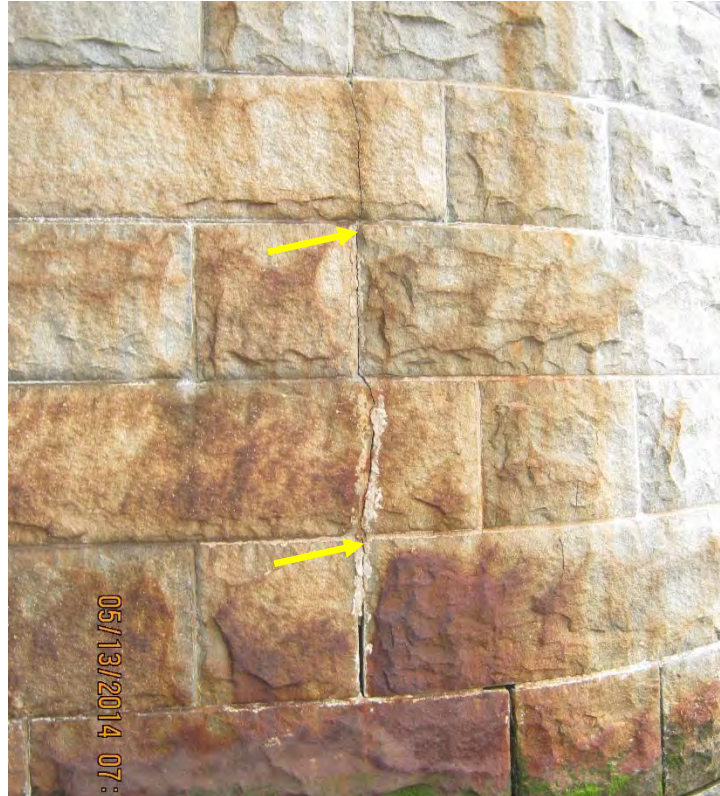
Photo S.5: Pier 7, cracks in granite blocks above water line.

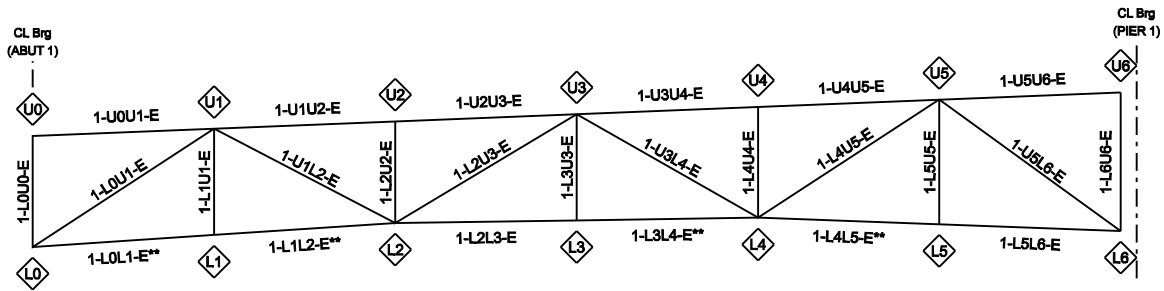
EAST TRUSS ELEVATION

Span 1 - East Truss						Losses			Comments	
Member ID	Member Type		Inner/ Outer	As-Built Area (in ²)	Inspected Area (in ²)	Top/South Flange	Web	Bott/North Flange		Total Loss %
L0U0	Vertical	C 12 x 25	Outer CH	7.32	6.94	1/8"			5.2%	
			Inner CH	7.32	7.13	1/16"			2.6%	
L1L2	Bott. Chord	C 12 x 40	Outer CH	11.73	11.52			1/16"	1.8%	
			Inner CH	11.73	11.30	1/16"		1/16"	3.6%	
L2U1	Diagonal	C 12 x 35	Outer CH	10.26	9.60	0.20"			6.4%	
			Inner CH	10.26	10.26					
L2L3	Bott. Chord	C 12 x 40	Outer CH	20.36	19.33	0.15"		0.15"	5.0%	
		2PL 11½ x ¾	Inner CH	20.36	19.72			3/16"	3.1%	
L3L4	Bott. Chord	C 12 x 40	Outer CH	20.36	19.56	1/8"		**100% x 1"	3.9%	**See Below
		2PL 11½ x ¾	Inner CH	20.36	19.29	1/4"		1/16"	5.3%	
L4L5	Bott. Chord	C 12 x 35	Outer CH	10.26	9.85			1/8"	4.0%	Heavy pack rust on lacing bars
			Inner CH	10.26	9.64			3/16"	6.0%	
U4U5	Top Chord	C 12 x 35	Outer CH	19.39	18.73			0.20"	3.4%	
	PL 18 x 3/8	2PL 11½ x 3/8	Inner CH	19.39	19.39

**Collision damage resulting in a 1" tear in bottom chord.

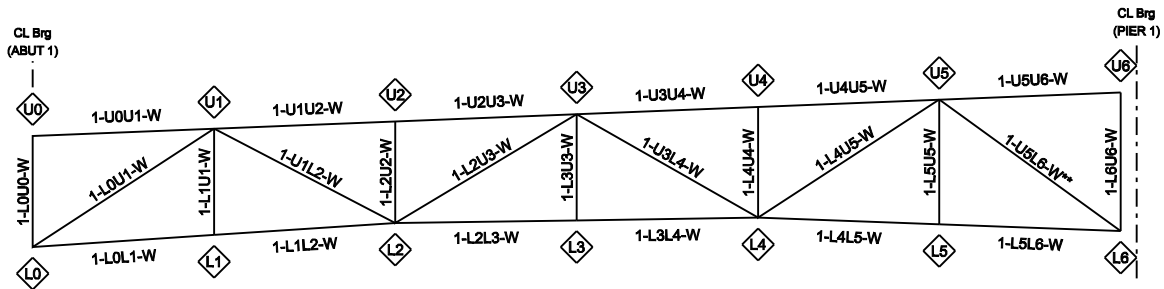
WEST TRUSS ELEVATION

Span 1 - West Truss						Losses			Comments	
Member ID	Member Type		Inner/ Outer	As-Built Area (in ²)	Inspected Area (in ²)	Top/South Flange	Web	Bott/North Flange		Total Loss %
L0U0	Vertical	C 12 x 25	Outer CH	7.32	7.32					
			Inner CH	7.32	7.13			1/16"	2.6%	
L0L1	Bott. Chord	C 12 x 40	Outer CH	11.73	11.09	3/16"			5.5%	
			Inner CH	11.73	11.73					
L2L3	Bott. Chord	C 12 x 40	Outer CH	20.36	18.21	1/4"		75%	10.5%	
		2PL 11½ x ¾	Inner CH	20.36	19.33			0.30"	5.0%	
L2U3	Diagonal	C 12 x 25	Outer CH	7.32	6.44	3/16"		0.10"	12.0%	
			Inner CH	7.32	7.32					
L3L4	Bott. Chord	C 12 x 40	Outer CH	20.36	19.08	1/8"		0.25"	6.3%	
		2PL 11½ x ¾	Inner CH	20.36	19.85	0.15"			2.5%	
L4L5	Bott. Chord	C 12 x 35	Outer CH	10.26	8.68	0.20"	0.10" x 1"	1/4"	15.4%	
			Inner CH	10.26	9.37		10% x 1"	50%	8.7%	
L4U5	Diagonal	C 12 x 35	Outer CH	10.26	9.60	0.20"			6.4%	Typical in multiple locations
			Inner CH	10.26	9.60	0.20"			6.4%	
L5L6	Bott. Chord	C 12 x 35	Outer CH	10.26	8.94	0.20"		0.20"	12.8%	Typical in multiple locations

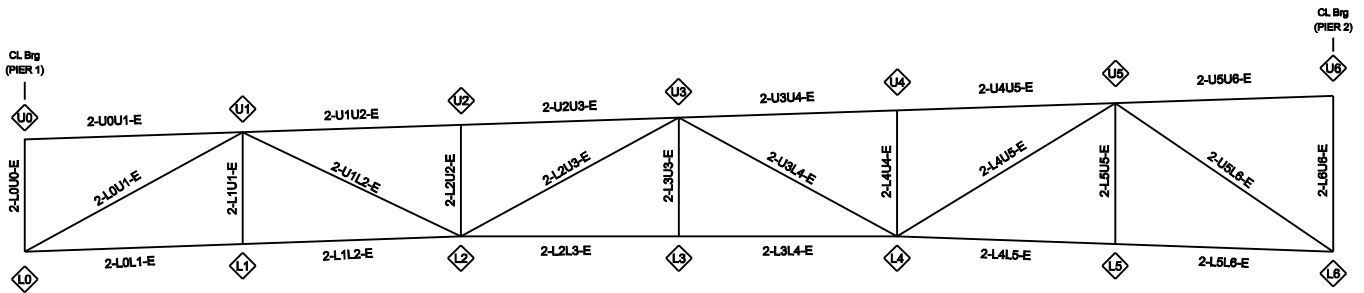
EAST TRUSS ELEVATION

Span 2 - East Truss						Losses				Comments
Member ID	Member Type		Inner/ Outer	As-Built Area (in ²)	Inspected Area (in ²)	Top/South Flange	Web	Bott/North Flange	Total Loss %	
L0U0	Vertical	C 12 x 25	Outer CH	7.32	5.07		3/16"		30.7%	Multiple locations of loss
			Inner CH	7.32	4.05		80%		44.7%	
L0U1	Diagonal	C 12 x 40	Outer CH	11.73	11.73					
			Inner CH	11.73	11.52	1/16"			1.8%	
L0L1	Bott. Chord	C 12 x 35	Outer CH	10.26	8.69	1/8"	1/16"	1/8"	15.3%	
			Inner CH	10.26	9.44	1/8"		1/8"	8.0%	
L1L2	Bott. Chord	C 12 x 35	Outer CH	10.26	10.26					
			Inner CH	10.26	9.85	1/8"			4.0%	
L2U1	Diagonal	C 12 x 25	Outer CH	7.32	7.13	1/16"			2.6%	
			Inner CH	7.32	7.32					
L2U3	Diagonal	C 12 x 25	Outer CH	7.32	6.75	1/8"		1/16"	7.8%	
			Inner CH	7.32	6.71	0.20"			8.3%	
L2L3	Bott. Chord	C 12 x 35	Outer CH	10.26	9.19	0.20"		1/8"	10.4%	
			Inner CH	10.26	8.94	0.20"		0.20"	12.8%	
L3L4	Bott. Chord	C 12 x 35	Outer CH	10.26	9.60	0.20"			6.4%

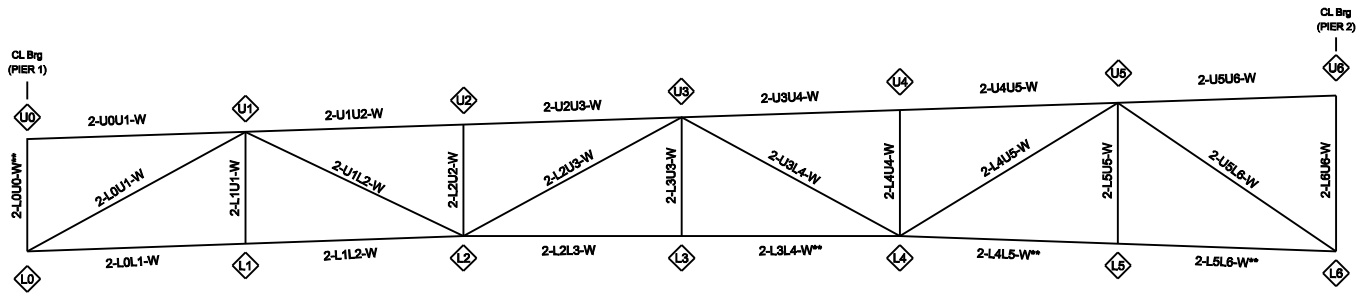
WEST TRUSS ELEVATION

Span 2 - West Truss						Losses			Comments	
Member ID	Member Type	Inner/Outer	As-Built Area (in ²)	Inspected Area (in ²)	Top/South Flange	Web	Bott/North Flange	Total Loss %		
L0U0	Vertical	C 12 x 25	Outer CH	7.32	6.57		1/16"		10.2%	Multiple locations of loss and holes
			Inner CH	7.32	5.39		2" Wide Hole w/ 3" of Trans Around Hole		26.4%	
L0U1	Diagonal	C 12 x 40	Outer CH	11.73	10.36	0.20"		0.20"	11.7%	
			Inner CH	11.73	10.53	0.20"		0.15"	10.2%	
L0L1	Bott. Chord	C 12 x 35	Outer CH	10.26	8.94	0.20"		40%	12.8%	Heavy loss in top lacing bars
			Inner CH	10.26	9.03	1/8"		1/4"	12.0%	
L1L2	Bott. Chord	C 12 x 35	Outer CH	10.26	8.62	0.20"		0.30"	16.0%	
			Inner CH	10.26	9.60	0.20"			6.4%	
L2U1	Diagonal	C 12 x 25	Outer CH	7.32	6.71	0.20"			8.3%	
			Inner CH	7.32	6.71	0.20"			8.3%	
L2U3	Diagonal	C 12 x 25	Outer CH	7.32	6.94	1/8"			5.2%	
			Inner CH	7.32	6.94	1/8"			5.2%	
L2L3	Bott. Chord	C 12 x 35	Outer CH	10.26	8.94	0.20"		0.20"	12.8%	Typical in multiple locations

Inner CH	10.26	9.64	3/16"			6.0%	
L3L4	Bott. Chord	C 12 x 35	Outer CH	10.26	8.94	0.20"		0.20"	12.8%	
			Inner CH	10.26	9.85	1/8"			4.0%	
L4U3	Diagonal	C 12 x 35	Outer CH	10.26	8.78	0.25"		0.20"	14.4%	Typical in multiple locations
			Inner CH	10.26	9.60	0.20"			6.4%	
L4U5	Diagonal	C 12 x 40	Outer CH	11.73	10.83	0.20"		1/16"	7.7%	
			Inner CH	11.73	10.65	1/8"		0.20"	9.2%	
L4L5	Bott. Chord	C 12 x 30	Outer CH	13.10	13.10					Hvy pack rust - member and PL
			2PL 11½ x ¾	Inner CH	13.10	13.10				
L5U5	Vertical	C 12 x 25	Outer CH	7.32	6.95		1/16" x 6"		5.1%	
			Inner CH	7.32	7.32					
L5L6	Bott. Chord	C 12 x 30	Outer CH	13.10	11.83	0.20"		0.20"	9.7%	Typical in multiple locations
			2PL 11½ x ¾	Inner CH	13.10	11.69	1/8"	1/16" x 1"	60%	
L6U5	Diagonal	C 12 x 40	Outer CH	18.92	18.24	0.20"			3.6%	
			2PL 11½ x ¾	Inner CH	18.92	18.49	1/8"

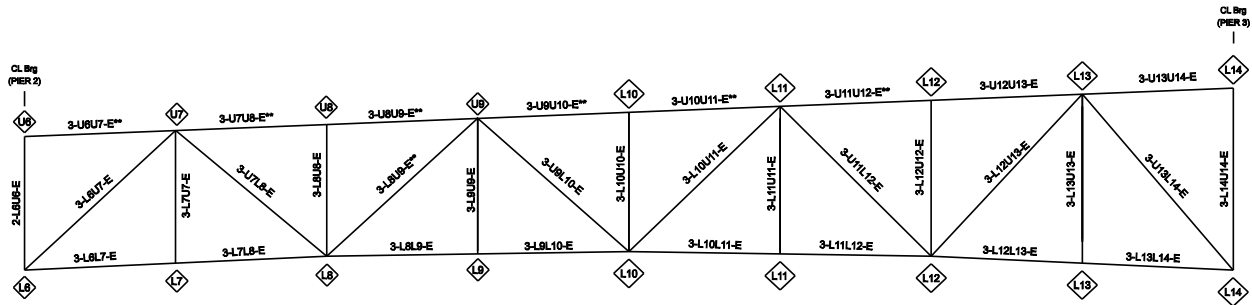
EAST TRUSS ELEVATION

Span 3 - East Truss					Losses				Comments	
Member ID	Member Type	Inner/Outer	As-Built Area (in ²)	Inspected Area (in ²)	Top/South Flange	Web	Bott/North Flange	Total Loss %		
L6U7	Diagonal	C 15 x 45	Outer CH	20.42	18.22	0.20"	1/16"	0.15"	10.8%	
		2PL 14½ x ½	Inner CH	20.42	19.97	1/8"			2.2%	
L6L7	Bott. Chord	C 12 x 35	Outer CH	10.26	9.85	1/8"			4.0%	
			Inner CH	10.26	9.85	1/8"			4.0%	
L7L8	Bott. Chord	C 12 x 35	Outer CH	10.26	9.64	1/16"		1/8"	6.0%	
			Inner CH	10.26	10.05	1/16"			2.0%	
L8U7	Diagonal	C 12 x 35	Outer CH	14.57	14.26		1/16" x 5"		2.1%	
		2PL 11½ x ¾	Inner CH	14.57	14.16	1/8"			2.8%	
L8U8	Vertical	C 12 x 25	Outer CH	7.32	6.95		1/16" x 6"		5.1%	
			Inner CH	7.32	7.32					
L8U9	Diagonal	C 12 x 30	Outer CH	8.79	8.39	1/8"			4.5%	
			Inner CH	8.79	8.79					
L8L9	Bott. Chord	C 12 x 35	Outer CH	14.57	13.95	1/8"		1/16"	4.2%	
		2PL 11½ x ¾	Inner CH	14.57	14.16	1/8"			2.8%	
L9L10	Bott. Chord	C 12 x 35	Outer CH	14.57	13.75	1/8"		1/8"	5.6%

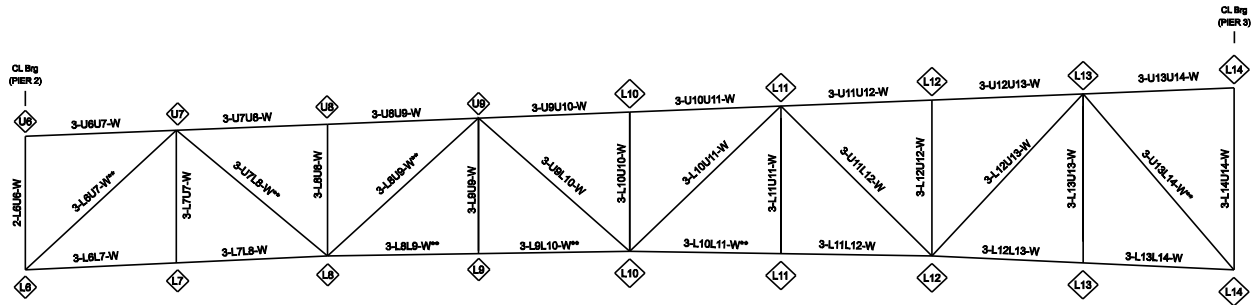
WEST TRUSS ELEVATION

Span 3 - West Truss					Losses				Comments	
Member ID	Member Type	Inner/Outer	As-Built Area (in ²)	Inspected Area (in ²)	Top/South Flange	Web	Bott/North Flange	Total Loss %		
L6U7	Diagonal	C 15 x 45	Outer CH	20.42	19.74	1/8"		1/16"	3.3%	
		2PL 14½ x ½	Inner CH	20.42	19.97	1/16"		1/16"	2.2%	
L6L7	Bott. Chord	C 12 x 35	Outer CH	10.26	9.44	1/8"		1/8"	8.0%	
			Inner CH	10.26	9.64	1/16"		1/8"	6.0%	
L7L8	Bott. Chord	C 12 x 35	Outer CH	10.26	8.61	50%		50%	16.1%	
			Inner CH	10.26	9.85	1/16"		1/16"	4.0%	
L8U7	Diagonal	C 12 x 35	Outer CH	14.57	13.96	3/16"			4.2%	
		2PL 11½ x ¾	Inner CH	14.57	14.37	1/16"			1.4%	
L8U9	Diagonal	C 12 x 30	Outer CH	8.79	8.16	0.20"			7.2%	
			Inner CH	8.79	8.59	1/16"			2.3%	
L8L9	Bott. Chord	C 12 x 35	Outer CH	14.57	13.91	0.20"			4.5%	
		2PL 11½ x ¾	Inner CH	14.57	14.57					
L9L10	Bott. Chord	C 12 x 35	Outer CH	14.57	13.09	0.20"		1/4"	10.2%	
		2PL 11½ x ¾	Inner CH	14.57	14.57					
L10U10	Vertical	C 12 x 25	Outer CH	7.32	7.13			1/16"	2.6%

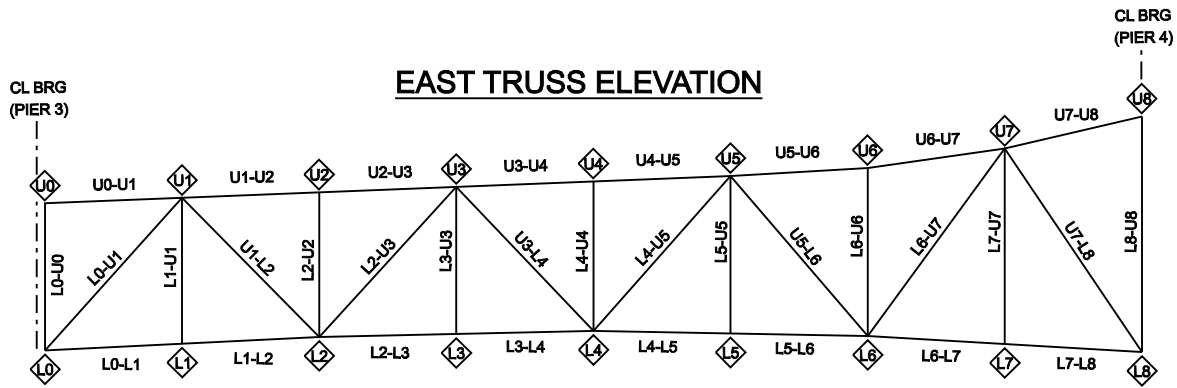
Span 4 - East Truss					Losses				Comments	
Member ID	Member Type		Inner/ Outer	As-Built Area (in ²)	Inspected Area (in ²)	Top/South Flange	Web	Bott/North Flange		Total Loss %
L0U0	Vertical	C 12 x 25	Inner CH	7.31	4.67	3/16"	1/8"	3/16"	36.2%	
			Outer CH	7.31	5.42	3/16"	1/16"	3/16"	25.9%	
L0L1	Bott. Chord	C 18 x 42.7	Inner CH	12.48	9.24	1/8"	1/8"	1/8"	26.0%	Pack rust and SL on lace bars
			Outer CH	12.48	9.24	1/8"	1/8"	1/8"	26.0%	
L0U1	Diagonal	C 18 x 51.9	Inner CH	15.18	11.90	1/8"	1/8"	1/8"	21.6%	
			Outer CH	15.18	11.90	1/8"	1/8"	1/8"	21.6%	
U0U1	Top Chord	C 18 x 42.7	Inner CH	15.48	15.48					
			Outer CH	15.48	13.23		1/8"		14.5%	
L1U1	Vertical	C 12 x 25	Inner CH	7.31	4.67	3/16"	1/8"	3/16"	36.2%	
			Outer CH	7.31	4.67	3/16"	1/8"	3/16"	36.2%	
L1L2	Bott. Chord	C 18 x 42.7	Inner CH	12.48	9.24	1/8"	1/8"	1/8"	26.0%	Pack rust and SL on lace bars
			Outer CH	12.48	9.24	1/8"	1/8"	1/8"	26.0%	
U1L2	Diagonal	C 15 x 33.9	Inner CH	9.90	9.26	1/8"	4.5" H hole	1/16"	6.4%

Outer CH	9.90	8.95	1/8"	1" corr hole	1/16"	9.6%	
U1U2	Top Chord	C 18 x 42.7	Inner CH	15.48	15.48					
			Outer CH	15.48	14.35		1/16"		7.3%	
L2U2	Vertical	C 12 x 25	Inner CH	7.31	5.80	1/16"	1/16"	3/16"	20.7%	
			Outer CH	7.31	6.56		1/16"		10.3%	
L2L3	Bott. Chord	C 18 x 58	Inner CH	16.98	14.80	1/8"	1/16"	1/8"	12.8%	Pack rust and SL on lace bars
			Outer CH	16.98	15.06	1/8"	1/16"	1/16"	11.3%	
L2U3	Diagonal	C 15 x 33.9	Inner CH	9.90	6.01	3/16"	Two 1 1/2" holes, 3 1/2"H with 1/8" Rem.	1/16"	39.3%	SL on lacing bars
			Outer CH	9.90	8.89	3/16"	1/4" at 1 1/2"H		10.2%	
U2U3	Top Chord	C 18 x 42.7	Inner CH	15.48	15.48					
			Outer CH	15.48	13.23		1/8"		14.5%	
L3U3	Vertical	C 12 x 25	Inner CH	7.31	5.24	1/16"	1/8"	1/8"	28.3%	Pack rust and SL on lace bars
			Outer CH	7.31	5.99	1/16"	1/16"	1/8"	18.1%	
L3L4	Bott. Chord	C 18 x 58	Inner CH	16.98	15.70	1/16"	1/4" x 3" H	1/16"	7.5%	
			Outer CH	16.98	15.33	1/16"	1/8" half of ht	1/16"	9.7%

U3L4	Diagonal	C 15 x 33.9	Inner CH	9.90	7.95	3/16"	1/8" x 6"H, 1/16" Rem. rest of ht		19.7%	
			Outer CH	9.90	8.03		1/8"		18.9%	
U3U4	Top Chord	C 18 x 42.7	Inner CH	15.48	15.48					
			Outer CH	15.48	14.35		1/16"		7.3%	
L4U4	Vertical	C 12 x 25	Inner CH	7.31	4.86	1/8"	1/8"	3/16"	33.6%	
			Outer CH	7.31	4.86	1/8"	1/8"	3/16"	33.6%	
L4L5	Bott. Chord	C 18 x 42.7	Inner CH	12.48	10.99	1/8"	1/4" x 2"H	1/8"	11.9%	Pack rust and SL on lace bars
			Outer CH	12.48	10.99	1/8"	1/8" x 4"H	1/8"	11.9%

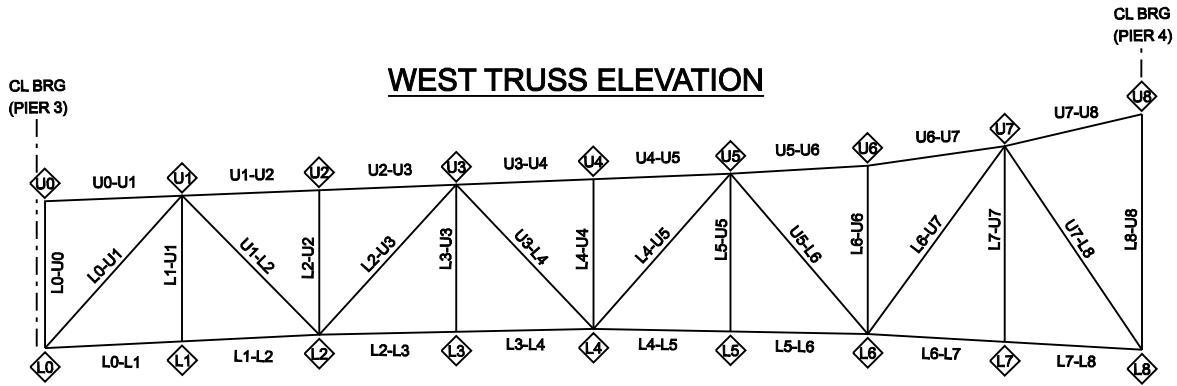
Span 4 - West Truss					Losses				Comments	
Member ID	Member Type		Inner/ Outer	As-Built Area (in ²)	Inspected Area (in ²)	Top/South Flange	Web	Bott/North Flange		Total Loss %
L0U0	Vertical	C 12 x 25	Inner CH	7.31	7.31	1/8"	1/8"	1/8"	31.0%	SL on lacing bars
			Outer CH	7.31	7.31	1/8"	1/8"	1/8"	31.0%	
L0L1	Bott. Chord	C 18 x 42.7	Inner CH	12.48	12.48	1/8"	1/8"	1/8"	26.0%	corr holes and SL on lace bars
			Outer CH	12.48	12.48	1/8"	1/8"	1/8"	26.0%	
L0U1	Diagonal	C 18 x 51.9	Inner CH	15.18	15.18	1/8"	1/8"	1/8"	21.6%	corr holes and SL on lace bars
			Outer CH	15.18	15.18	1/8"	1/8"	1/8"	21.6%	
L1U1	Vertical	C 12 x 25	Inner CH	7.31	7.31	1/8"	1/8"	1/8"	31.0%	SL on lacing bars
			Outer CH	7.31	7.31	1/8"	1/8"	1/8"	31.0%	
L1L2	Bott. Chord	C 18 x 42.7	Inner CH	12.48	12.48	1/8"	1/8"	1/8"	26.0%	SL on lacing bars
			Outer CH	12.48	12.48	1/8"	1/8"	1/8"	26.0%	
U1L2	Diagonal	C 15 x 33.9	Inner CH	9.90	9.90	1/8"	1/8"	1/8"	27.5%	SL on lacing bars

Outer CH	9.90	9.90	1/8"	1/8"	1/8"	27.5%	
L2U2	Vertical	C 12 x 25	Inner CH	7.31	7.31	1/8"	1/8"	1/8"	31.0%	SL on lacing bars
			Outer CH	7.31	7.31	1/8"	1/8"	1/8"	31.0%	
L2L3	Bott. Chord	C 18 x 58	Inner CH	16.98	16.98	1/8"	1/8"	1/8"	19.4%	corr holes and SL on lace bars
			Outer CH	16.98	16.98	1/8"	1/8"	1/8"	19.4%	
L2U3	Diagonal	C 15 x 33.9	Inner CH	9.90	9.90	1/8"	1/8"	1/8"	27.5%	SL on lacing bars
			Outer CH	9.90	9.90	1/8"	1/8"	1/8"	27.5%	
L3U3	Vertical	C 12 x 25	Inner CH	7.31	7.31	1/8"	1/8"	1/8"	31.0%	SL on lacing bars
			Outer CH	7.31	7.31	1/8"	1/8"	1/8"	31.0%	
L3L4	Bott. Chord	C 18 x 58	Inner CH	16.98	16.98	1/8"	1/8"	1/8"	19.4%	corr holes and SL on lace bars
			Outer CH	16.98	16.98	1/8"	1/8"	1/8"	19.4%	
U3L4	Diagonal	C 15 x 33.9	Inner CH	9.90	9.90	1/8"	1/8"	1/8"	27.5%	SL on lacing bars
			Outer CH	9.90	9.90	1/8"	1/8"	1/8"	27.5%	
L4U4	Vertical	C 12 x 25	Inner CH	7.31	7.31	1/8"	1/8"	1/8"	31.0%	SL on lacing bars

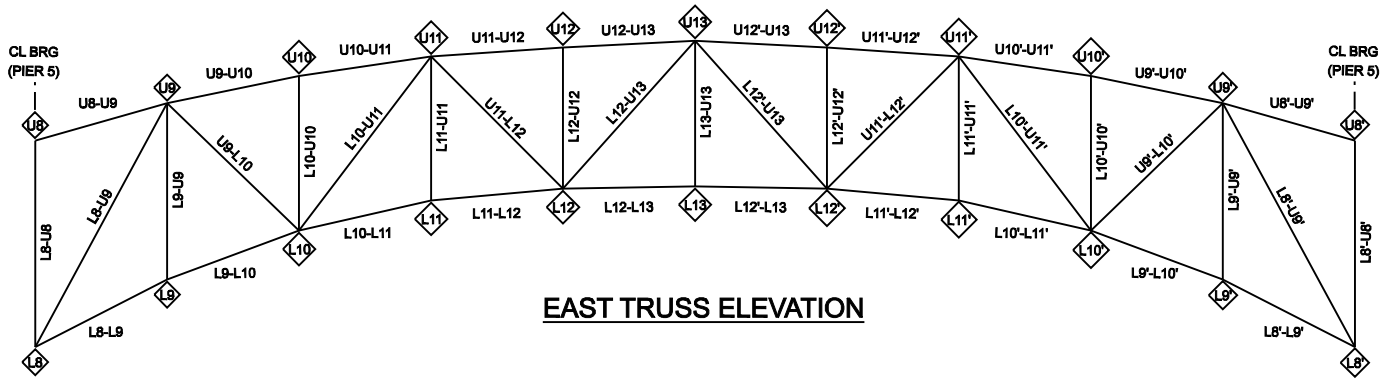
EAST TRUSS ELEVATION

Span 5 - East Truss					Losses				Comments	
Member ID	Member Type		Inner/ Outer	As-Built Area (in ²)	Inspected Area (in ²)	Top/South Flange	Web	Bott/North Flange		Total Loss %
L8-U8	Vertical	C 12x30	Inner CH	8.79	7.99	1/4"			9.0%	One North lacing bar 90% SL 1/2"x1/2" at U8
			Outer CH	8.79	8.39	1/8"			4.5%	
L8-U9	Diagonal	2L 4x4x13/16 4PL 20 x 9/16	Inner CH	60.51	60.51					4.1%
			Outer CH	60.51	58.01		1/8"			
L9-U9	Vertical	C 12x25	Inner CH	7.31	6.55	1/8"		1/8"	10.4%	Pack rust to 1/2" with SL on lacing bars
			Outer CH	7.31	5.24	1/8"	3/4" hole, 3 3/4"W 50% SL int, 1/16" FW ext	1/8"	28.3%	
L9-L10	Bott. Chord	C 18x42.7 2PL 17 1/2 x 3/8	Inner CH	19.04	18.05	1/8"		1/8"	5.2%	SL on lacing bars
			Outer CH	19.04	18.05	1/8"		1/8"	5.2%	
U9-L10	Diagonal	2L 4x4x1/2 2PL 20 x 1/2	Inner CH	31.75	31.75					4.7%
			Outer CH	31.75	30.25	1/16"	1/16"			
U11-L12	Diagonal	C 15x33.9	Inner CH	9.90	9.90					18.9%
			Outer CH	9.90	8.03		1/8"
