STATE OF NEW HAMPSHIRE
DEPARTMENT OF TRANSPORTATION

IN-DEPTH INSPECTION AND CONDITION REPORT

GENERAL SULLIVAN BRIDGE - DOVER 200/023
OVER THE LITTLE BAY

May 2014 Inspection
and
June 2016 Inspection

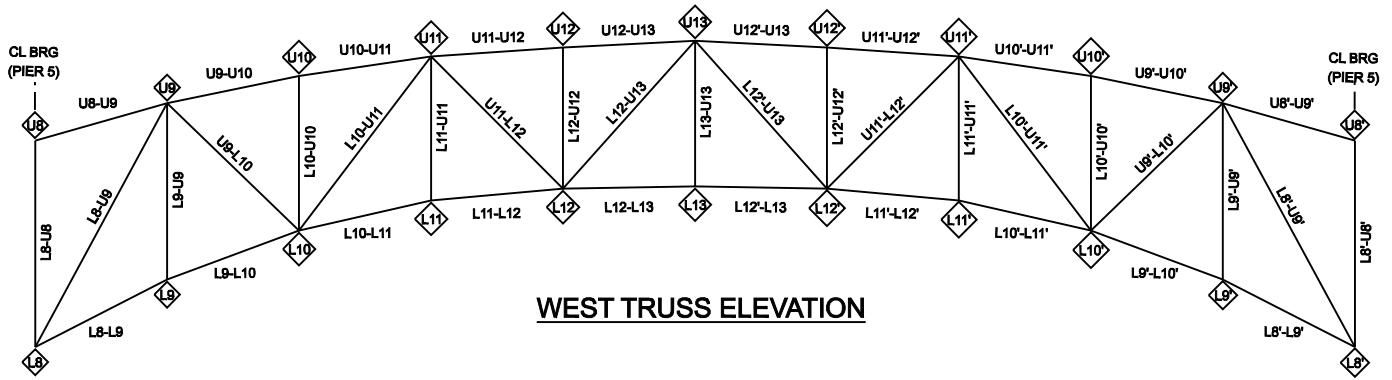
WEST TRUSS ELEVATION

Span 5 - West Truss					Losses				Comments	
Member ID	Member Type		Inner/ Outer	As-Built Area (in ²)	Inspected Area (in ²)	Top/South Flange	Web	Bott/North Flange		Total Loss %
L8U8	Vertical	C 12x30	Inner CH	8.79	7.29		1/8"		17.1%	
			Outer CH	8.79	7.29		1/8"		17.1%	
L8L9	Bott. Chord	C 18x42.7 2PL 17½ x ¾	Inner CH	19.04	15.87	1/8"	1/8"	1/8"	16.7%	Pack rust and SL on lace bars
			Outer CH	19.04	15.87	1/8"	1/8"	1/8"	16.7%	
L9U9	Vertical	C 12x25	Inner CH	7.31	3.06	1/8"	Holes 7" wide, 1/8-3/16 rem. else	1/8"	58.2%	
			Outer CH	7.31	5.05	1/8"	1/8"	1/8"	31.0%	
L9L10	Bott. Chord	C 18x42.7 2PL 17½ x ¾	Inner CH	19.04	15.87	1/8"	1/8"	1/8"	16.7%	
			Outer CH	19.04	15.87	1/8"	1/8"	1/8"	16.7%	
L10U10	Vertical	C 12x25	Inner CH	7.31	5.05	1/8"	1/8"	1/8"	31.0%	
			Outer CH	7.31	6.26	1/8"	3/4" hole	1/8"	14.4%	
L10L11	Bott. Chord	C 18x45.8	Inner CH	13.38	11/8"	1/8"	1/8"	1/8"	24.3%	Pack rust and SL on lace bars
			Outer CH	13.38	11/8"	1/8"	1/8"	1/8"	24.3%

L11U11	Vertical	C 12x25	Inner CH	7.31	5.81		1/8"		20.5%	
			Outer CH	7.31	5.81		1/8"		20.5%	
L11L12	Bott. Chord	C 18x51.9	Inner CH	15.18	11.90	1/8"	1/8"	1/8"	21.6%	
			Outer CH	15.18	11.90	1/8"	1/8"	1/8"	21.6%	
L12U12	Vertical	C 12x25	Inner CH	7.31	5.81		1/8"		20.5%	
			Outer CH	7.31	5.81		1/8"		20.5%	
L12L13	Bott. Chord	C 18x42.7 2PL 17½ x ½	Inner CH	21.23	18.05	1/8"	1/8"	1/8"	15.0%	Pack rust and SL on lace bars
			Outer CH	21.23	18.05	1/8"	1/8"	1/8"	15.0%	
L13U13	Vertical	C 12x25	Inner CH	7.31	5.81		1/8"		20.5%	SL on lacing bars
			Outer CH	7.31	5.81		1/8"		20.5%	
L13L12'	Bott. Chord	C 18x42.7 2PL 17½ x ½	Inner CH	21.23	21.23					
			Outer CH	21.23	19.98		1/8" x 6"H	1/8"	5.9%	
U13L12'	Diagonal	C 15x33.9	Inner CH	9.90	8.78		1/8" SL 9"W		11.4%	Pack rust and SL on lace bars
			Outer CH	9.90	9.90					
L12'U12'	Vertical	C 12x25	Inner CH	7.31	5.81		1/8"SL FW 4"H		20.5%	
			Outer CH	7.31	3.93	3/16" x 3"	3/16" SL x 3" H	3/16" x 3"	46.3%

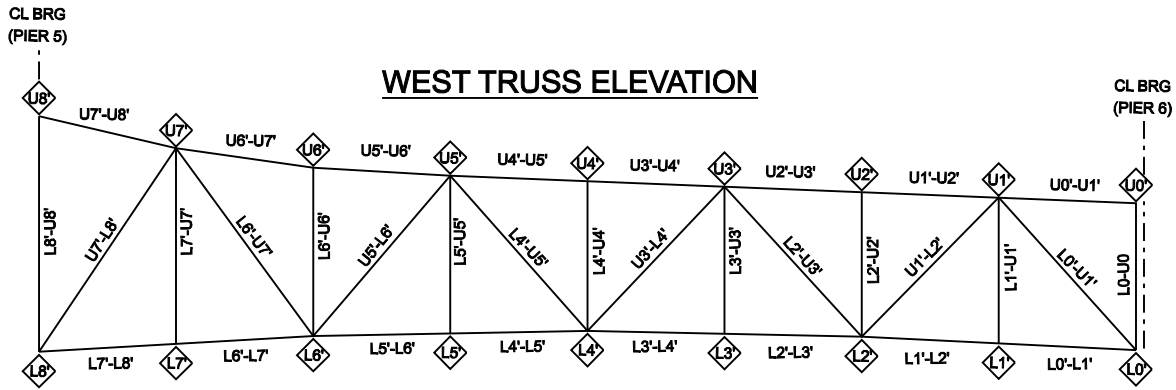
Span 6 - West Truss					Losses				Comments	
Member ID	Member Type		Inner/ Outer	As-Built Area (in ²)	Inspected Area (in ²)	Top/South Flange	Web	Bott/North Flange		Total Loss %
L0'-U0'	Vertical	C 12x25	Inner CH	7.31	5.05	1/8"	1/8"	1/8"	31.0%	
			Outer CH	7.31	5.05	1/8"	1/8"	1/8"	31.0%	
L0'-L1'	Bott. Chord	C 18x42.7	Inner CH	12.48	8.99	1/8"	1/8"	3/16"	27.9%	corrosion holes in lacing bars
			Outer CH	12.48	8.99	1/8"	1/8"	3/16"	27.9%	
L1'-U1'	Vertical	C 12x25	Inner CH	7.31	5.05	1/8"	1/8"	1/8"	31.0%	
			Outer CH	7.31	5.05	1/8"	1/8"	1/8"	31.0%	
L1'-L2'	Bott. Chord	C 18x42.7	Inner CH	12.48	8.99	1/8"	1/8"	3/16"	27.9%	corrosion holes in lacing bars
			Outer CH	12.48	8.99	1/8"	1/8"	3/16"	27.9%	
U1'-L2'	Diagonal	C 15x33.9	Inner CH	9.90	8.20	1/4"		1/4"	17.2%	
			Outer CH	9.90	8.20	1/4"		1/4"	17.2%	
L2'-L3'	Bott. Chord	C 18x58	Inner CH	16.98	14.80	1/8"	1/16"	1/8"	12.8%	corr holes & SL on lacing bars
			Outer CH	16.98	14.80	1/8"	1/16"	1/8"	12.8%

L2'-U3'	Diagonal	C 15x33.9	Inner CH	9.90	8.20	1/4"		1/4"	17.2%	
			Outer CH	9.90	8.20	1/4"		1/4"	17.2%	
L3'-U3'	Vertical	C 12x25	Inner CH	7.31	5.77	1/8"	Hole 2" L x 1" H	1/8"	21.0%	corr holes in batten PL SL on lace bars
			Outer CH	7.31	5.80	1/8"	1/16"	1/8"	20.7%	
L3'-L4'	Bott. Chord	C 18x58	Inner CH	16.98	14.80	1/8"	1/16"	1/8"	12.8%	SL & corr holes on batten PL and lace bars
			Outer CH	16.98	14.80	1/8"	1/16"	1/8"	12.8%	
U3'-L4'	Diagonal	C 15x33.9	Inner CH	9.90	4.45	1/4"	1/4"	1/4"	55.1%	SL on lacing bars
			Outer CH	9.90	4.45	1/4"	1/4"	1/4"	55.1%	
L4'-U4'	Vertical	C 12x25	Inner CH	7.31	5.80	1/8"	1/16"	1/8"	20.7%	SL on lacing bars
			Outer CH	7.31	5.80	1/8"	1/16"	1/8"	20.7%	
L4'-L5'	Bott. Chord	C 18x42.7	Inner CH	12.48	10.36	1/8"	1/16"	1/8"	16.9%	SL on lacing bars
			Outer CH	12.48	10.36	1/8"	1/16"	1/8"	16.9%	
L4'-U5'	Diagonal	C 15x40	Inner CH	11.70	6.19	1/4"	1/4"	1/4"	47.1%	SL on lacing bars
			Outer CH	11.70	6.19	1/4"	1/4"	1/4"	47.1%

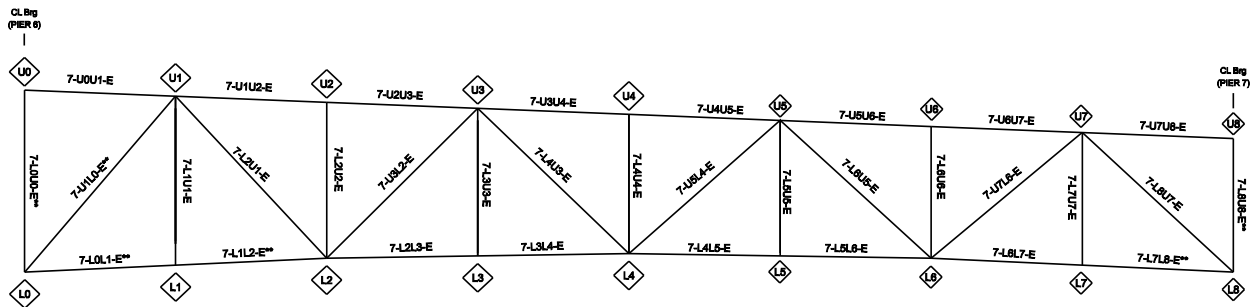
EAST TRUSS ELEVATION

Span 7 - East Truss						Losses			Comments	
Member ID	Member Type		Inner/ Outer	As-Built Area (in ²)	Inspected Area (in ²)	Top/South Flange	Web	Bott/North Flange		Total Loss %
L0U0	Vertical	C 12 x 25	Outer CH	7.32	6.71			0.20"	8.3%	Losses @ batten PL
			Inner CH	7.32	6.91		35% for 3"		5.6%	
L0L1	Bott. Chord	C 15 x 35	Outer CH	10.23	3.42		9.0" Hole w/ 75% for 6"	50%	66.6%	Losses @ batten PL
			Inner CH	10.23	6.33	50%	2" Hole w/ 50% for 5"	40%	38.1%	
L0U1	Diagonal	C 15 x 40	Outer CH	17.14	15.22	0.20"	0.25" x 4"	1/16"	11.2%	
		2PL 14½ x ¾	Inner CH	17.14	16.70	1/8"			2.6%	
L1L2	Bott. Chord	C 15 x 35	Outer CH	10.23	6.75		55%		34.0%	
			Inner CH	10.23	6.14		5" Hole w/ 40% for 2" & 65% for 6"		40.0%	
L2U1	Diagonal	C 15 x 40	Outer CH	11.70	11.26	1/16"		1/16"	3.8%	
			Outer CH	11.70	11.70					
L2L3	Bott. Chord	C 15 x 50	Outer CH	21.89	20.02		1/8"		8.6%	
		2PL 14½ x ½	Inner CH	21.89	20.02		1/8"		8.6%	
L4L5	Bott. Chord	C 15 x 50	Outer CH	21.89	20.69	1/16"		40%	5.5%

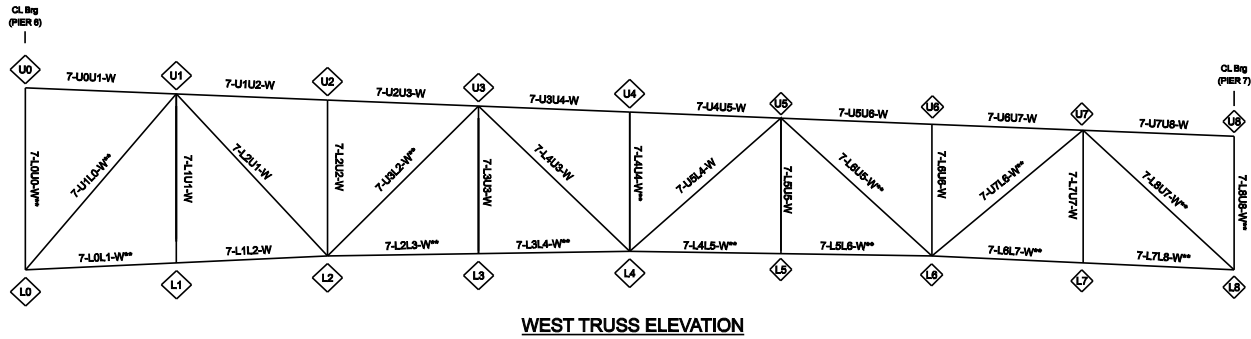
Span 7 - West Truss						Losses			Comments	
Member ID	Member Type		Inner/ Outer	As-Built Area (in ²)	Inspected Area (in ²)	Top/South Flange	Web	Bott/North Flange		Total Loss %
L0U0	Vertical	C 12 x 25	Outer CH	7.32	6.71	40%			8.4%	Hvy pack rust - member and PL
			Inner CH	7.32	5.82		1/8"		20.5%	
L0L1	Bott. Chord	C 15 x 35	Outer CH	10.23	5.44	75%	2" Hole w/20% for 6"	80%	46.9%	Multiple locations of loss and holes
			Inner CH	10.23	5.15	0.25"	4" Hole w/40% for 11"	0.20"	49.7%	
L0U1	Diagonal	C 15 x 40	Outer CH	17.14	16.43	0.20"			4.1%	
		2PL @ 14½ x ¾	Inner CH	17.14	16.26	1/8"		1/8"	5.1%	
U0U1	Top Chord	C 15 x 50	Outer CH	18.02	15.61		1" Hole	70%	13.4%	
		1 PL @ 18 x ¾	Inner CH	18.02	18.02					
L1L2	Bott. Chord	C 15 x 35	Outer CH	10.23	8.45			80%	17.4%	
			Inner CH	10.23	8.98		1/16" for 8" & 1/8" for 6"		12.2%	
L2U1	Diagonal	C 15 x 40	Outer CH	11.70	10.98	1/8"	3/16" x 1.5"		6.2%	
			Inner CH	11.70	11.70

L2L3	Bott. Chord	C 15 x 50	Outer CH	21.89	21.24		1/8" x 1.5"	1/8"	3.0%	
		2 PL 14½ x ½	Inner CH	21.89	21.66	1/16"			1.1%	
L2U3	Diagonal	C 15 x 33.9	Outer CH	9.90	9.35		1/8" x 1"	1/8"	5.6%	
			Inner CH	9.90	7.66		3.5" Hole w/40% for 6"		22.6%	
L3L4	Bott. Chord	C 15 x 50	Outer CH	21.89	20.95		1/16"		4.3%	
		2 PL 14½ x ½	Inner CH	21.89	21.66			1/16"	1.1%	
L4U3	Diagonal	C 15 x 55	Outer CH	16.11	15.62		1/8" x 2"	1/16"	3.0%	
			Inner CH	16.11	16.11					
L4U4	Vertical	C 12 x 30	Outer CH	8.79	8.59			1/16"	2.3%	
			Inner CH	8.79	8.42		1/16" x 6"		4.3%	
L4U5	Diagonal	C 15 x 55	Outer CH	16.11	15.63	1/8"			3.0%	
			Inner CH	16.11	15.23		0.20" x 2"	1/8"	5.4%	
L4L5	Bott. Chord	C 15 x 50	Outer CH	21.89	20.68	0.20"		1/8"	5.5%	
		2 PL 14½ x ½	Inner CH	21.89	20.22	1/8"		50%	7.7%	
L5L6	Bott. Chord	C 15 x 50	Outer CH	21.89	20.49	1/16"	0.20" x 1"	40%	6.4%	
		2 PL 14½ x ½	Inner CH	21.89	21.89					
L6U5	Diagonal	C 15 x 33.9	Outer CH	9.90	9.50		0.20" x 2"		4.0%

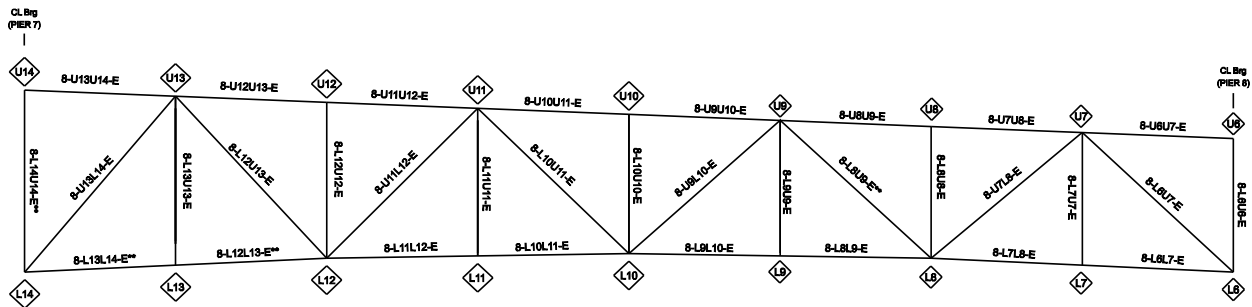
EAST TRUSS ELEVATION

Span 8 - East Truss					Losses				Comments	
Member ID	Member Type		Inner/Outer	As-Built Area (in ²)	Inspected Area (in ²)	Top/South Flange	Web	Bott/North Flange		Total Loss %
L14U14	Vertical	C 12 x 25	Outer CH	7.32	6.72		0.20" for 3"		8.2%	Losses in multiple locations
			Inner CH	7.32	4.42		5" Hole w/ 50% for 5"		39.6%	
L14U13	Diagonal	C 12 x 40	Outer CH	16.04	15.61	1/8"			2.7%	
		2 PL @ 11½ x ¾	Inner CH	16.04	15.70	1/16"	1/8" x 1"		2.1%	
L14L13	Bott. Chord	C 12 x 30	Outer CH	8.79	6.44	1/8"	50% x 3"	75%	26.7%	
			Inner CH	8.79	6.50	0.20"	50% x 1.5"	80%	26.0%	
L13L12	Bott. Chord	C 12 x 30	Outer CH	8.79	8.04		1/16"		8.5%	
			Inner CH	8.79	8.39	1/16"		1/16"	4.5%	
L12U13	Diagonal	C 12 x 30	Outer CH	8.79	8.39	1/8"			4.5%	
			Inner CH	8.79	8.79					
L12L11	Bott. Chord	C 12 x 40	Outer CH	17.48	17.27	1/16"			1.2%	
		2PL 11½ x ½	Inner CH	17.48	17.27	1/16"			1.2%	
L10U11	Diagonal	C 12 x 25	Outer CH	7.32	7.32

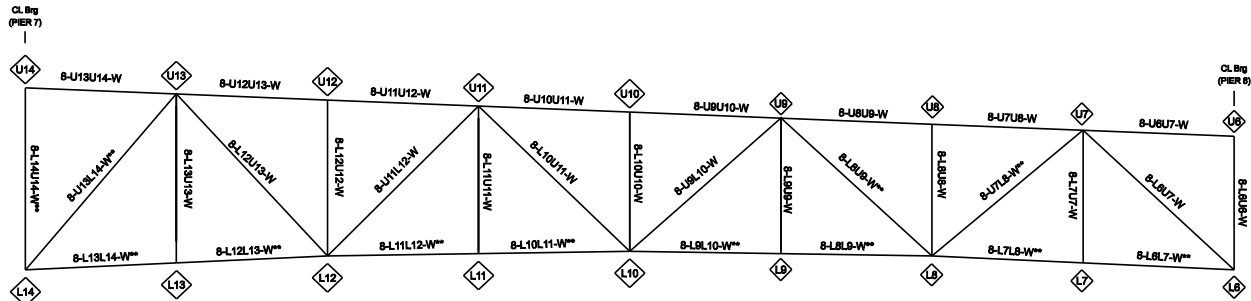
WEST TRUSS ELEVATION

Span 8 - West Truss					Losses				Comments	
Member ID	Member Type		Inner/ Outer	As-Built Area (in ²)	Inspected Area (in ²)	Top/South Flange	Web	Bott/North Flange		Total Loss %
L14U14	Vertical	C 12 x 25	Outer CH	7.32	6.16		2" Hole w/ 50% for 2"		15.9%	Losses in multiple locations
			Inner CH	7.32	5.95		2" Hole w/ .2 for 3"		18.8%	
L14U13	Diagonal	C 12 x 40	Outer CH	16.04	14.54		1/8"		9.4%	Hvy pack rust - member and PL
			Inner CH	16.04	15.15	1/8"	1/8" x 2"	1/16"	5.6%	
		2PL 11½ x ¾	Inner CH	16.04	14.54		1/8"		9.4%	
U14U13	Top Chord	C 12 x 25	Outer CH	10.70	10.70					
		1PL 18 x ¾	Inner CH	10.70	10.50			1/16"	1.8%	
L14L13	Bott. Chord	C 12 x 30	Outer CH	8.79	7.45	1/16"	1/16"	1/8"	15.3%	
			Inner CH	8.79	6.64	1/8"	1.5" Hole w/ 50% for 2"	0.15"	24.4%	
L13L12	Bott. Chord	C 12 x 30	Outer CH	8.79	8.21		1/8" x 1.5"	1/8"	6.6%	
			Inner CH	8.79	8.39			1/8"	4.5%	
L12L11	Bott. Chord	C 12 x 40	Outer CH	17.48	17.05	1/8"			2.4%

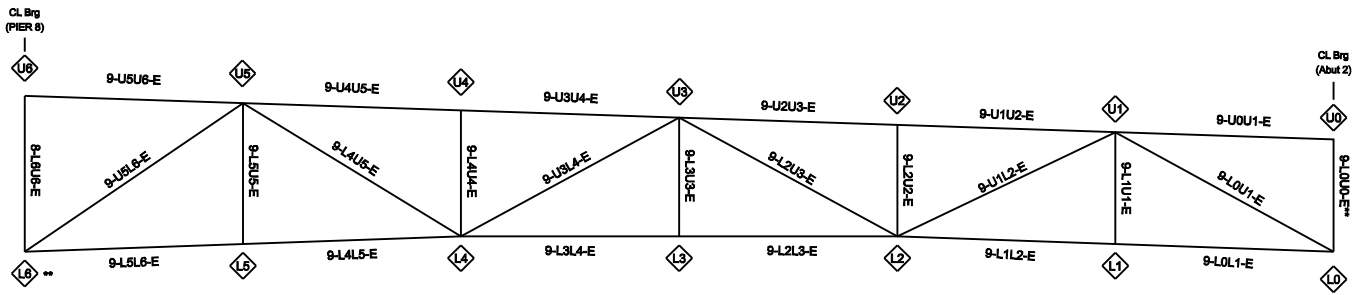
EAST TRUSS ELEVATION

Span 9 - East Truss					Losses				Comments	
Member ID	Member Type	Inner/ Outer	As-Built Area (in ²)	Inspected Area (in ²)	Top/South Flange	Web	Bott/North Flange	Total Loss %		
L6L5	Bott. Chord	C 12 x 30	Outer CH	13.10	12.51	1/16"		1/8"	4.5%	
		2PL 11½ x ¾	Inner CH	13.10	12.52	1/16"	1/16" x 3"	1/16"	4.5%	
L5L4	Bott. Chord	C 12 x 30	Outer CH	13.10	12.70	1/8"			3.0%	
		2PL 11½ x ¾	Outer CH	13.10	12.70	1/8"			3.0%	
L4U5	Diagonal	C 12 x 40	Outer CH	11.73	11.45		1/16" x 1"	1/16"	2.4%	
			Inner CH	11.73	11.73					
L4U3	Diagonal	C 12 x 35	Outer CH	10.26	10.05	1/16"			2.0%	
			Inner CH	10.26	10.05	1/16"			2.0%	
L4L3	Bott. Chord	C 12 x 35	Outer CH	10.26	10.05	1/16"			2.0%	
			Inner CH	10.26	10.05	1/16"			2.0%	
L3L2	Bott. Chord	C 12 x 35	Outer CH	10.26	9.85	1/16"		1/16"	4.0%	
			Inner CH	10.26	10.05			1/16"	2.0%	
L1L0	Bott. Chord	C 12 x 35	Outer CH	10.26	10.05	1/16"			2.0%	
			Inner CH	10.26	10.26					
L0U0	Vertical	C 12 x 25	Outer CH	7.32	5.50		2.5" Hole w/ 40% for 5.5"		24.8%

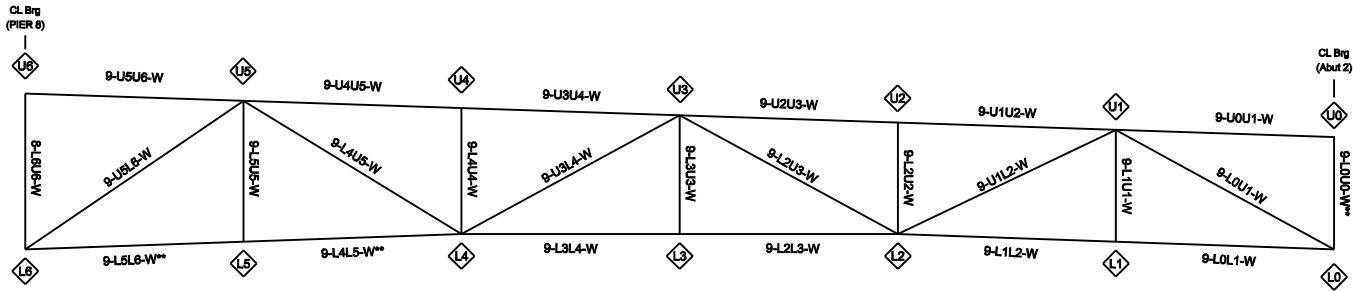
WEST TRUSS ELEVATION

Span 9 - West Truss					Losses				Comments
Member ID	Member Type	Inner/ Outer	As-Built Area (in ²)	Inspected Area (in ²)	Top/South Flange	Web	Bott/North Flange	Total Loss %	
L6L5	Bott. Chord	C 12 x 30	Outer CH	13.10	12.71	1/8"		3.0%	Typical in multiple locations
		2PL 11½ x ¾	Inner CH	13.10	12.32	1/16"	3/16"	6.0%	
L6U5	Diagonal	C 12 x 40	Outer CH	18.92	18.70	1/16"		1.1%	
		2PL 11½ x ¾	Inner CH	18.92	18.70	1/16"		1.1%	
L5L4	Bott. Chord	C 12 x 30	Outer CH	13.10	12.70	1/8"		3.0%	
		2PL 11½ x ¾	Inner CH	13.10	12.31	1/8"	1/8"	6.0%	
L4L3	Bott. Chord	C 12 x 35	Outer CH	10.26	9.87		1/8" x 1.5"	3.8%	
			Inner CH	10.26	10.05		1/16"	2.0%	
L4U3	Diagonal	C 12 x 35	Outer CH	10.26	10.05	1/16"		2.0%	
			Inner CH	10.26	9.40	1/16"	0.20"	8.4%	
L3L2	Bott. Chord	C 12 x 35	Outer CH	10.26	9.77	0.15"		4.8%	
			Inner CH	10.26	10.05	1/16"		2.0%	
L1L2	Bott. Chord	C 12 x 35	Outer CH	10.26	10.26				
			Inner CH	10.26	10.01		1/8" x 2"	2.4%

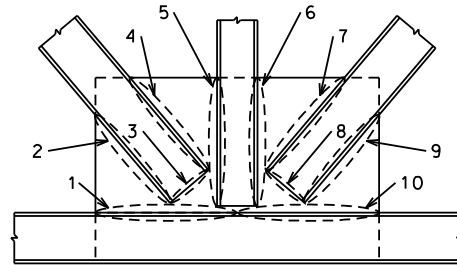
Span 1 - West Truss Gusset Plates														
Plate ID (Type)	Primary Plate Thickness	Rein. Plate Thickness	Inner/Outer	Losses										
				1	2	3	4	5	6	7	8	9	10	Misc.
PL0 (Corner)	5/8"	5/8"	Outer/Inner							Misc.				1/8" for last 6"
PL2 (Multi)	3/4"		Outer/Inner	0.20"							1/16"		0.20"	
PL3 (Vertical)	3/8"		Outer/Inner			Misc	0.10"							0.10" - bott. 8"
PL4 (Multi)	3/4"		Outer/Inner	0.20"			1/4"						3/8"	1/16" x 12" starting 12" from edge
PL5 (Vertical)	3/8"		Outer/Inner	Misc.			Misc.							1/8" x 18"
PL6 (Corner)	5/8"	3/4"	Outer/Inner						Misc.					1/4" x 5" @ edge

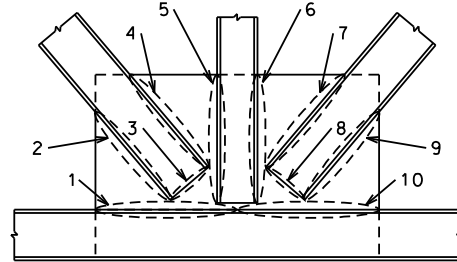
Span 2 - West Truss Gusset Plates														
Plate ID (Type)	Primary Plate Thickness	Rein. Plate Thickness	Inner/ Outer	Losses										Misc.
				1	2	3	4	5	6	7	8	9	10	
PL0	5/8"	5/8"	Outer		1/8" x 9"	1/16" x 12"				Misc				#2- from end of memb, #3- from PL edge #6 - 0.20" for 18" then 1/16" from memb end
(Corner)			Inner			Misc.			3/16"					1/8" x 9" - 24" from PL edge 1/16" x 12" @ edge of PL
PL1	3/8"		Outer	1/8"			1/8"							
(Vertical)			Inner	1/16"			1/16"							
PL2	5/8"		Outer	3/16"			3/16"			1/8"			3/16"	
(Multi)			Inner	1/16"			1/16"			1/8"			1/8"	
PL3	3/8"		Outer	1/8"			1/8"							
(Vertical)			Inner	1/8"			1/8"							
PL4	1/2"		Outer	3/16"			1/16" x 4"	0.20"		Misc			3/16" x 12"	0.35" for 6" then 3/16", #4 - @ end, #10 - end of memb,
(Multi)			Inner	1/16"						1/16" x 24"			1/16" x 36"	#7 - from edge, #10 - from end of memb, 1/16" x 12" above #7
PL5	3/8"		Outer	1/8"		1/8"	1/8"							
(Vertical)			Inner	1/16"			1/16"

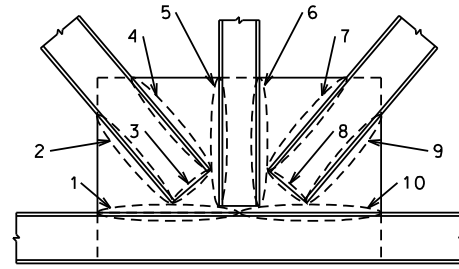
Span 3 - West Truss Gusset Plates															
Plate ID (Type)	Primary Plate Thickness	Rein. Plate Thickness	Inner/ Outer	Losses										Misc.	
				1	2	3	4	5	6	7	8	9	10		
PL7	3/8"		Outer	1/8"	1/16"	1/16"	1/8"								1/8" around diaph & 3/16" x 3" dia - inside of PL
(Vertical)			Inner	1/8"			1/8"								
PL8	1/2"		Outer	0.20" x 12"		0.20"		1/16"	1/8" x 24"	1/8"				0.20"	hole in web of chord @ panel point, #1 - from end of memb
(Multi)			Inner										1/16"		
PL9	3/8"		Outer	1/8"			1/8"								
(Vertical)			Inner	1/16"			1/16"								
PL10	5/8"		Outer	1/8"			0.20"	0.20"	1/16"	1/16"	1/16"	1/16"	3/16"		
(Multi)			Inner										1/16"		
PL11	3/8"		Outer	1/16"			1/16"								
(Vertical)			Inner	1/8"	1/16"		1/8"								
PL12	5/8"		Outer	3/16"			1/8"	1/16"	1/16"	1/8"			1/8"		
(Multi)			Inner				1/16"	1/16"	1/16" x 9"	1/16"	1/16"		1/8"	1/8" @ inner diagonal rivets #6 - from end of memb	
PL13	3/8"		Outer	0.20"	1/16"	1/8"	0.20"								3" hole in chord @ node

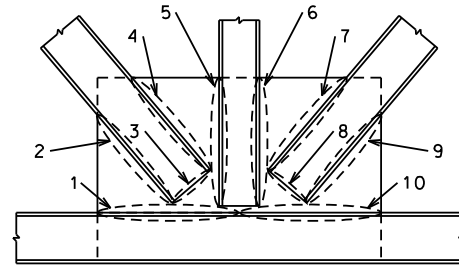
Span 3 - East Truss Gusset Plates															
Plate ID (Type)	Primary Plate Thickness	Rein. Plate Thickness	Inner/Outer	Losses										Misc.	
				1	2	3	4	5	6	7	8	9	10		
PL7	3/8"		Outer	1/8"			1/8"								
(Vertical)			Inner	1/16"		1/16"	1/16"								1/16" x 6" x 6" inside on north edge
PL8	1/2"		Outer	1/16"			1/8"		1/8"	1/16"				1/8"	
(Multi)			Inner	1/16"			1/16"		1/8"					1/16"	
PL9	3/8"		Outer	1/16"			1/16"								
(Vertical)			Inner												
PL10	5/8"		Outer	1/16"		1/16"	1/8"	1/16"	1/16"	Misc.				1/8"	1/8" for 4" then 1/16"
(Multi)			Inner	1/8" x 24"			1/16"	1/8"			1/16"		1/16" x 18"		#1,10 - from end of memb
PL11	3/8"		Outer	1/8"			1/8"								
(Vertical)			Inner												
PL12	5/8"		Outer	1/16"			1/8"	1/8"	1/16"	1/8"				1/16" x 9"	#10 - from end of memb
(Multi)			Inner	1/16"										1/16"	
PL13	3/8"		Outer	1/16"		1/16"	1/16"								
(Vertical)			Inner	1/16"		1/16"	1/16"								
PL14	5/8"	3/4"	Outer		1/16"	1/8" x 33"			1/16" x 9"						#3, #6 - from edge

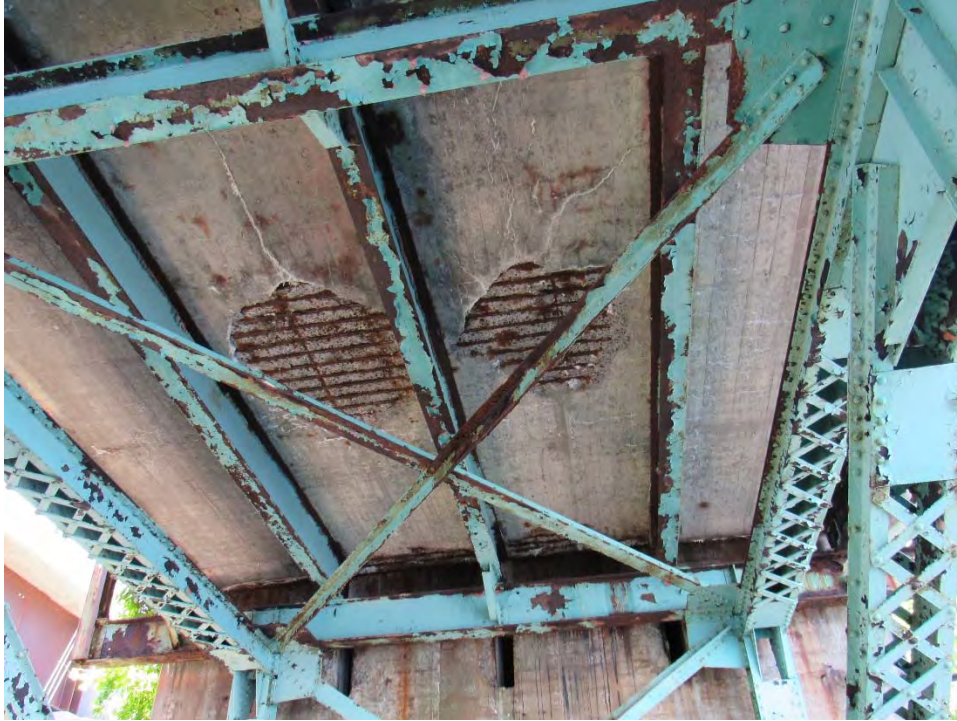
- Light to moderate cracking with efflorescence and rust staining throughout (Photo D4)
- Extensive areas with delaminations or spalling with exposed reinforcing steel (Photo D5)
 - Spalls range in size up to 36 square feet
 - Spalls are typically 3 inches deep, but some smaller spalls are up to 4 inches deep
- Extensive cracking, spalling, exposed rebar, and rebar section loss along the east and west deck fascias at curb opening locations and on the solid sections between curb openings (Photo D6)

Photo D5: Span 9 - Spalled Deck Areas with Exposed Rebar

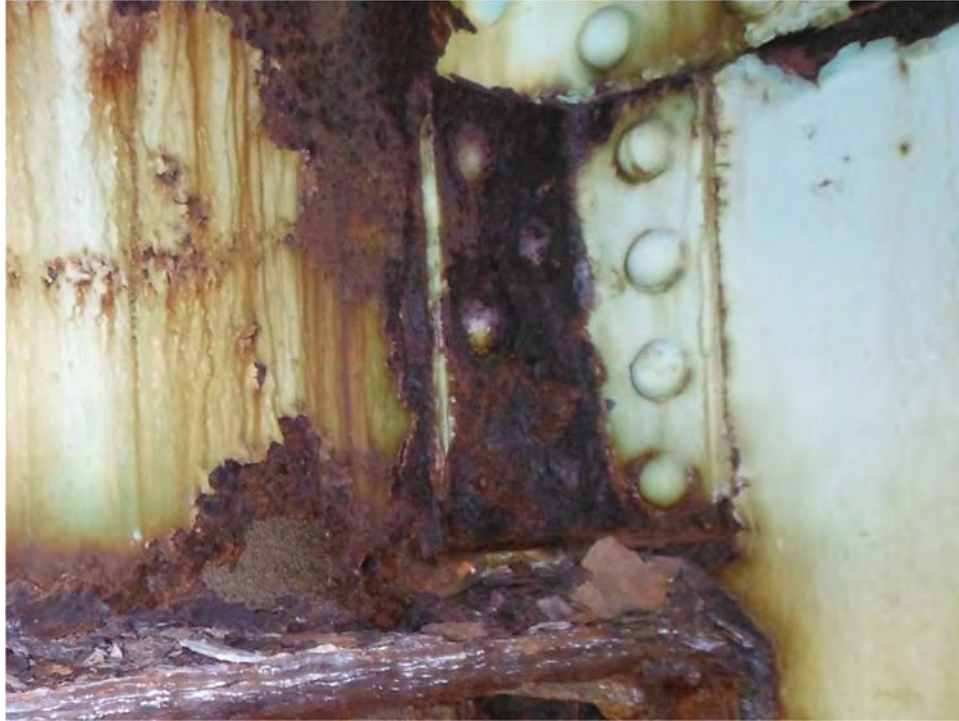
The exterior stringers are in significantly worse condition compared to the interior stringers. Stringers adjacent to joints and deck ends also have more paint loss and section loss. (Photo D8 and Photo D9). The majority of the interior stringers and floorbeams exhibit only minor increases in section loss since 2014. However, sample inspections of exterior stringers in Spans 3 thru 7 exhibit significant increased section loss since 2014. (Photo D10 thru Photo D13).

Photo D10: 2014 Inspection - Span 6 Exterior Stringer

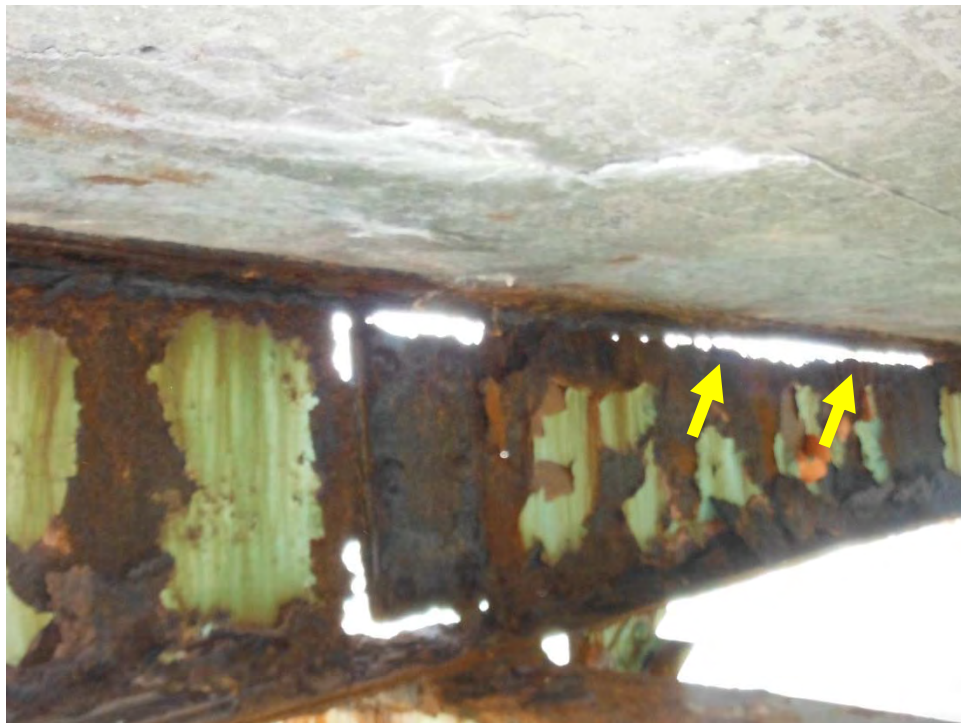
Photo D13: 2016 Inspection – Span 3 Exterior Stringer (Increased Section Loss)

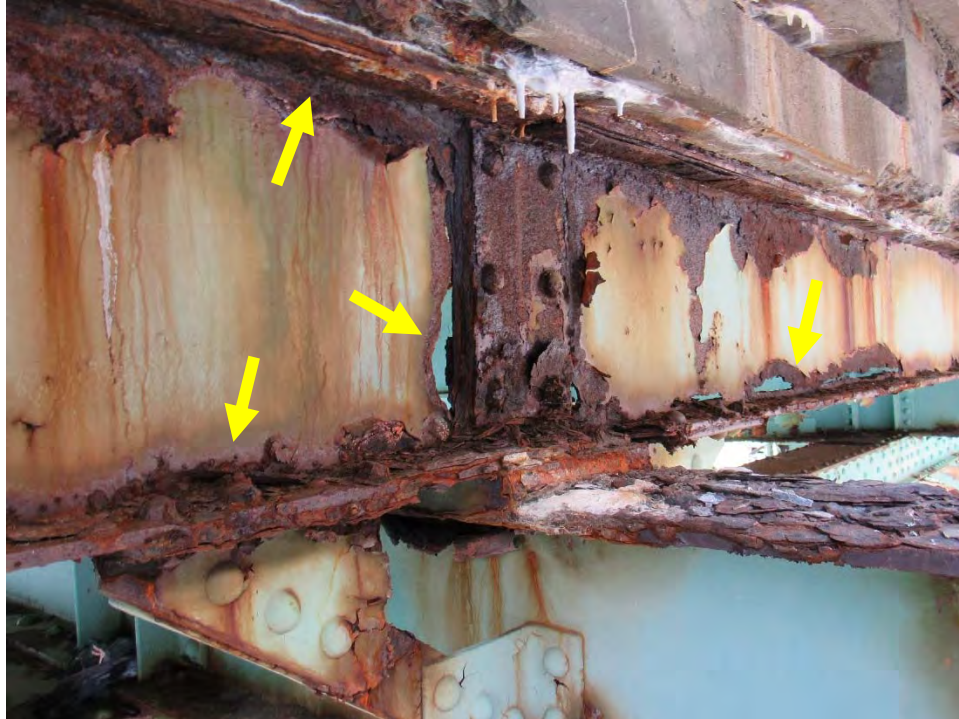
Photo D14: Span 2 Exterior Stringers at Floorbeam Support

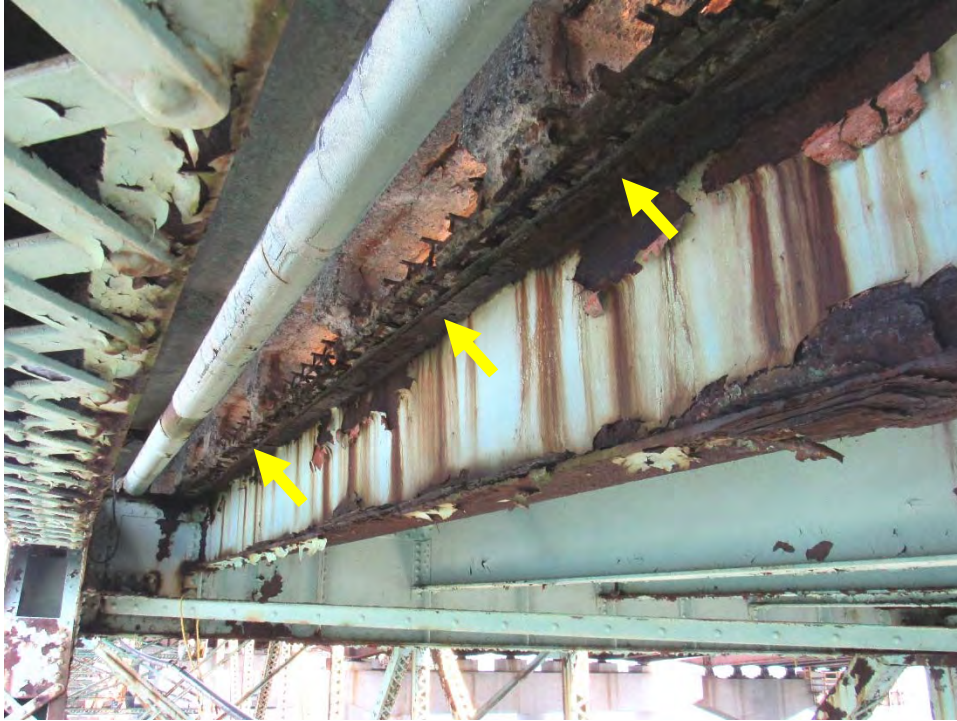
As noted in the 2014 Inspection Report, at several of the exterior stringers, the top flange has completely separated from the deck and the stringers are sagging. (Photo D16 and Photo D17)

Photo D16: Span 6, West Exterior Stringer Separated From Deck

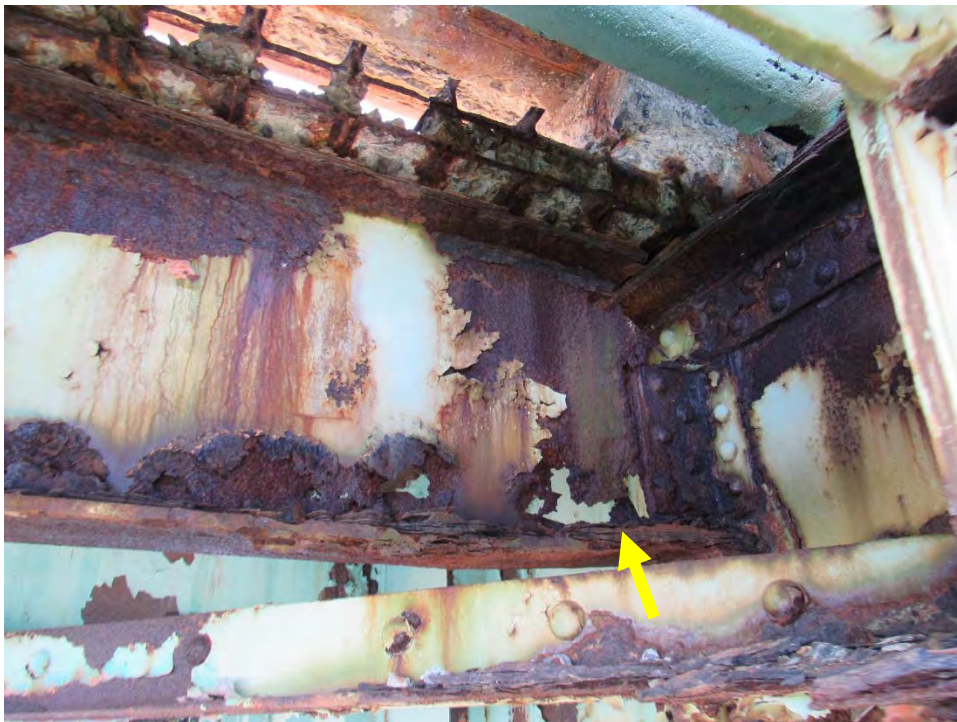
Photo D17: Span 6, West Exterior Stringer – Heavy Section Loss at Floorbeam Connection

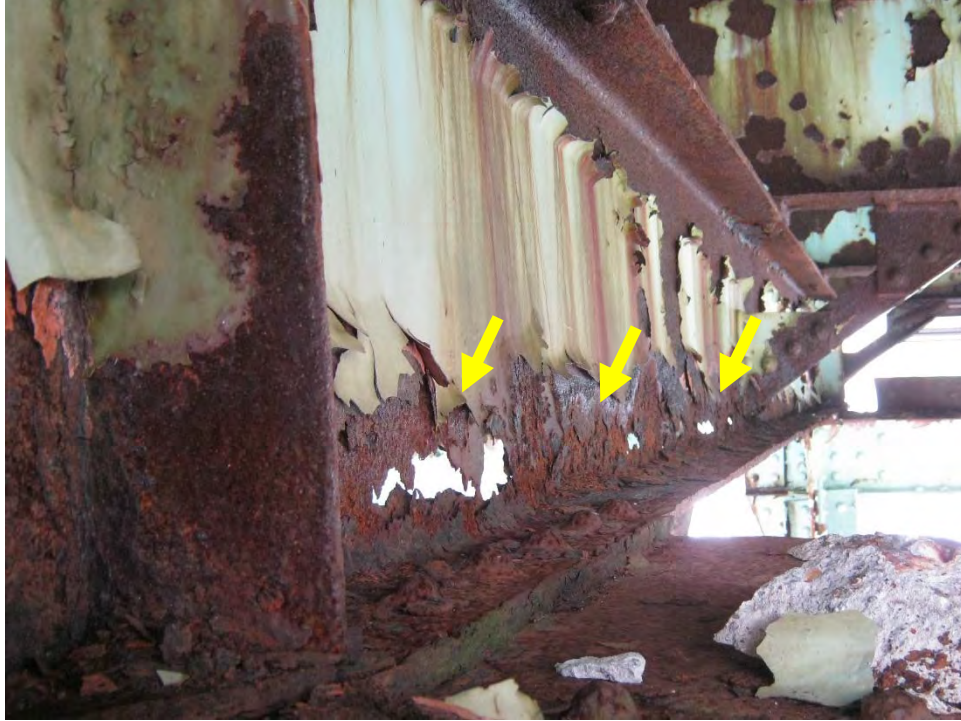
The majority of floorbeams exhibit only minor increases in section loss since 2014. Floorbeams adjacent to joints and deck ends are the most deteriorated with significant section losses. (Photo D18)

Photo D18: Span 8 – Floorbeam at Deck Joint

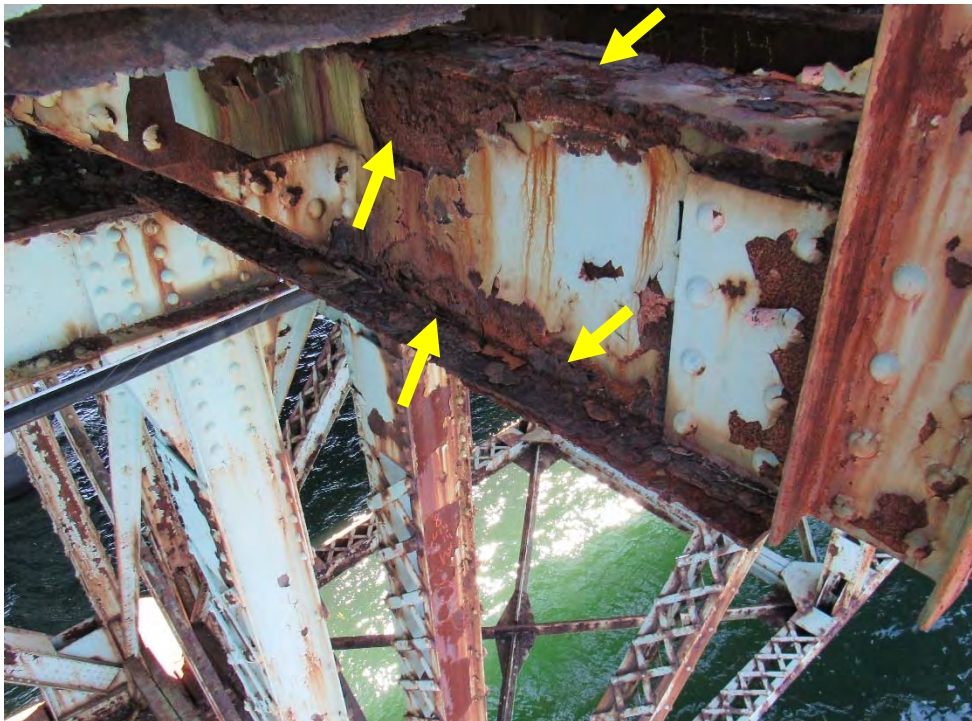
Photo D19: Span 8 Floorbeam – Section Loss at End Region

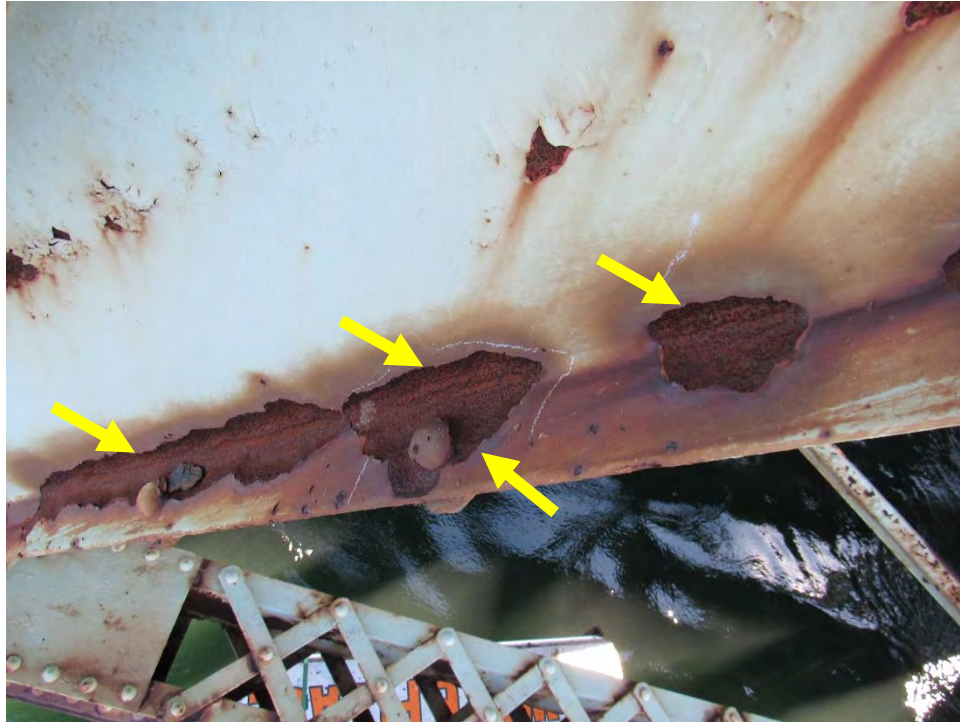
Photo D22: Span 7 – Diagonal Losses at Bottom Flange and Web

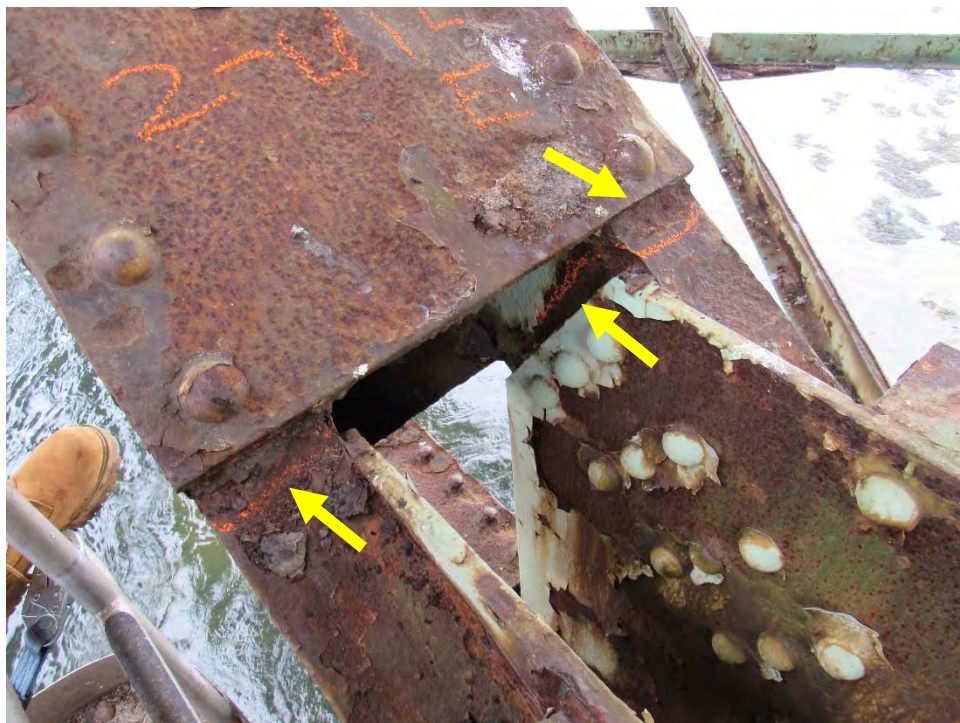
Photo D23: Span 2 Diagonal Member - Losses at Gusset and Batten Plate Connections

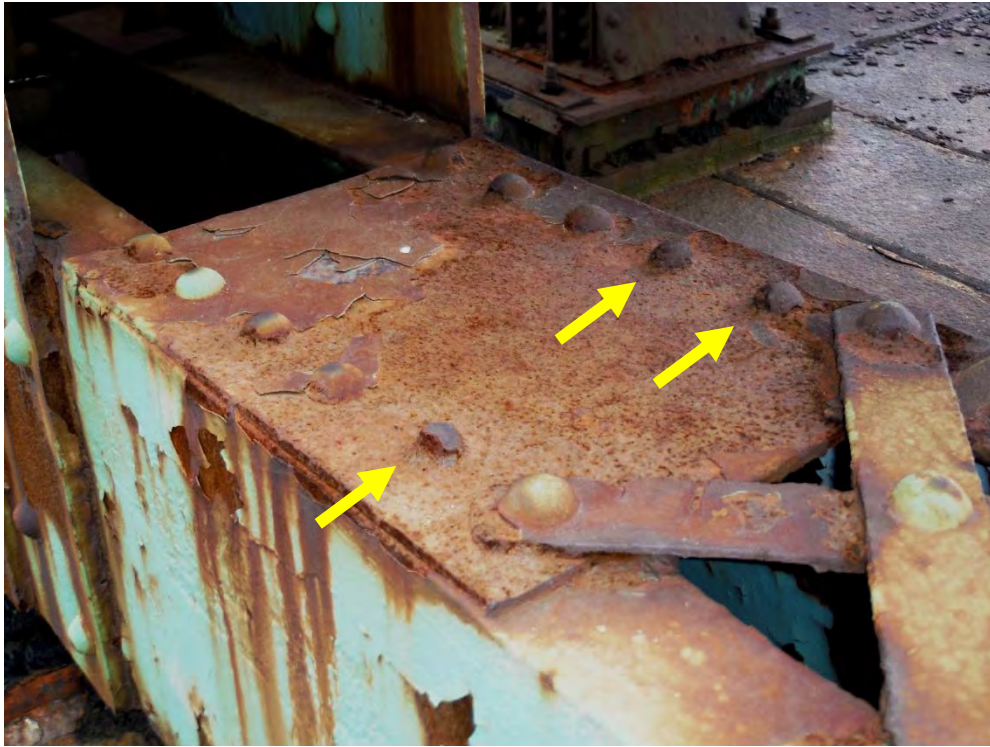
Minor to moderate section loss on rivet heads was found sporadically throughout the bridge, but no rivets appeared to be loose or cracked (Photo D24). As noted in the 2014 Inspection Report, intermittent, pack rust between channels and web plates, batten plates and/or lace bars is also common throughout the bridge. (Photo D25)

Photo D24: Span 4 – Section Loss at Rivets Heads

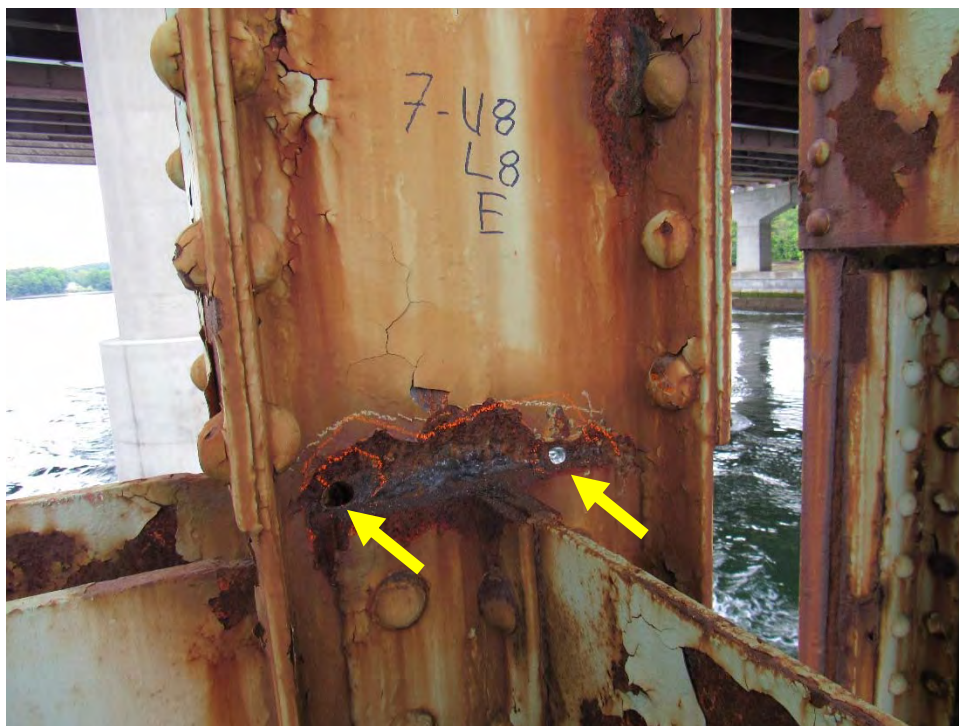
Visible and measurable increases in section loss since 2014 of truss members and gusset plates are generally limited to locations near bridge deck joints (Photos D28 thru Photo D33). Some of the gusset plates along the bottom chords exhibit minor increases in section loss. A new corrosion hole was also discovered in the web of Span 4 vertical member L3-U3 (Photo D34).

Photo D33: 2016 Inspection – Span 7 East Member L8U8 (New Holes)

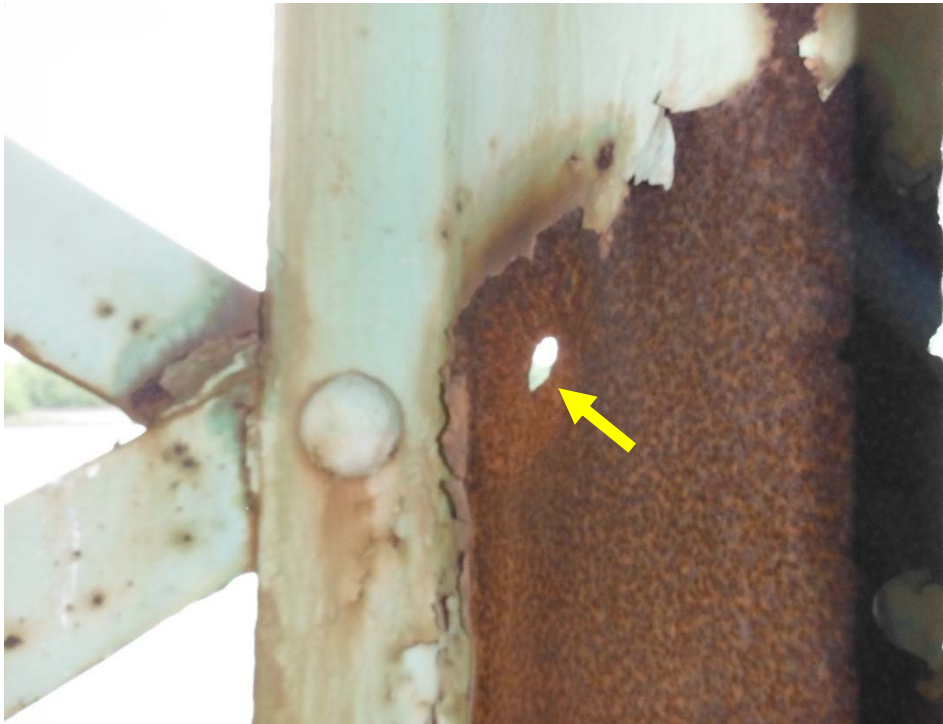
Photo D34: Span 4 Member L3U3 – New Hole in Web

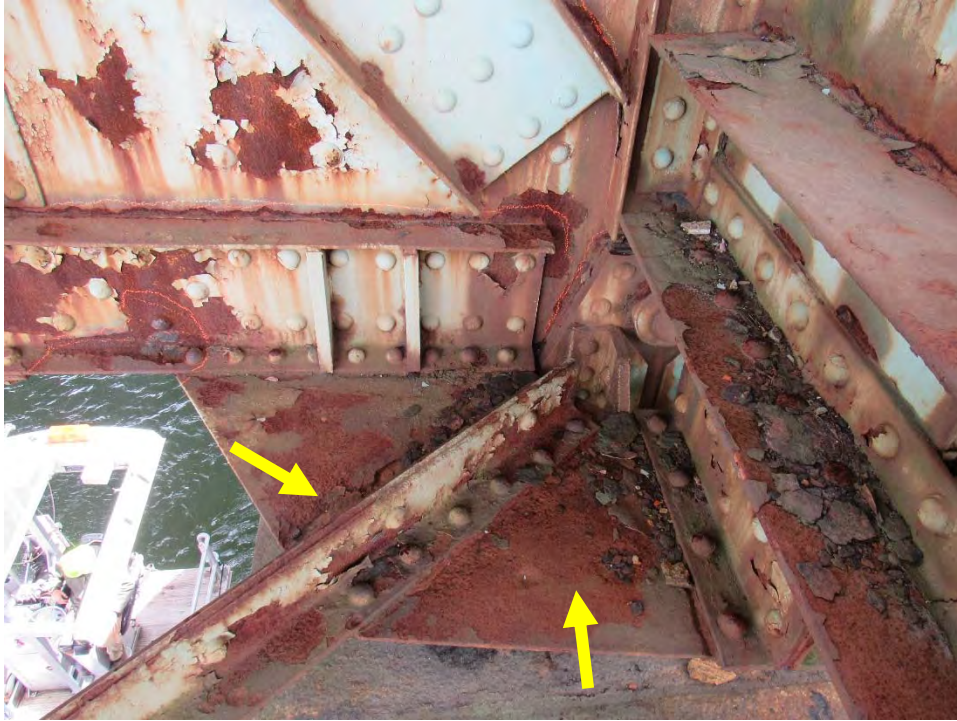
Photo D36: Span 3 Lower Lateral Bracing and Connection Plate Deterioration

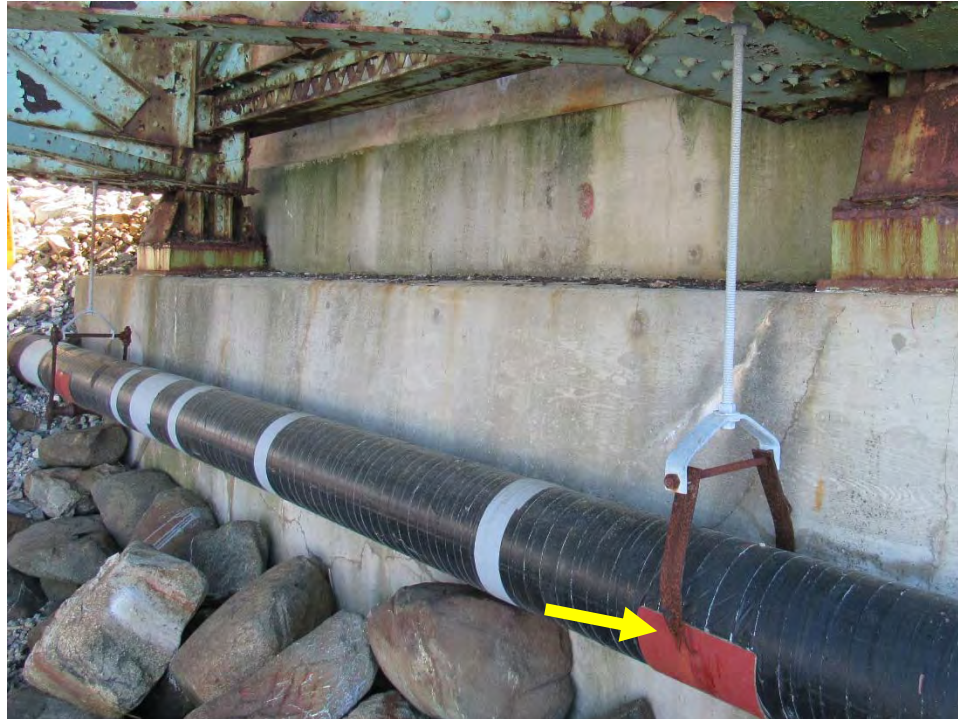
One of the two brackets supporting the gas line, which runs in front of the Newington Abutment, has completely deteriorated and broken off. (Photo D47)

Photo D47: Gas Line – Broken Utility Bracket
